SCHOOLS DEVELOPMENT AUTHORITY

Facilities Condition Assessment Report

Camden High School Camden, NJ

As of April 2012

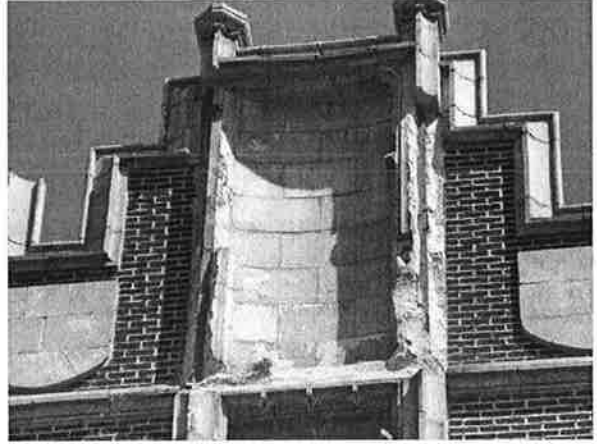
- Terra cotta – Architectural features are in terra cotta and in poor condition, especially at finer details. All terra cotta joints are in poor condition, while approximately 25% of terra cotta work missing or deteriorating. Of note are the small bushes growing from terra cotta at parapet wall. In numerous locations, the structural steel supporting the terra cotta is exposed; a temporary, spray-on cementitious terra cotta repair was observed in several locations.

Typical Terra Cotta Deterioration

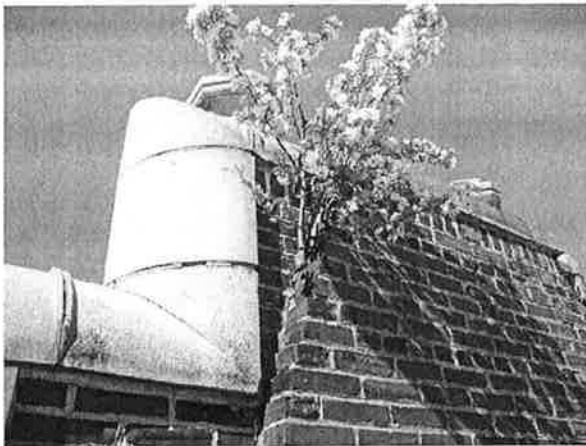
Parapet wall with Vegetation (common)

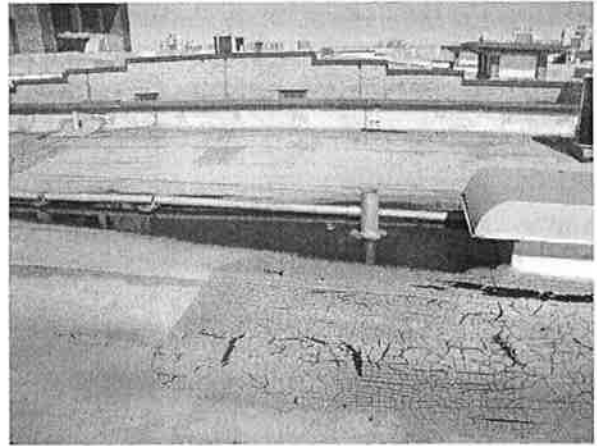
- Roof and gutter system – The roofing system is comprised of membrane multi-ply hot mopped modified bitumen sheets. This surface has been painted and is showing signs of nearing the end of its useful life. Alligating and bubbling were observed on various locations, while standing water was observed on a southeast section of the roof. One corner of the roof showed signs of tearing from the flashings and deterioration of the roofing material. Age of roof is unknown. Roof drainage via internal roof drains.

1916 Roof w/ Alligatoring and Standing Water

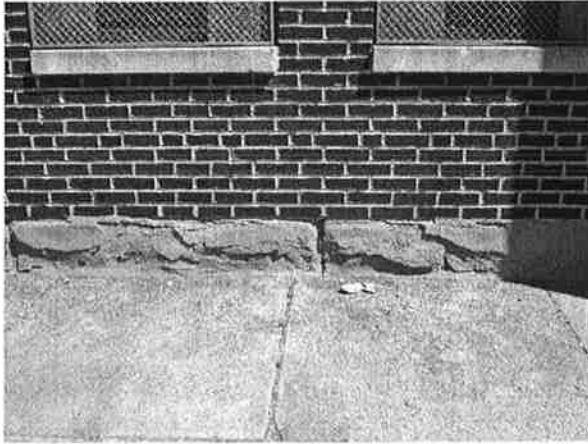
Spalling Bluestone Plinths

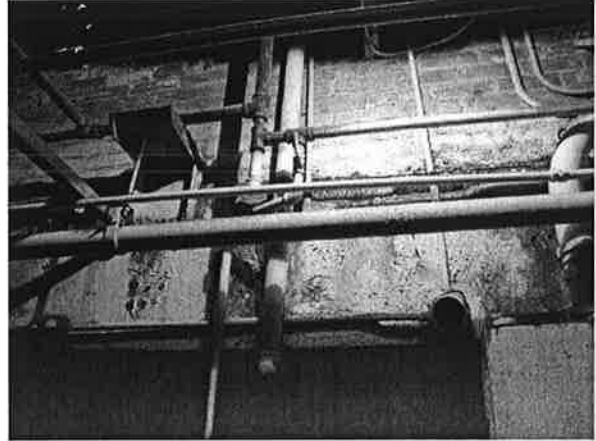
- Basement– The basement appears to be sound and dry. A concrete beam located in the center of the boiler room is cracked, while a beam along the back wall of the room has exposed rebar.

Deteriorating beam in Boiler Room

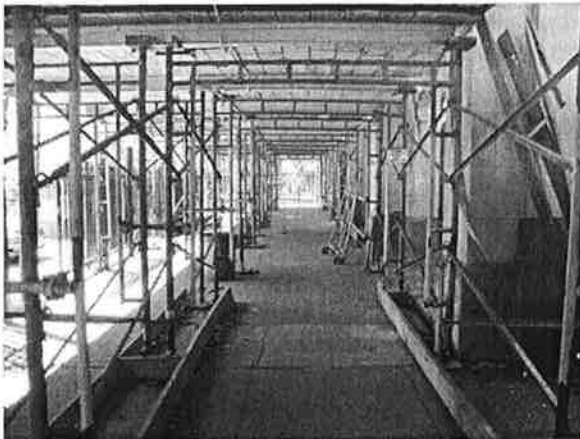
- Exterior Scaffolding – Scaffolding was installed to provide pedestrian protection at the entrances/exits to this section of the building due to falling terra cotta; installation was completed in 2007 by NJSDA. Scaffolding was observed in place at the entrances/exits located on the Garden Drive and Baird Boulevard sides of the building. Observation from underneath of the scaffolding shows rusted scaffolding pipe and rotting wooden bases.

View Underneath Scaffolding

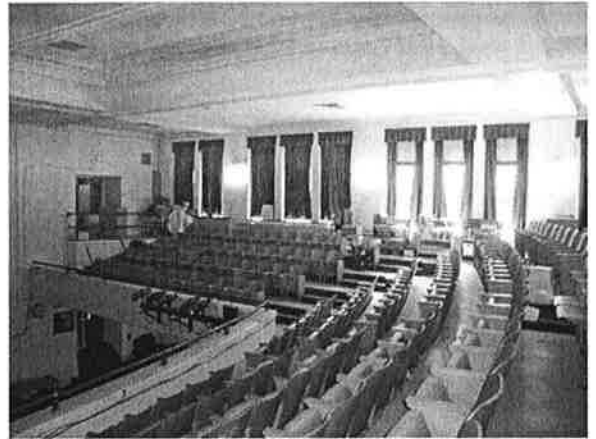
- Auditorium balcony – District staff indicated the auditorium balcony had been closed for a number of years due to structural concerns; however no published report can be produced by the district detailing the issues with the balcony. Visual observation shows no obvious signs of structural distress.

Auditorium Balcony

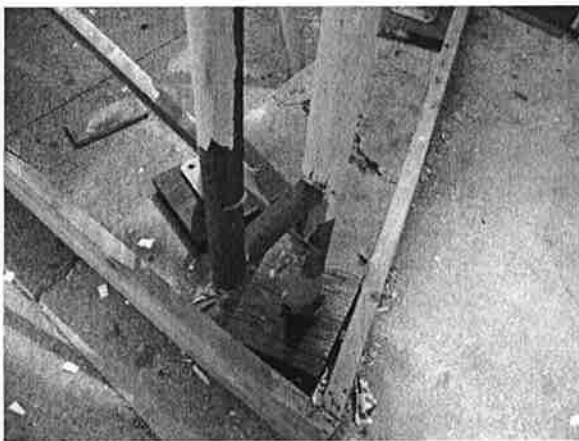
Corroded Scaffolding Pipe

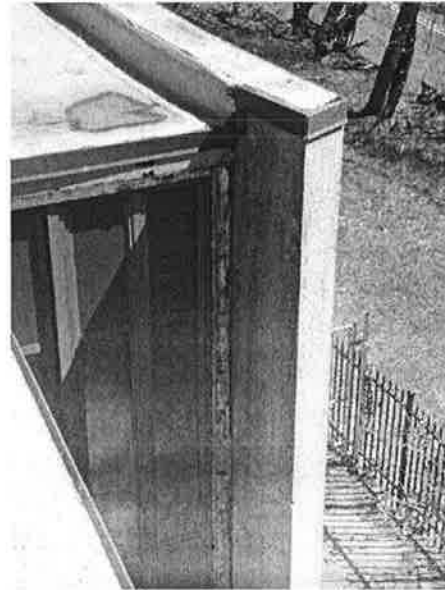
Rusted Window Lintel - Annex Stair Tower

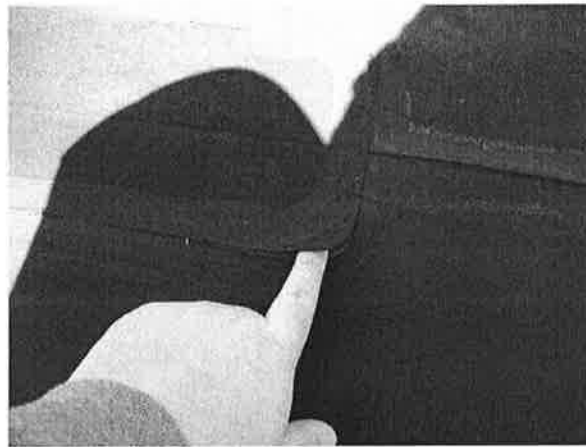
- Roof – The EPDM roof is in fair condition. The surface shows a need for general maintenance at seams and spot locations until such time it is replaced.
- Masonry – Brick facing on CMU walls was observed to be in fair condition.
- Basement – The half basement within the three-story pod was observed to be sound and dry.
- Roof construction – Steel I-beam structural system with lightweight concrete panels. No issues observed.
- Windows – Single-pane windows appear to be original. All windows are enclosed with metal caging. No issues were observed or reported.
- Exterior doors – Building has metal doors in varying condition that appear to be functional.

Faulty Seam on Vocational Wing Roof

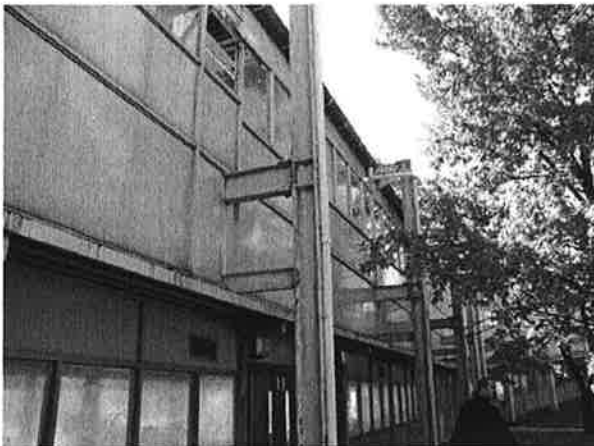
- **Structural Steel Columns** – Issues with the exterior structural steel columns supporting the 1970 bridge have been reported by the District. Only the first floor of this bridge is open for use; the second floor of this bridge is closed due to these District reported structural concerns. SDA staff has requested a copy of any existing reports concerning these issues; further investigation is warranted.

Steel Column Supports for 1970 Bridge

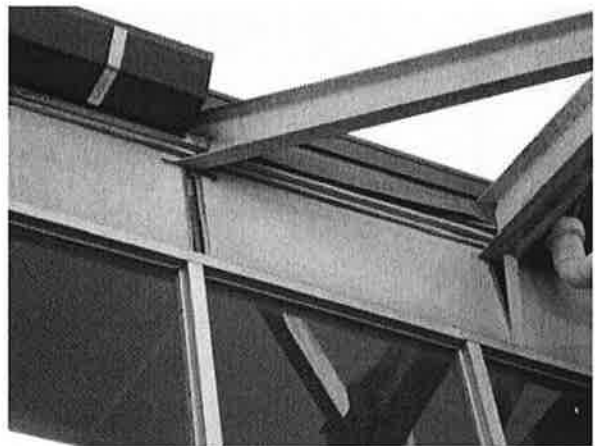
Structural Steel Joints with 1970 Bridge

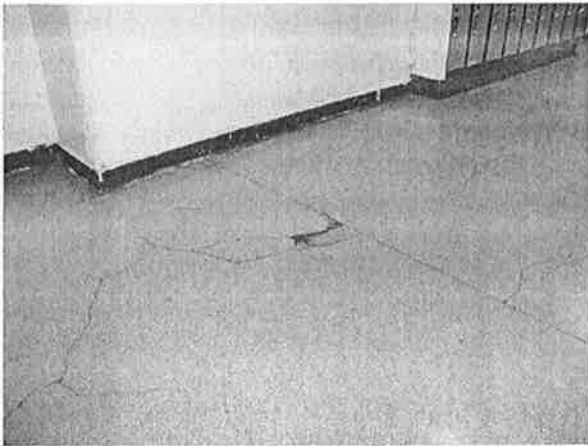
Cracked Terrazzo Floor in Basement

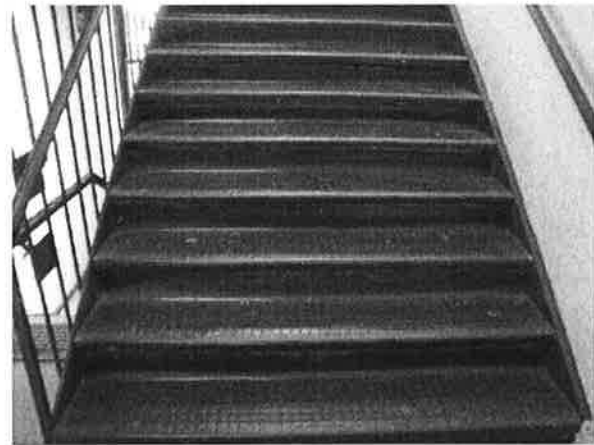
- Stairs – Treads (of unknown material but likely terrazzo) have anti-slip coverings in fair condition with the need for replacement. Walls within the stairwells are plaster while the landings are 12”x12” VCT. Both walls and landing surfaces appear to be in good condition.

Typical Stair Treads

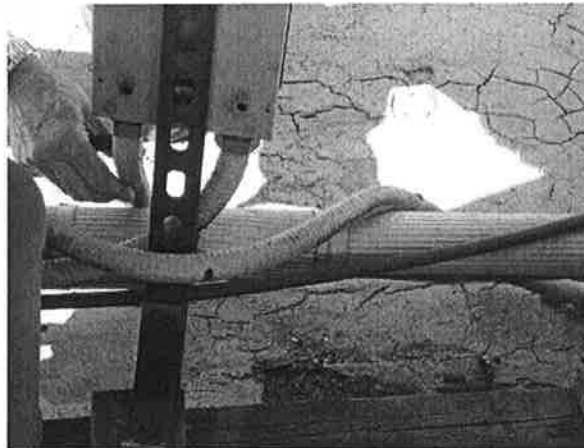
- Ventilation – SECTION REDACTED
- Air conditioning – Air conditioning was not present in classrooms within this section of the school. Some rooms are air conditioned by residential Air Conditioning (AC) units utilizing rooftop condensers. Condensers for the split system in the cafeteria and weight room are located on the rooftop. Dated to 1993 and 1994, many of the condensers are in poor condition with rusted and/or loose electrical disconnect boxes. Many of the disconnect switches for the condensers show corrosion on tops of switches and are inadequately supported (loose, wobbly or fallen).

Loose Electrical Conduit from Disconnect Box

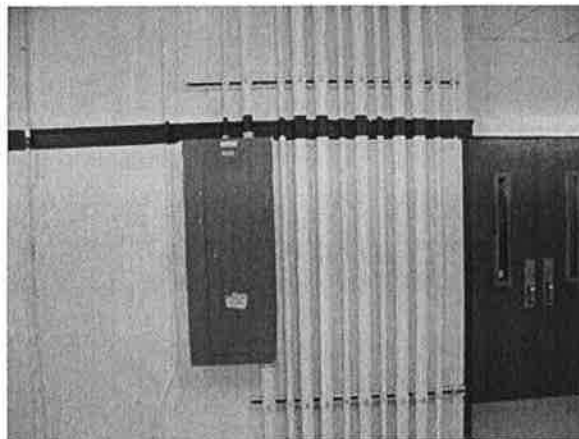
- Panels - Lighting, receptacle, computer and HVAC panels are located in corridors which do not conform to current standards requiring panels to be installed in electric closets. Exterior trims are in fair condition. Visual inspection of wiring in a few selected panels did not display signs of discoloration or brittleness. Wiring connections were tight.

Typical Electrical Panel in Hallway

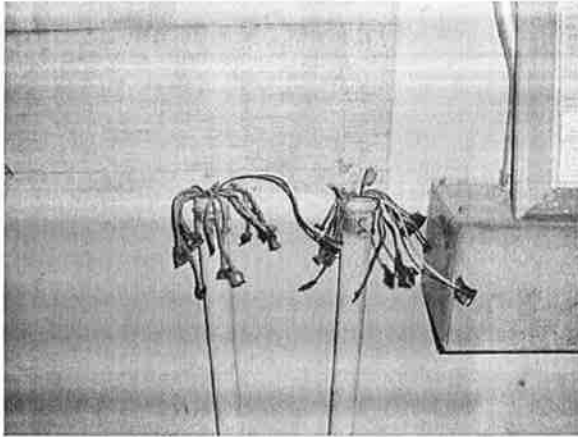
- Main Electric Room - The vocational wing pods are served by a type 2 switchboard (front and rear accessible) with thermal magnetic circuit breakers manufactured by Square D. Inspection sticker dated 1972. Exterior condition of switchboard shows no corrosion and looks in good condition.
- Mechanical Area - An electric hot water heater front panel cover was removed and needs to be reinstalled for safety.
- Stairwells - Conduit penetrations through stairwell are not fire-stopped.
- Mechanical Area - Two (2) conduit stub-ups containing wiring hanging out and taped off without being concealed in an electrical box. Unknown if wiring is live or abandoned in place.

Loose Wiring out of Conduit Stub-ups

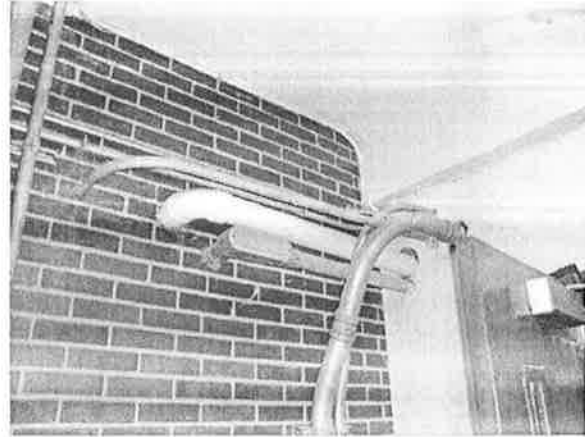
Conduit Penetrations through Stairwell

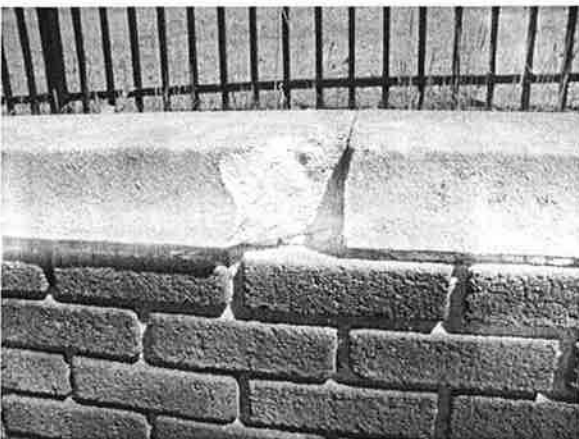
- Retaining Walls - Brick retaining walls were observed on the Garden Drive and Park Avenue sides of the property; poured concrete retaining walls were observed in the rear of the main building and on the Baird Boulevard side of the Annex. All walls were observed to be in poor to fair condition.

Damaged Retaining Wall Coping

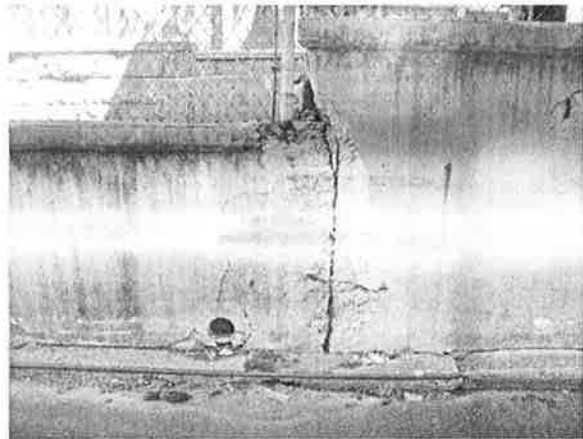
Damaged Concrete Retaining Wall
