SCHOOLS DEVELOPMENT AUTHORITY

Facilities Conditions Assessment Report Cleveland Street School 355 Cleveland Street Orange, NJ

As of April 2013

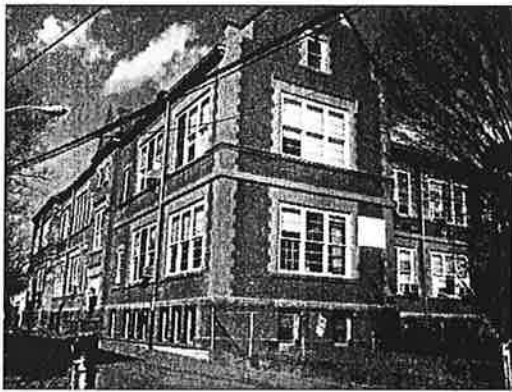
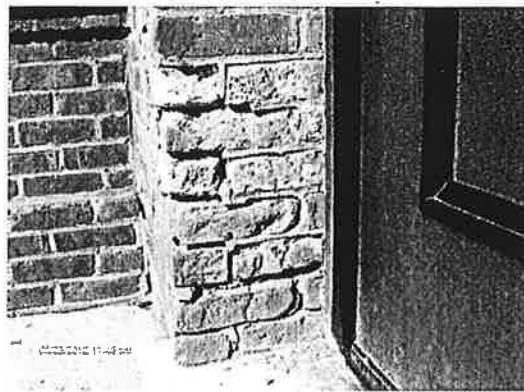
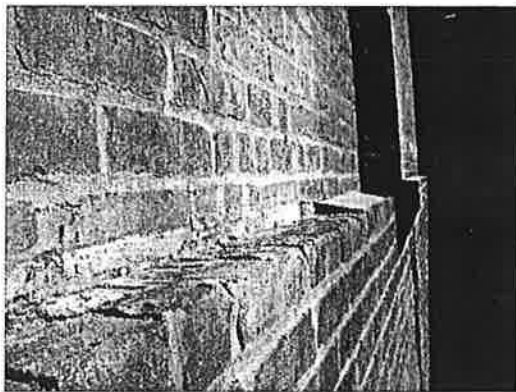
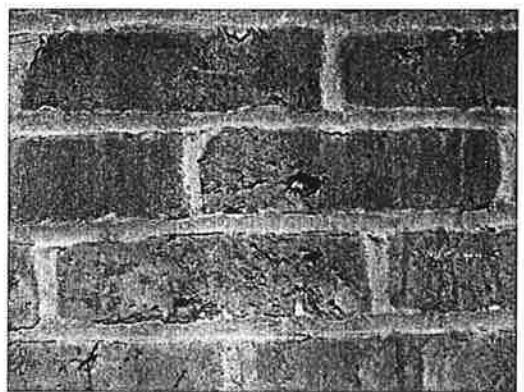
- **General:** The Cleveland Street School is two story multi-wythe brick structure with a full basement, partially below grade. The exterior brick is in relatively good condition considering its age and requires limited spot repointing. No visible cracks in the foundation walls or unusual settling was observed. The façade at the rear side of the building has multiple areas of deteriorating brick surface however no signs of water infiltration were observed on the corresponding interior walls.

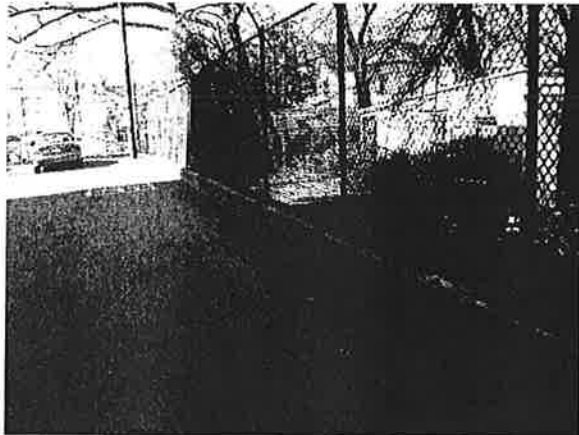
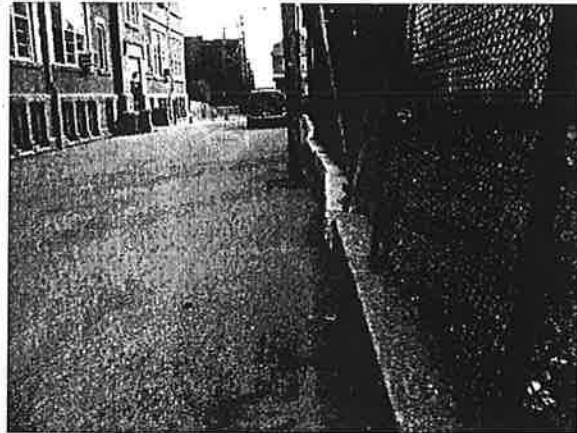
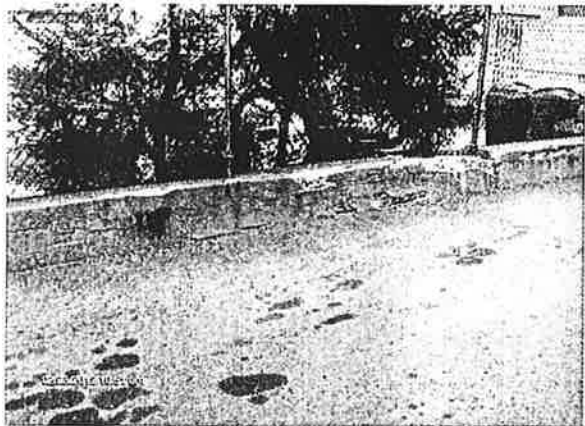
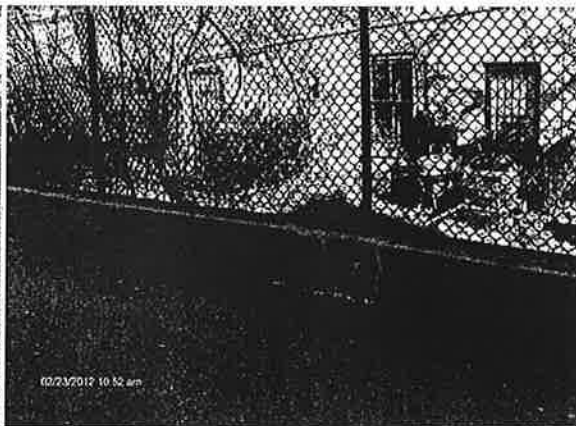
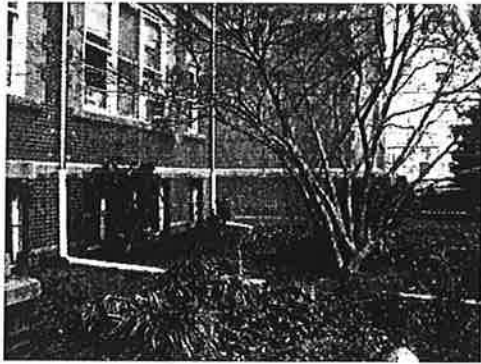
There are paved driveways on the north and south sides of the school which lead to a paved court yard in the rear. An eight foot high chain link fence runs the full length of the property sides and rear. The fence posts are embedded into a curb that sits on top of a retaining wall which gradually increases in height from front to back of property. The fence and posts are bent and showing signs of age. Several sections of the retaining wall curb cap are cracked and or displaced.

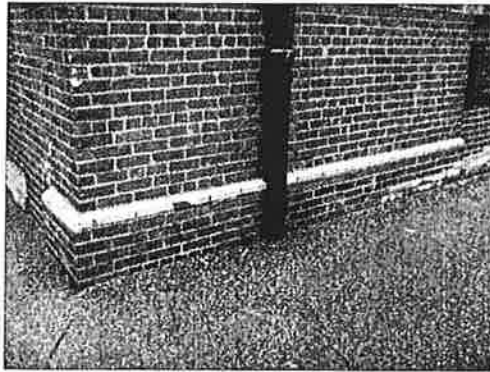
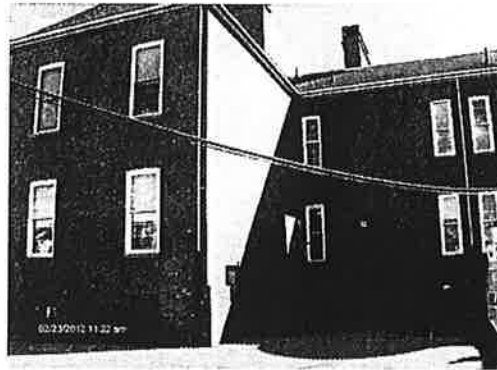
At front of the school, two lawns with gardens are found on each side of the main entrance walkway surrounded by a chain link fence. Water infiltration was reported and evidence in the form of spalling observed along the interior of the east side basement wall below grade. Roof leaders in the front of the school discharge onto the front lawn area. Berms in the garden create a condition that may result in surface water being trapped and directed towards the foundation rather than away.

The outside rear corners of the school are unprotected from vehicles accessing the rear courtyard or making deliveries. There are no steel bollards at the rear corners of the building to prevent damage from vehicles maneuvering in close conditions.

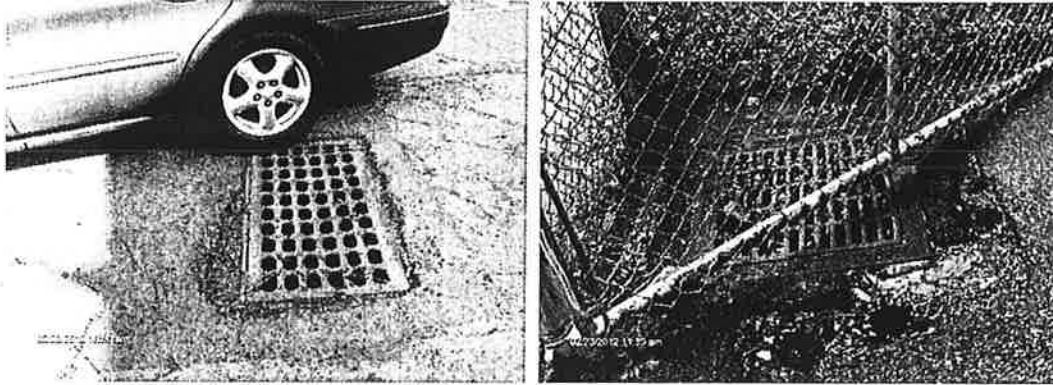
- **Site Drainage:** Three area storm drain inlets at the rear of the building appear to be full of debris. It was reported these lines are clogged, causing water ponding in the play area and driveways. The drainage lines run from the rear of the school around the sides and discharge in the street. Roof leader downspouts on the north side discharge onto the paved driveway causing icy conditions in the winter. The remaining side and rear downspouts discharge underground directly into the storm drain piping system. Further investigation of the operation and condition of the site drainage lines should be considered.

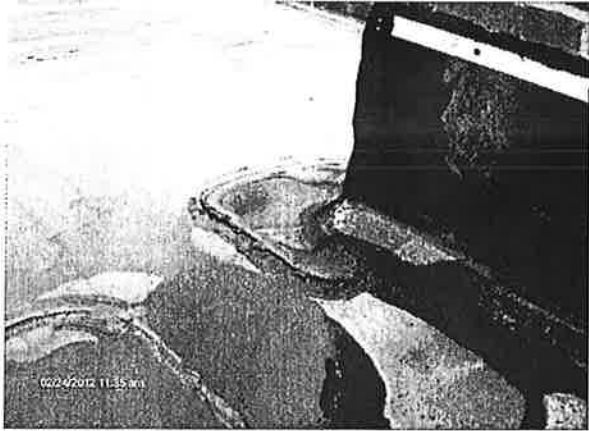
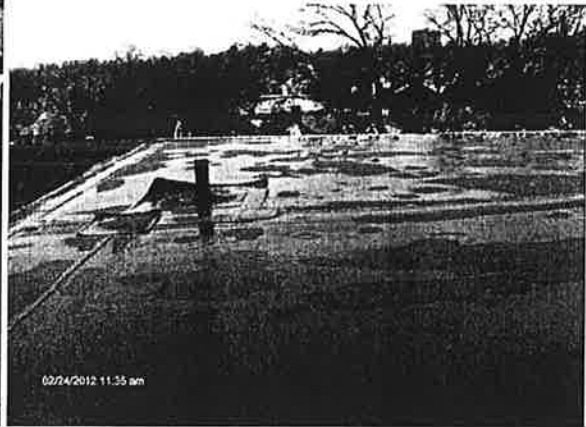
An approximately 2,440 square foot Ethylene Propylene Diene Monomer (EPDM) roof on the center portion of the south wing is showing signs of wear. Seams and patches are delaminating and there is an active leak coming from this roof into the South Stair A.

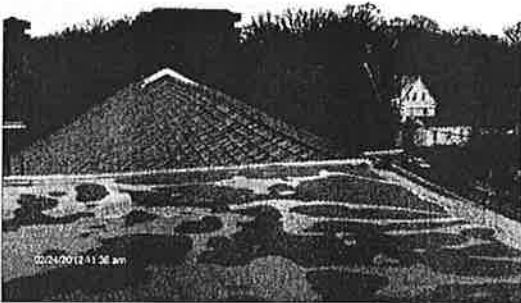
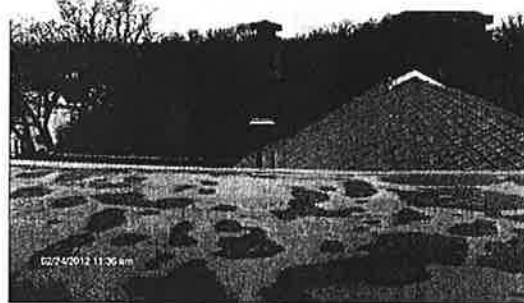
From the ground in the rear of the school it visually appears that there is a dip in the roof ridge beam that runs north and south between the two side wings. An inspection of this area from the inside the attic space did not support the condition observed from the ground. From in the attic space there were no internal visual signs of sagging.

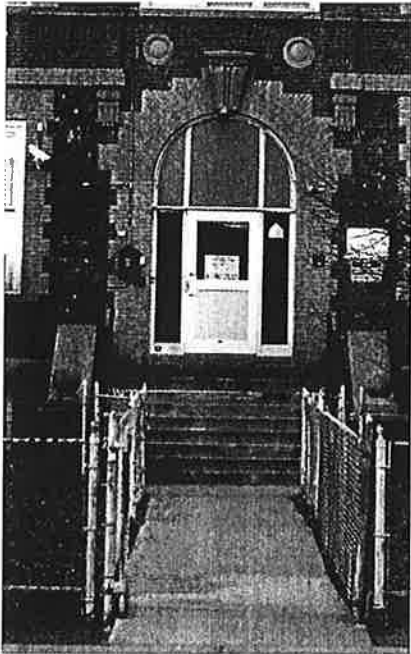
The existing EPDM roof and roof framing appears to have been built over a previous existing slate roof. The area between the two roofs is littered with old slate roofing material adding an unwanted dead load to the structure.

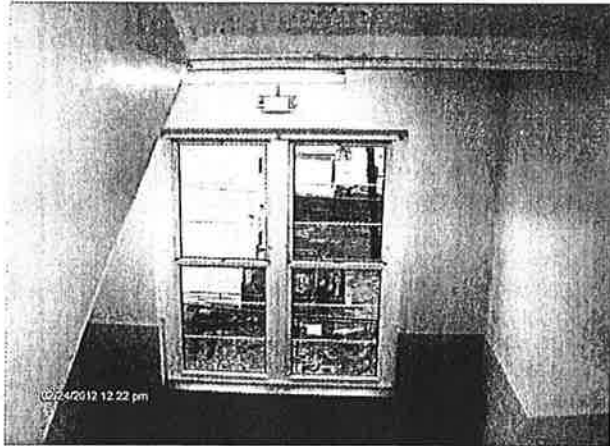
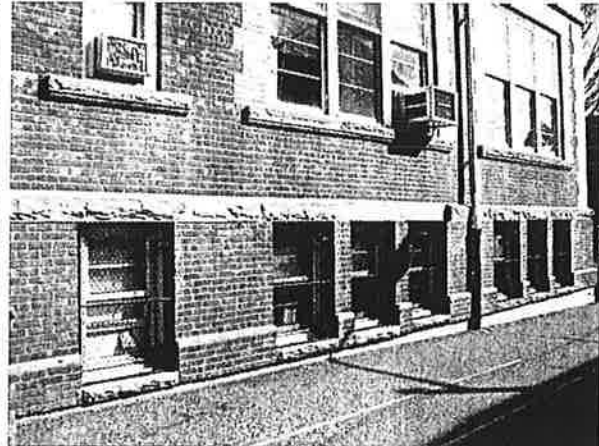
- **External Windows:** Windows are double hung with insulated glass and insect screens while Basement windows have heavy wire security screens on the outside. A random sampling of 53 of the approximately 212 active windows showed 6 windows (11%) either would not open or hold position when opened. All windows should be tested for proper operation.

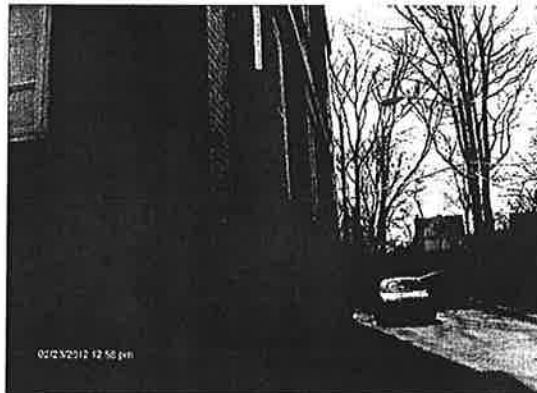
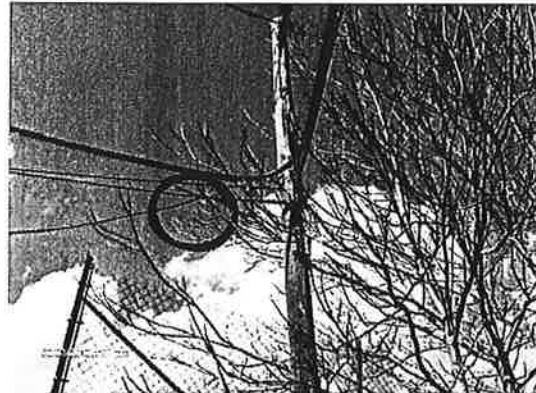
- **Exterior lighting:** Exterior lighting is provided by street lights mounted on wooden poles that surround the school property. There are two lights in the rear, two on the south side, one on the north side and one light in the front of the school. Several of the wooden utility poles in the rear of the property are deteriorating.

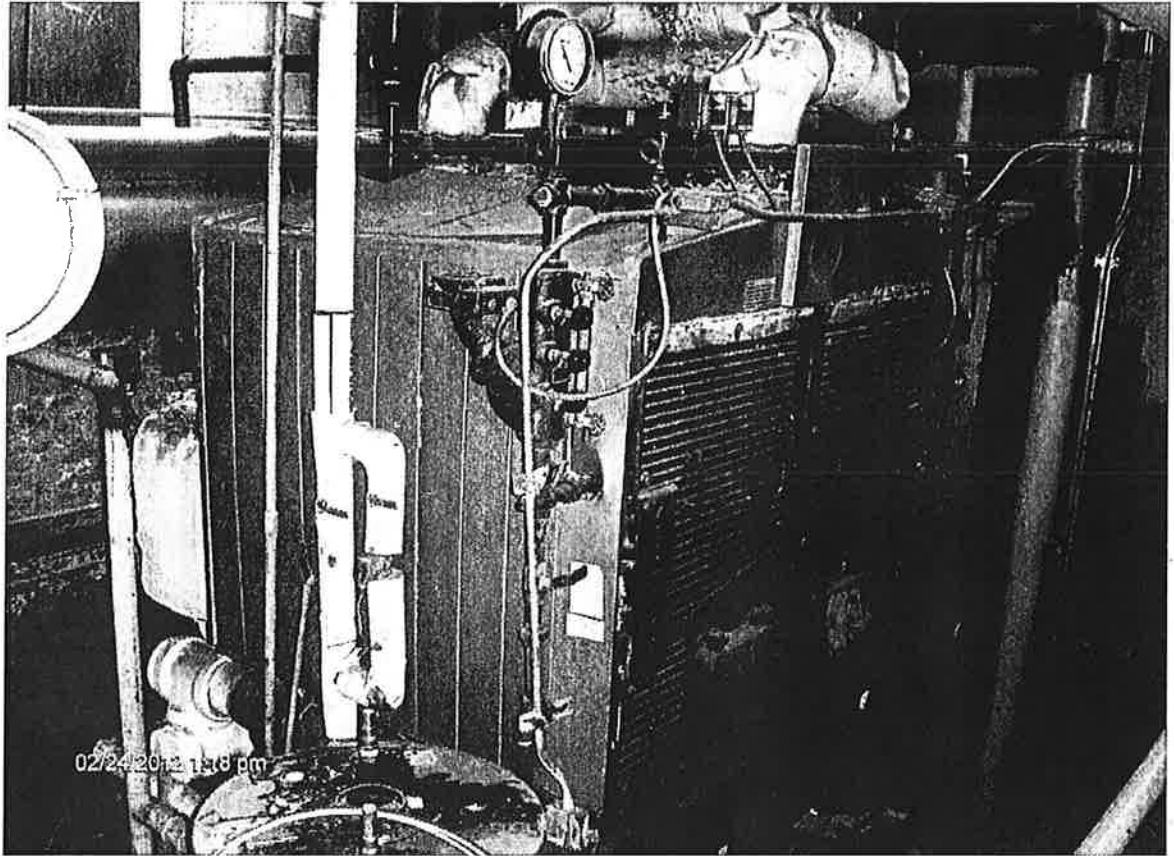
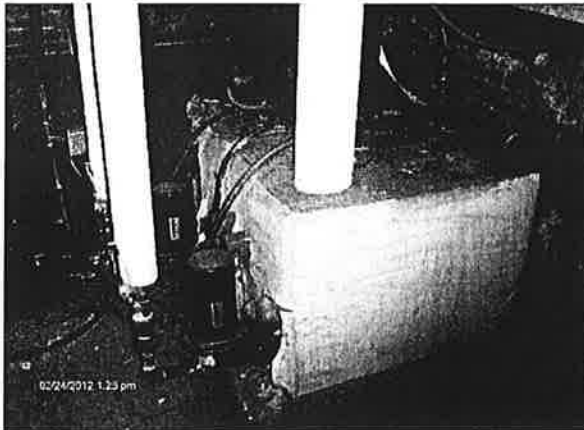
Heat is provided by two (2) 1965 H.B. Smith gas fired cast iron 10 section low pressure steam boilers.. The boilers were not in operation during the site visit and neither current nor expired Certificates of Inspection were available or posted in the boiler room at the time of the site visit.

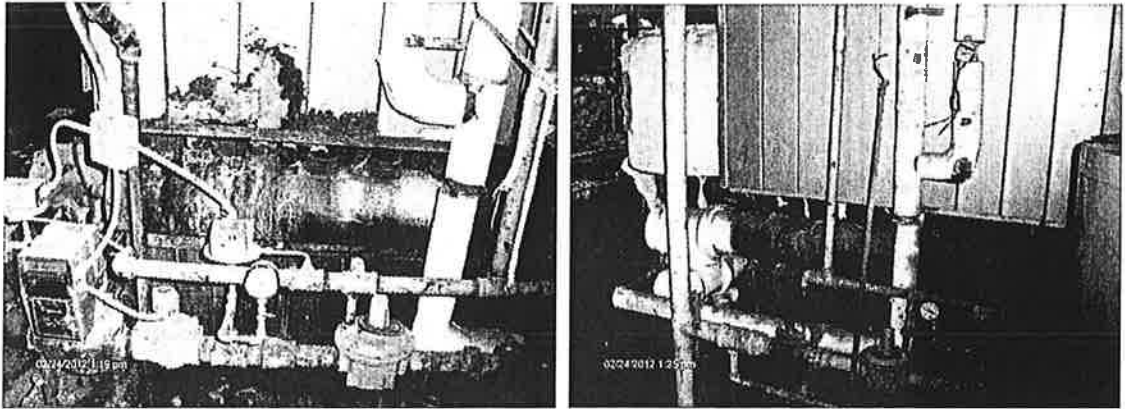
Visual evidence was observed of active leaks at the mud drums of both boilers. Several nipples connecting boiler sections to the mud drum are leaking. The leaks in boiler #2 are so advanced they have rusted through the boiler jacket above the right mud drum.

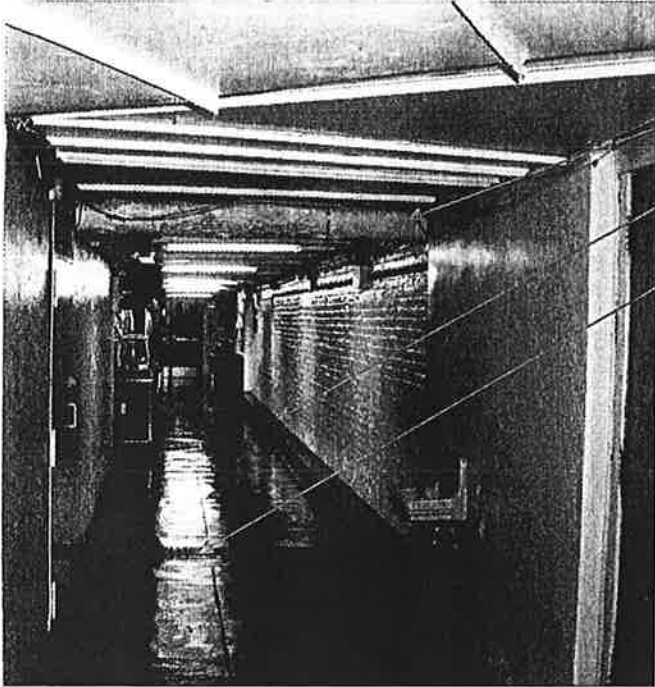
Steam and condensate piping run along ceiling, walls and floor in basement.

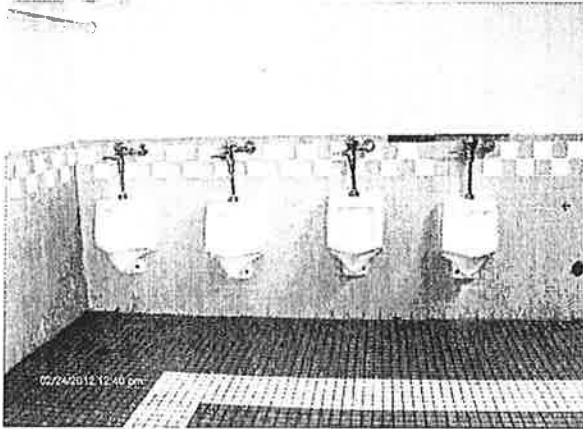
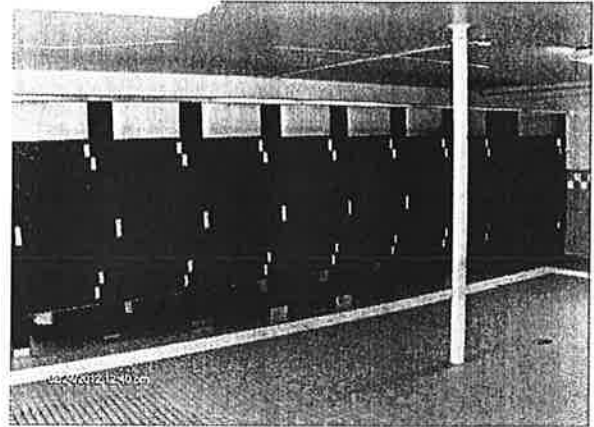
- Plumbing:** The only student restrooms for grades 1st -7th are located on the basement level. Both the Girls and Boys rooms are excessive in space. The Boys room has six sinks, four wall mounted urinals and eight toilet stalls. The Girls room has six sinks and twelve toilet stalls. The windows in both rooms are boarded over and ventilation is provided by small residential type exhaust fans.

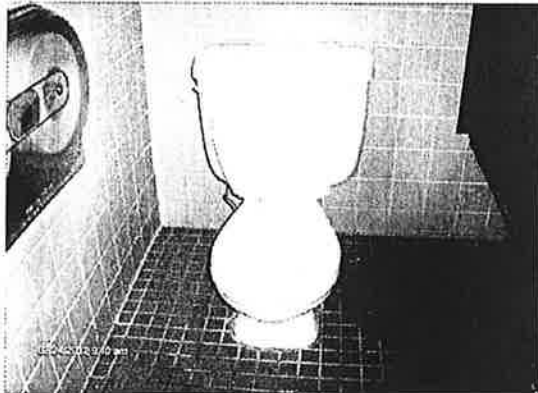
Kindergarten Restroom

A 1st floor hallway janitor's closet has been converted into a restroom for Kindergarten rooms 115 and 101 due to the Kindergarten classrooms not containing toilets. This restroom has two age appropriate toilets and a full size slop sink. The first floor Nurses Office also has a restroom with toilet and sink. There is a water leak in the ceiling of the basement food storage area which is directly under the Nurse's Restroom.

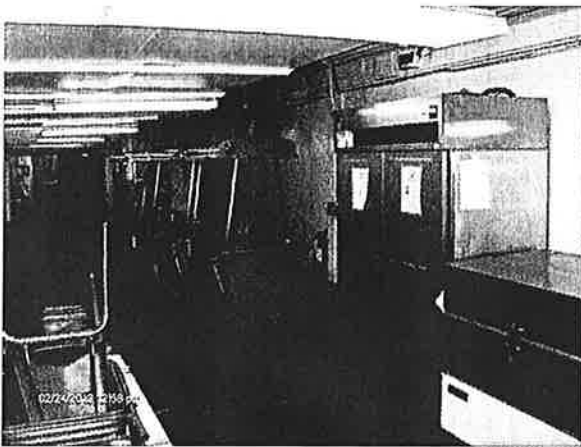
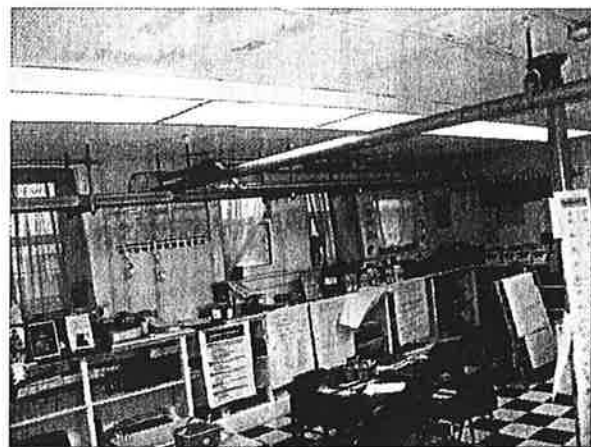
Basement – The corridors have concrete floors with brick walls. The main corridor is used as a kitchen with serving equipment lining the west wall. Heating, sanitary, electrical and water pipes are suspended from corridor and classroom ceilings as well as inactive metal ventilation ducts. Classrooms have concrete walls and tile floors over wooden subfloors. In rooms B07, B07-A, B04-A, B04, and B03 there are areas where the wood subflooring has rotted and failed. Classroom B03 has rotted subflooring possibly from uncontrolled moisture emanating from slab cracks or from seepage in the below grade exterior walls. Evidence of rot was found in the spongy and flexing flooring under the new Vinyl Composition Tile (VCT) in Room B03. This condition is also evident in B07. While there is no observable evidence of similar deterioration in Classrooms B04 and B07 they contained raised wood flooring found on the same slab.

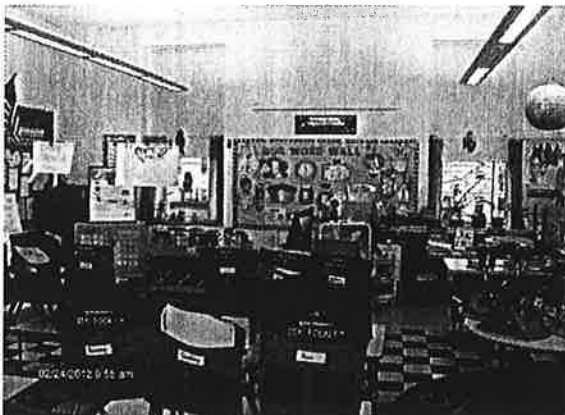
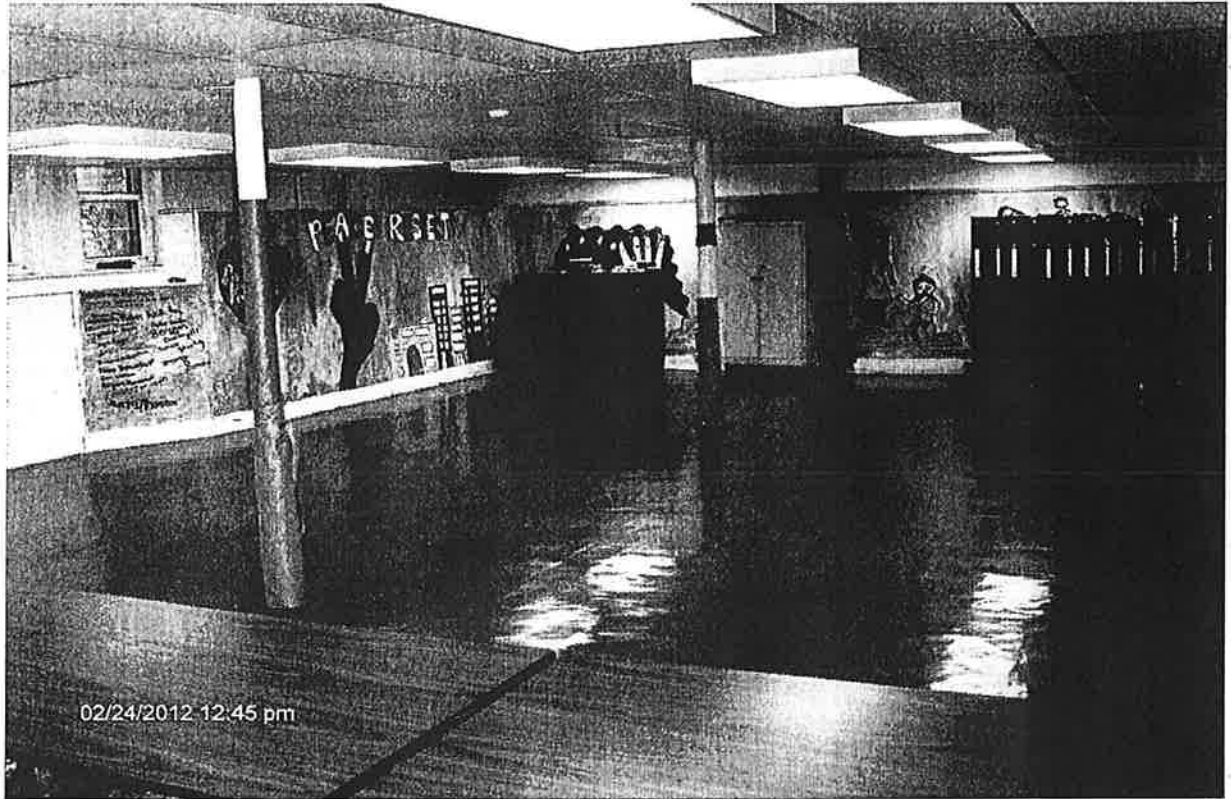
Cafeteria/Activity Room – The cafeteria dually also serves as an indoor activity room and has only one egress door. Since this room could hold more than 50 students, a second door is desirable (CODE mandated for new construction) and could be installed in the corridor wall at the south end of the room. The existing suspended ceiling in the Cafeteria/Activity Room is sagging, stained and provides very low head room clearance. Room does not have sufficient height even without ceiling to meet minimum clearance for gym operation. The surface mounted light fixtures further reduce the available clearance.

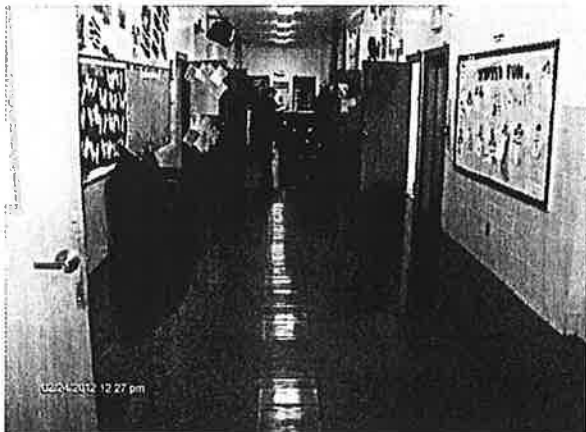
Classroom floors are a combination of 12"x12" VCT, 9"x9" and wood. Ceilings in the classrooms are similar to the corridor, walls are plaster with numerous cracks. On average there are two wall cracks in each room running 3'-4' in length.. Approximately 50 ceiling tiles require repairs.. Pendent style fluorescent light fixtures hang in the classrooms and provide adequate lighting.

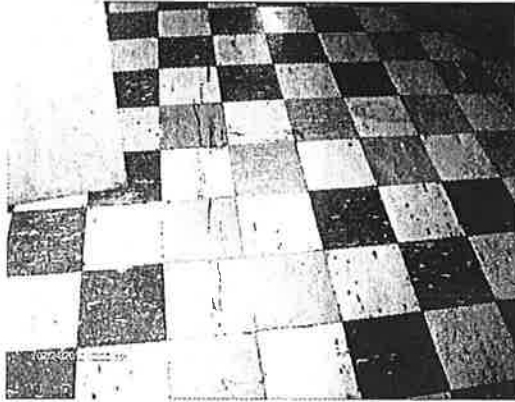
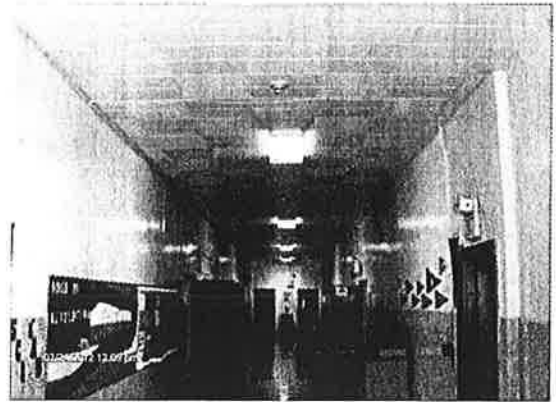
Second Floor – Walls, floors and ceiling are similar to those on the 1st floor and require the same attention with the following exceptions. Corridor floors are 9”x9” (possibly VAT) tiles that are cracking, breaking up and in need of attention. Corridor lighting requires further investigation since there are 45% fewer light fixtures on the 2nd floor than on the 1st floor.
