SCHOOLS DEVELOPMENT AUTHORITY

Facilities Conditions Assessment Report

Connors School

As of June 2013

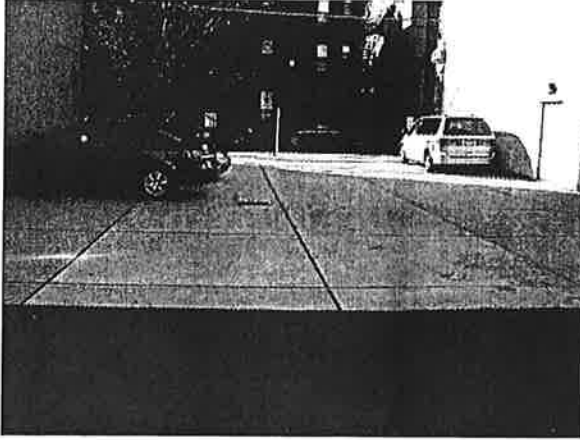
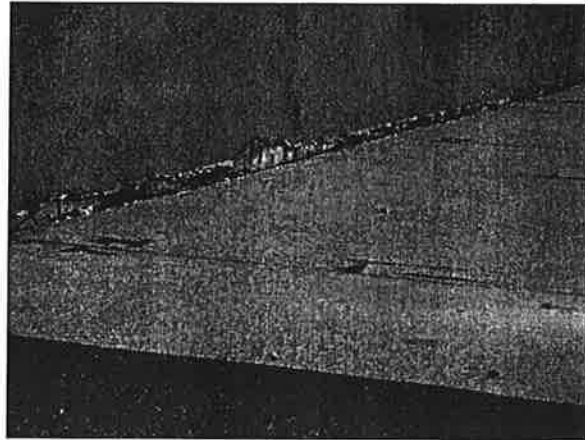
- **Parking:** The remaining open space at rear of the building, measuring approximately 2,600 sf, is a concrete paved surface used for parking and vehicular access to the loading/service entrance. Parking is limited to one handicap designated space and two additional spaces. There was no observed surface damage to the concrete. Due to limited open space on site, there is no parking to accommodate the staff and visitors parking. Signs of settlement on the concrete surface were observed along the adjacent residential building.

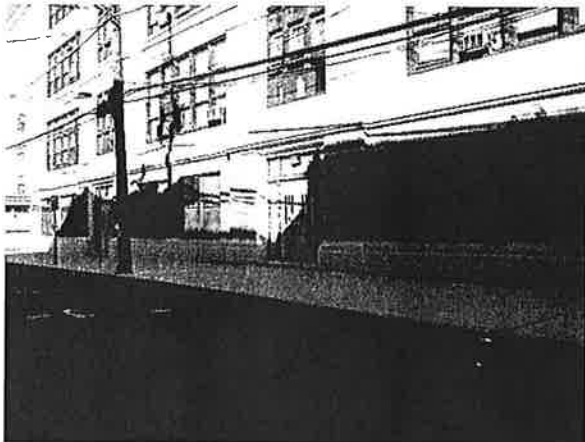
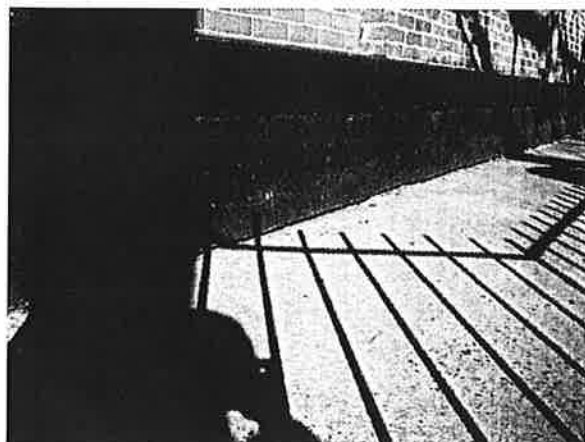
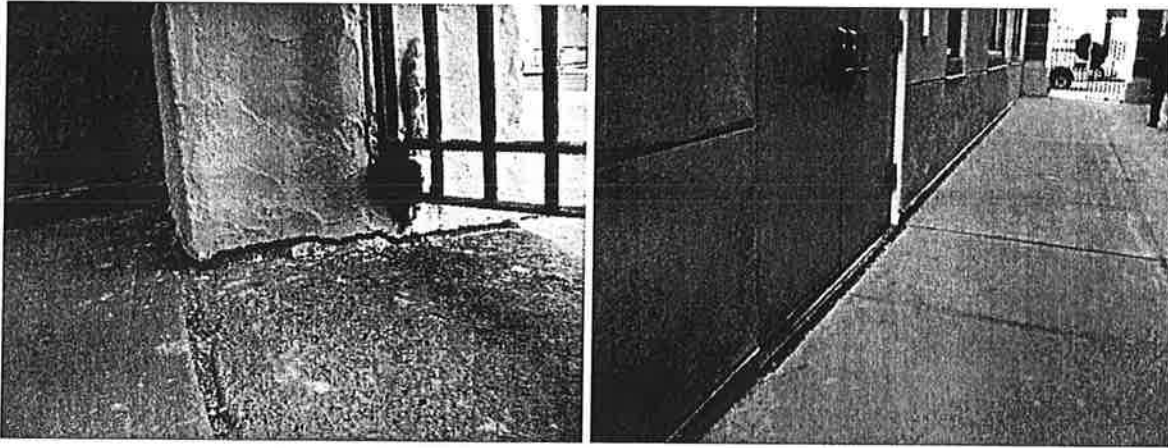
- **Sidewalks:** Sidewalks and curbs on the South side of the building and about 70 % of the West side of the building are newly concrete paved. The remaining West side sidewalk towards North end is older concrete that is showing signs of settlement along the building line.

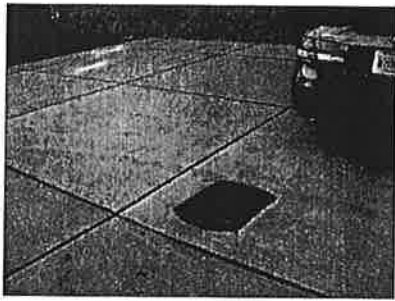
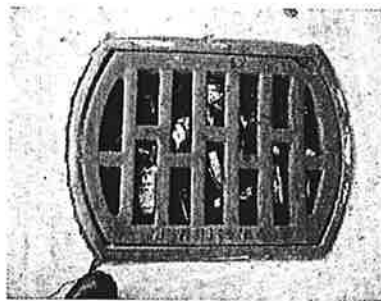
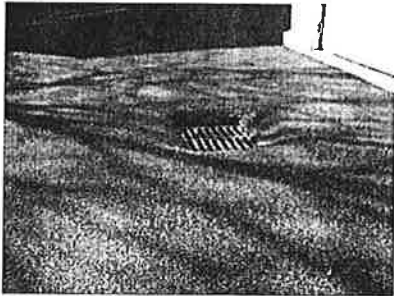
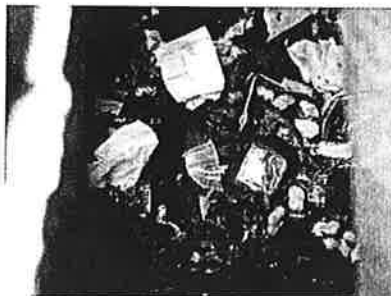
- **Site Drainage:** At the rear side open space there are two(2) catch basins, one within the playground area and the other at the parking lot section. Both catch basins were found to be clogged with debris.

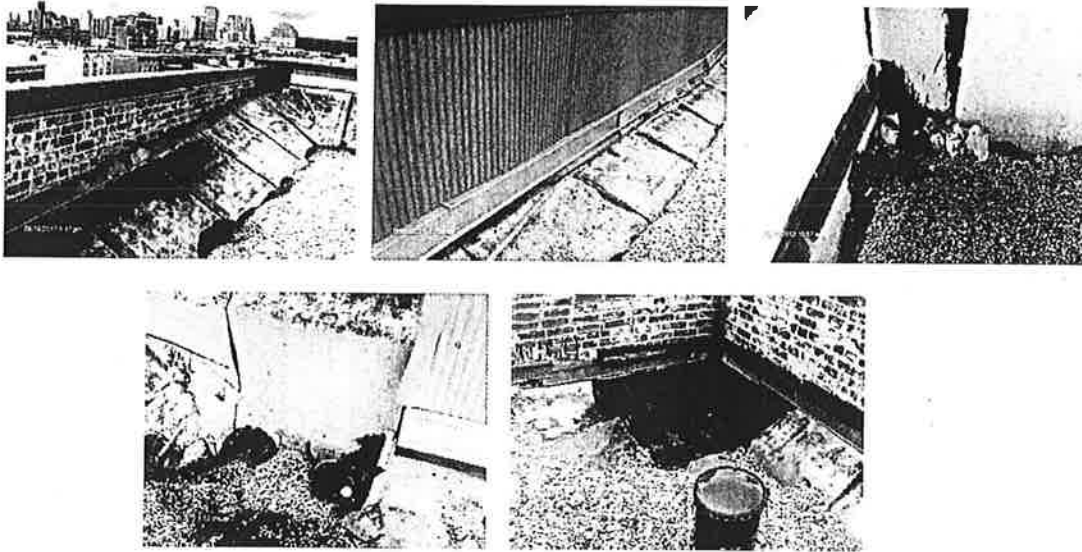
- **Roofs:** The building has Built-up roofs with screened aggregate at two levels, the Upper Roof covers the third floor section of the building and the lower roof covers the gymnasium / auditorium section. The roof over the third floor (approximately 14,916 SF) was replaced under a H&S project in 2001 and is in fair condition with the exception of the parapet covering and flashing which had open seams, loose and missing flashing pieces and termination bars. Roof drains located next to the parapet were covered in debris.

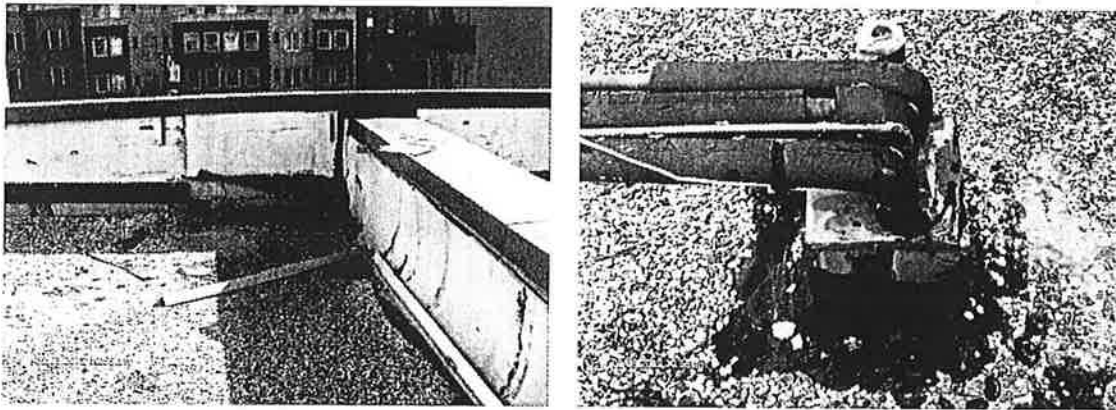
The Lower Roof (approximately 3,536 SF) is partitioned into three (3) sections by up-stand support beams. The three sections of roof and the central dome appear age deficient and the possible cause of water seepage into the boiler room and near the stage section in the Gym. Roof drains leading to internal downspouts were clogged with debris. Flashing sections along the parapet and building were loose, missing and open.

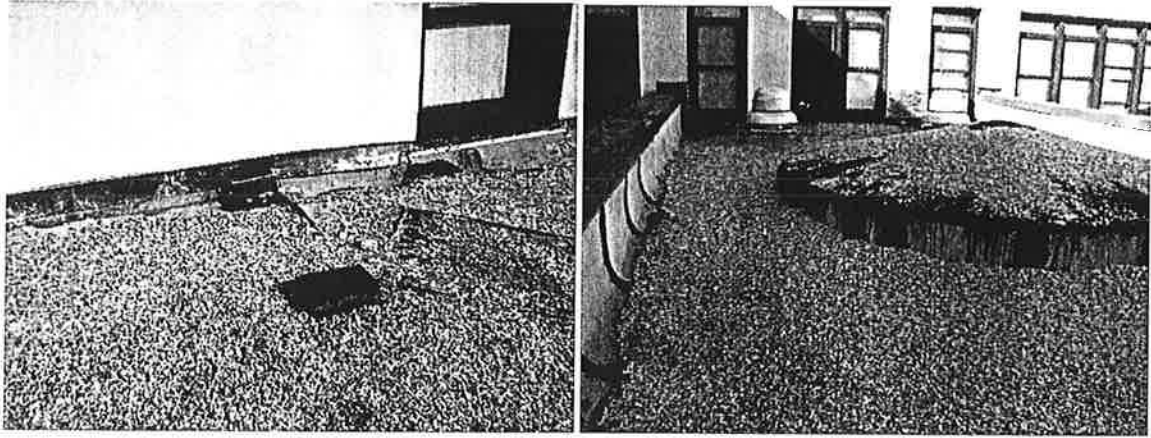
Pitch pockets for pipe penetration are not sealed allowing water infiltration.

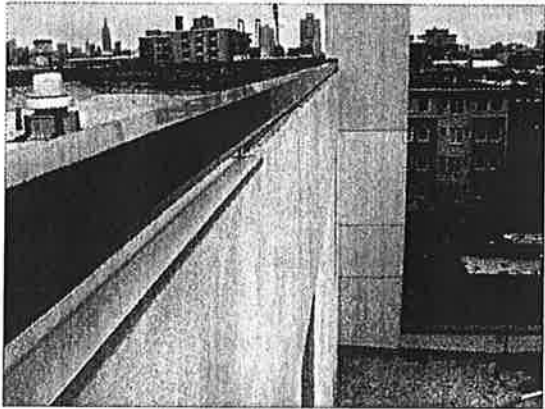
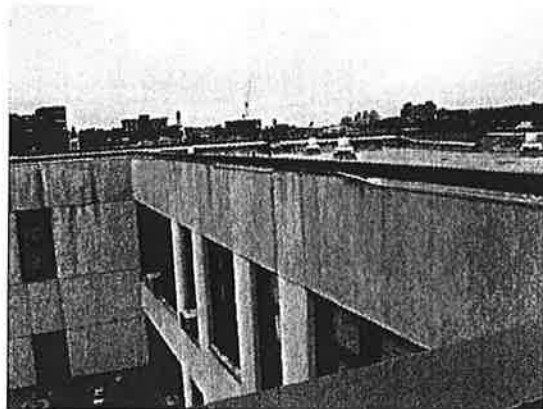
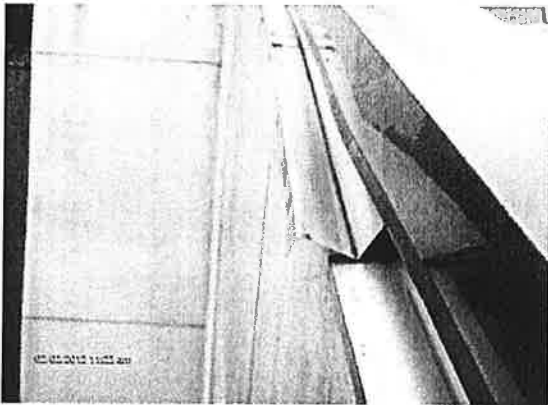
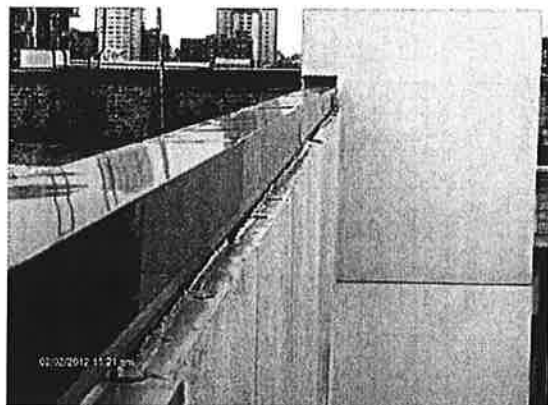
- **Building Façade:** The entire building is brick covered. The brick façades of the building north and east sides have been covered with stucco panels. These stucco panels are described as, elastomeric paint over one inch thick wire lath reinforced stucco over light weight cement backer board furred approximately one inch from the surface of the underlying brick cladding . Some stucco panels have hair line cracks and other minor damage. Missing and loose flashing above the stucco panels was observed at the parapet on the east wall.

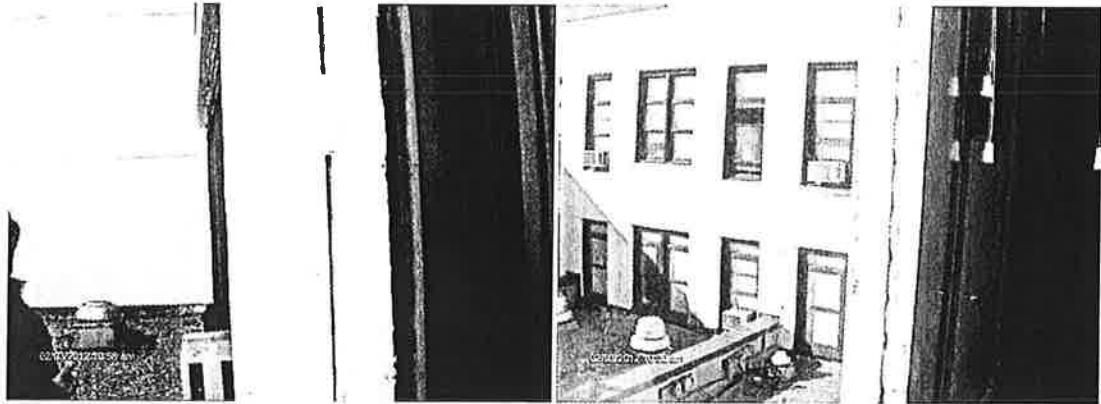
Numerous areas of open and unsealed joints were observed in the stucco wall cladding system around windows and openings leading to potential water infiltration.

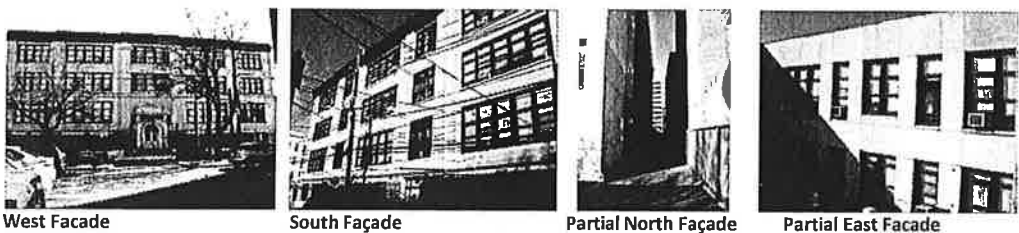
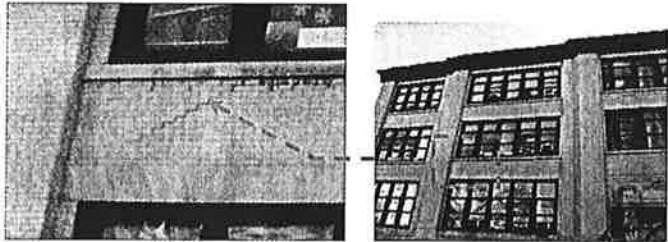
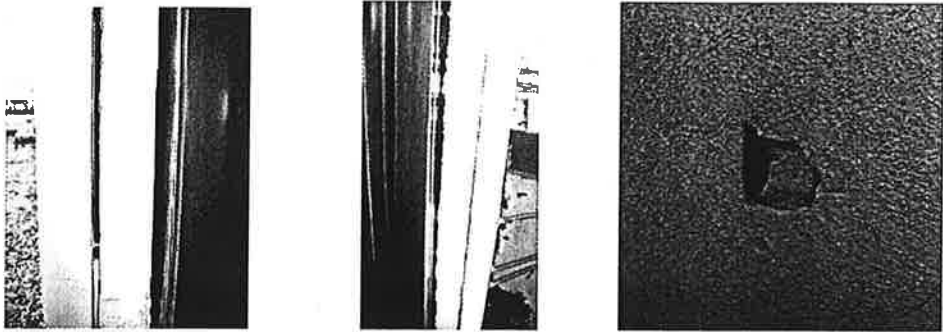
West and the South façades are original brickwork in fairly good condition. Minor step cracks in the brick masonry at the bottom of 2nd and 3rd floor windows on West façade was observed with no reports of water infiltration.

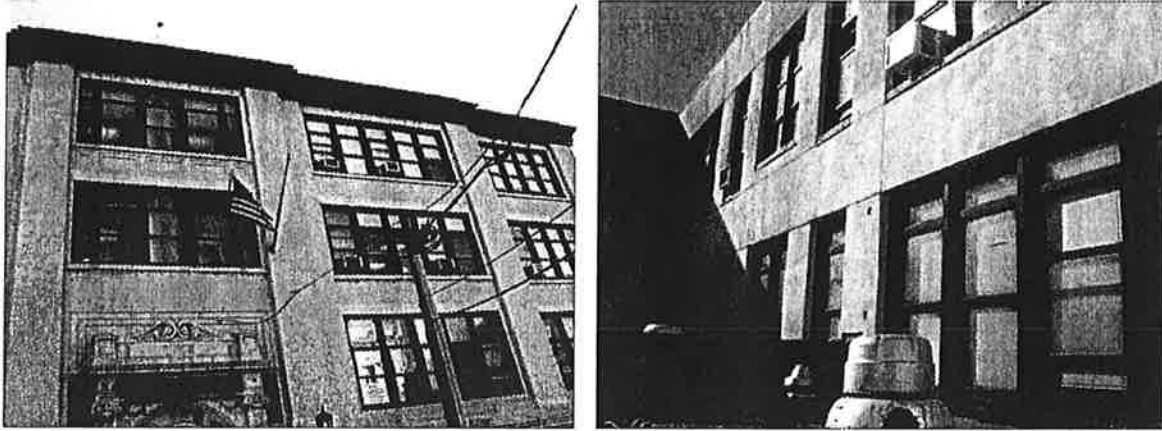
- **External Windows:** All external windows are glass with metal mullion panels mounted on metal frames, all are operational with functional hardware. Several steel lintels over the windows are showing signs of rust.

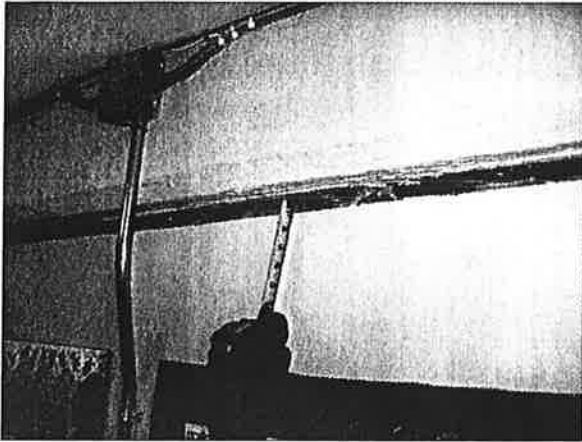
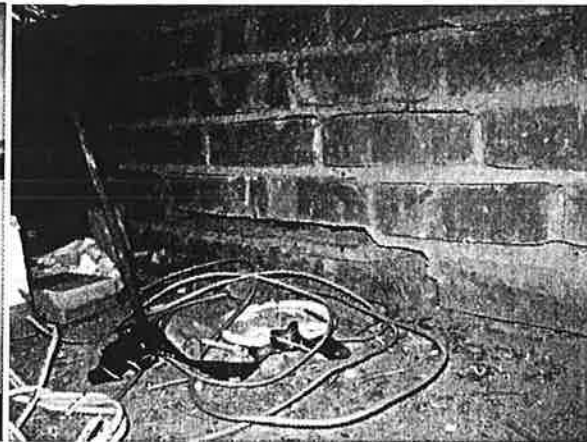
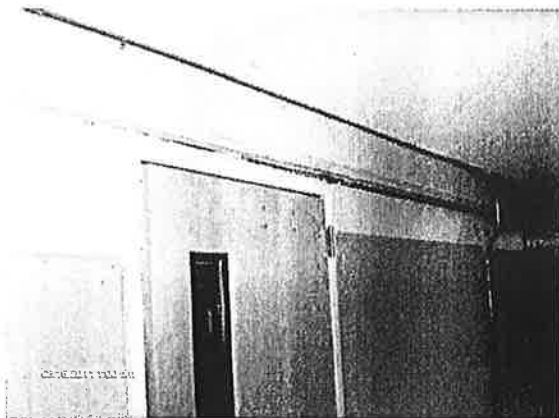
The basement level contains the cafeteria, kitchen, restrooms, storage/maintenance area and several classrooms. A condition exists in the basement where gaps between the floor and wall and walls and ceiling were observed. It looks as if the floor is sinking. This condition appears in the classrooms in the SW corner of the building, the basement rest rooms and several other areas throughout the basement.

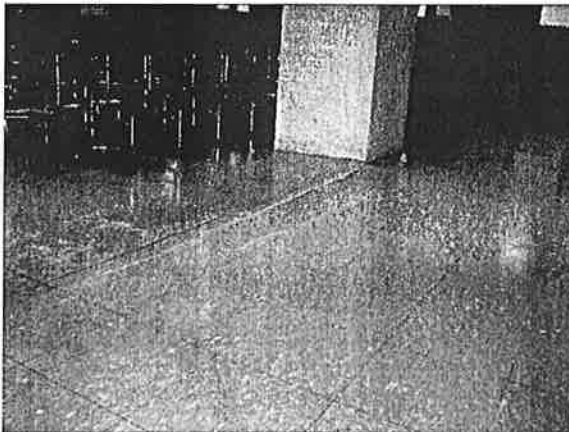
Visually it appears that the floor may be sinking between the column in the middle of the lunch room and the area beneath the stairs at the main entrance. This condition appears not only in the sloping floor but the gaps where the walls meet the ceilings and floors.

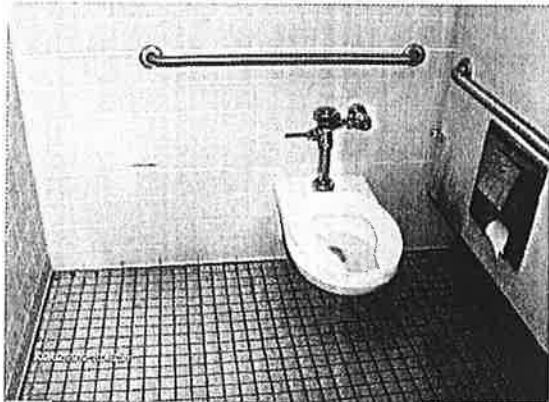
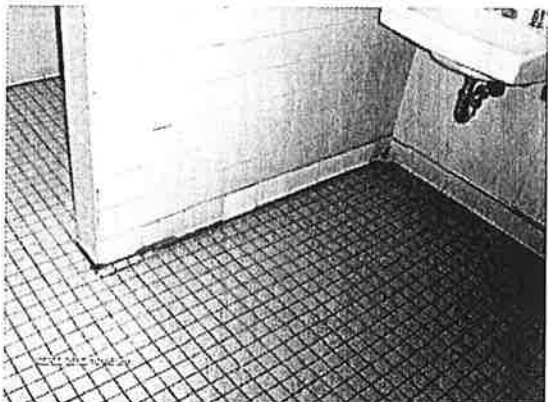
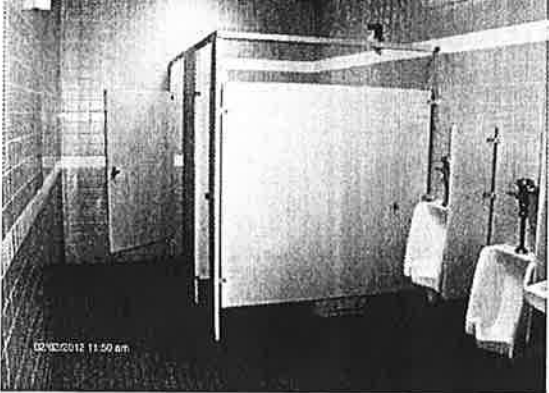
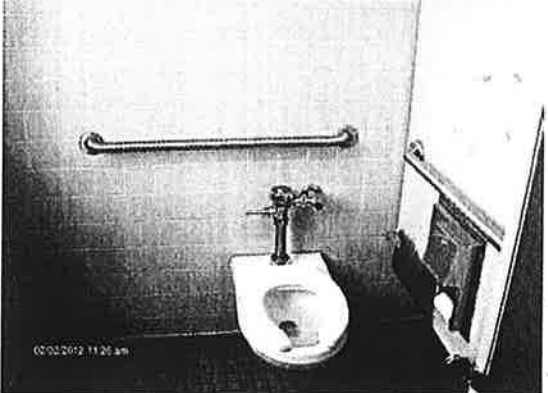
- **Restrooms** – There are boys and girls barrier free restrooms on every floor. Restrooms have 4x4 ceramic tile walls and 2x2 ceramic tile floors, suspended acoustical tile ceilings and fluorescent light fixtures. Restrooms are showing signs of age with cracking tiles and rusting partitions.

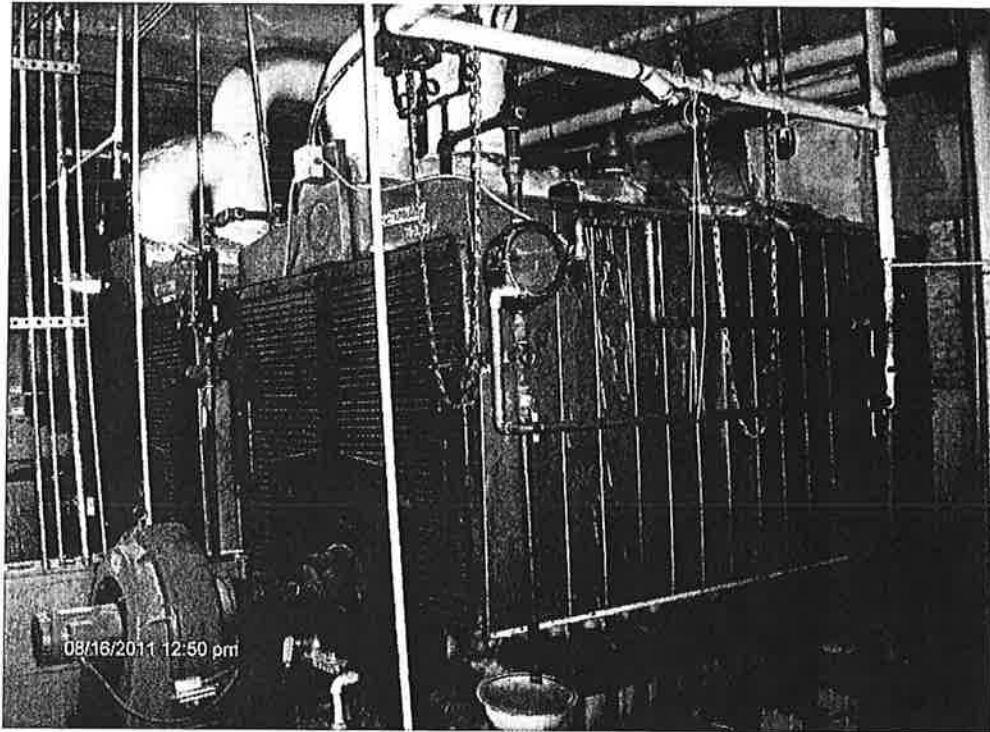
- **Boilers** – Two (2) 1978 HB Smith Model M450L gas fired sectional steam boilers. There was visual evidence of leaks on several nipples leading into the mud drums on boiler #2. No current Certificate of Inspection was posted or available on boiler #2. A Certificate of Inspection for boiler #1 expiring September 6, 2012 was posted. The district reports that boiler #1 is used as the primary lead boiler and that boiler #2 is only run when an operator is in the building and only on colder days. An August 15, 2011 letter from the districts boiler contractors CJ Vanderbeck stated “Boiler #2 has cracked sections and should not be run for safety reasons. In a letter received from the Hoboken Board of Education on January 10, 2012, the Mount Vernon Group stated that Boiler #2 NJ005506-07H is non-operational.

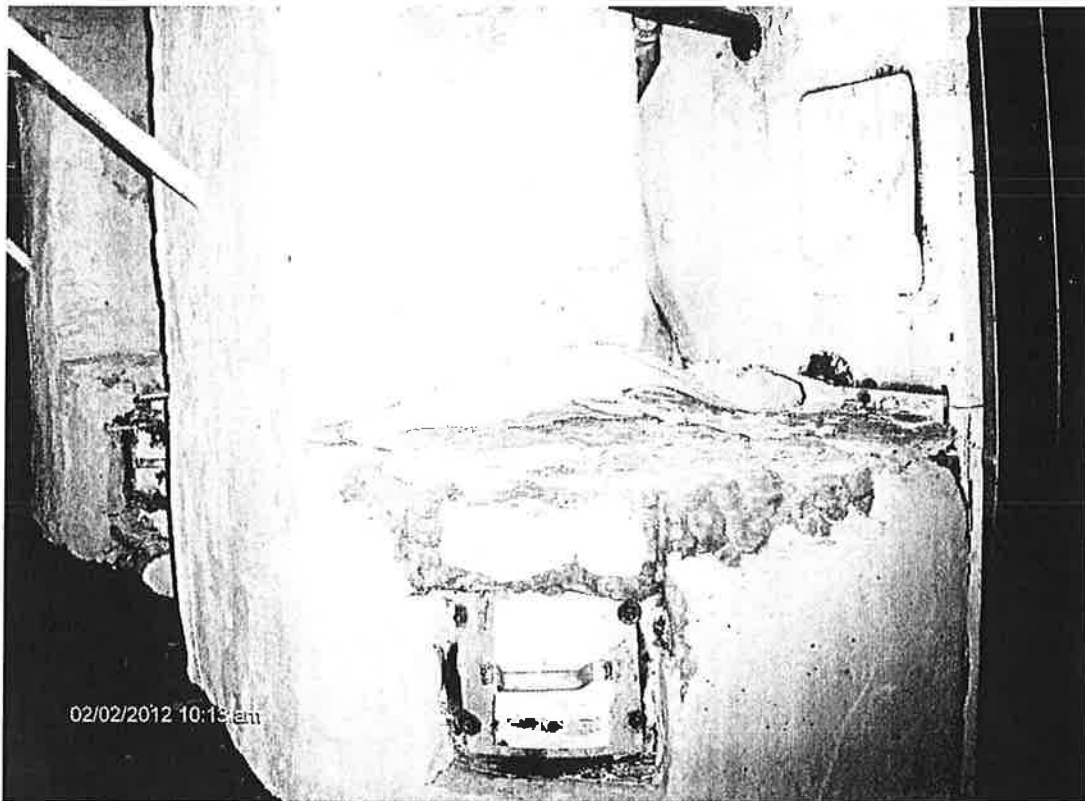
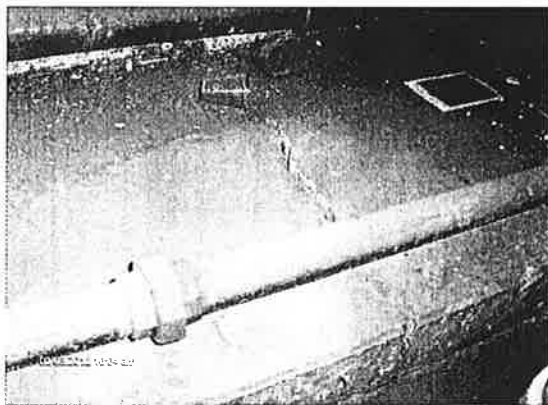
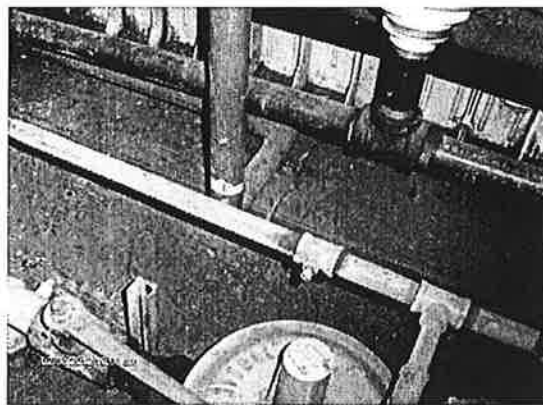
The boilers sit on a 6" high concrete pad that has a shear crack at the SE corner. Insulation on the boiler breeching has areas where the covering material is flaking and breaking off.

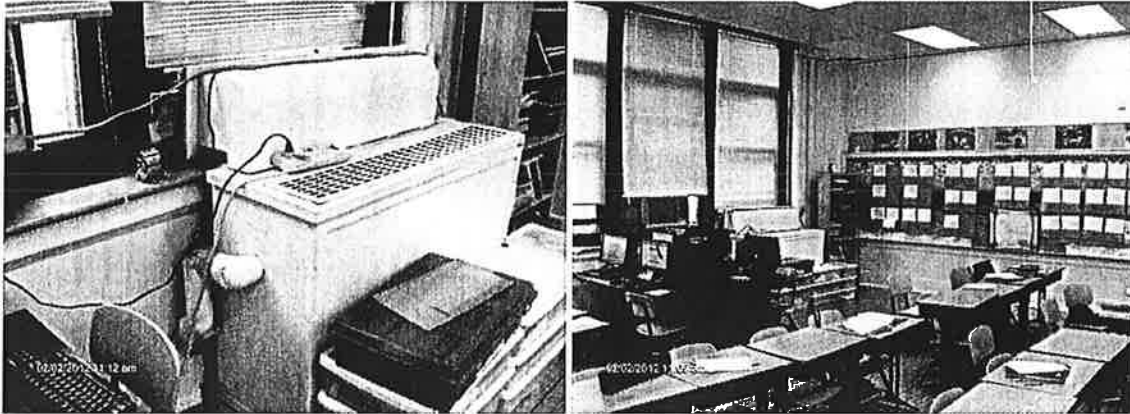
- **Unit Ventilators** – Classrooms are heated by old unit ventilators with steam coils and fin tube radiation. The unit ventilators are not directly ducted to the outside for fresh air intake. A 90 degree duct facing the window on the top of the unit ventilators requires the window to be opened to draw in fresh air. There are no operable automatic controls on the unit ventilators. All unit ventilators are controlled on/off switches located on each unit.

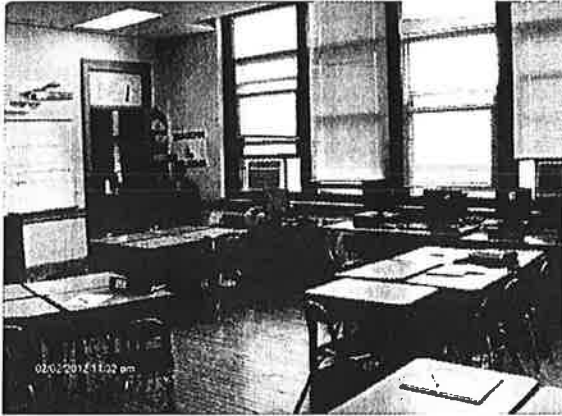
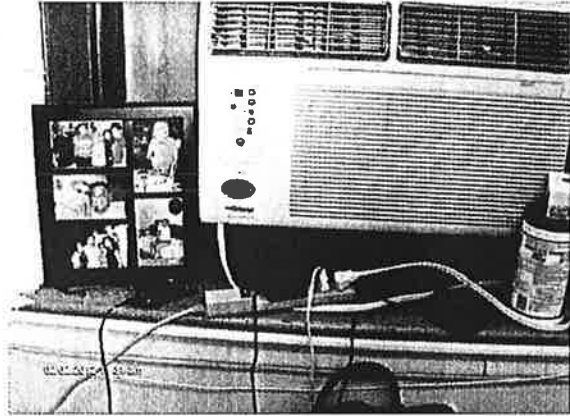
- **Hot Water Heater** – A 100 gallon AO Smith gas fired domestic hot water heater is located in the boiler room. The hot water heater outside metal covering is rusting but the unit is operational.

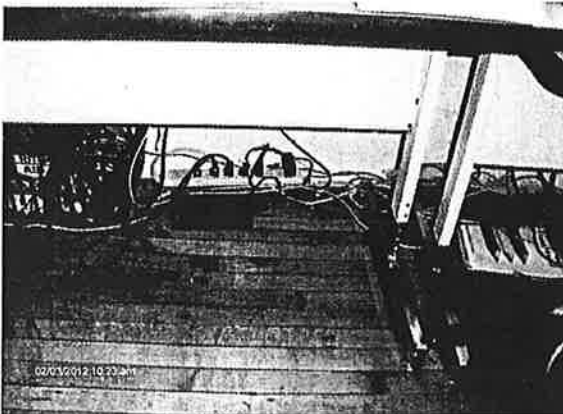
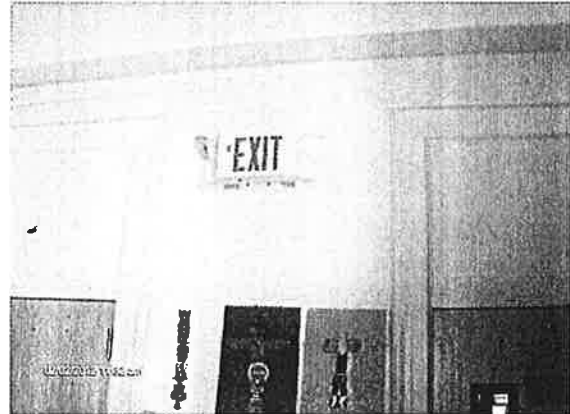
Most classrooms have only two (2) electrical outlets resulting in the use of power strips and extension cords. A district representative stated that they can only run 6-10 computers at a time to avoid tripping breakers in adjacent rooms.
