# SCHOOLS DEVELOPMENT AUTHORITY

Facilities Conditions Assessment Report  
Orange High School  
400 Lincoln Avenue

As of April 2013

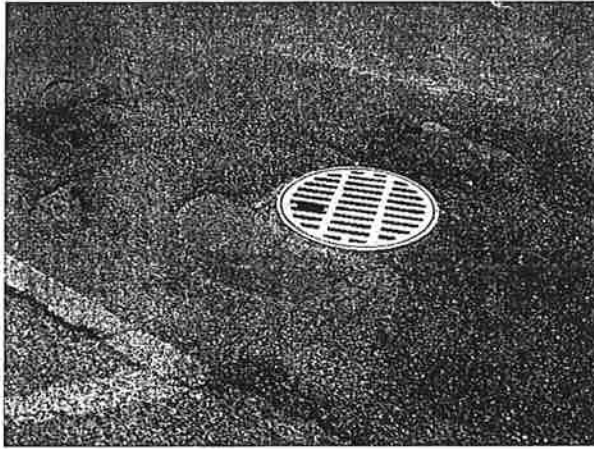
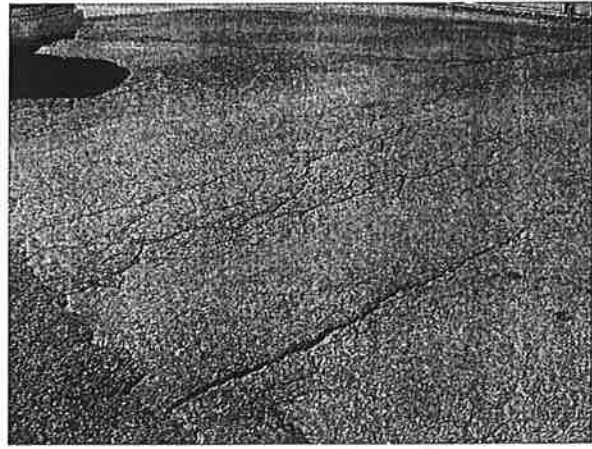
**Rear Parking Lot**

The paved parking area behind the school is accessed from Clarendon Place. This area is fully fenced in with a chain link fence and contains approximately 100 parking spaces. This area has numerous cracks, patches and areas of unevenness. Utility poles surrounding the parking lot support exterior lighting fixtures that provide night time illumination. The effectiveness of the exterior lighting could not be determined during the day time site visit.

Painted parking space markings are faded or have been removed as result of patching causing a random parking pattern.

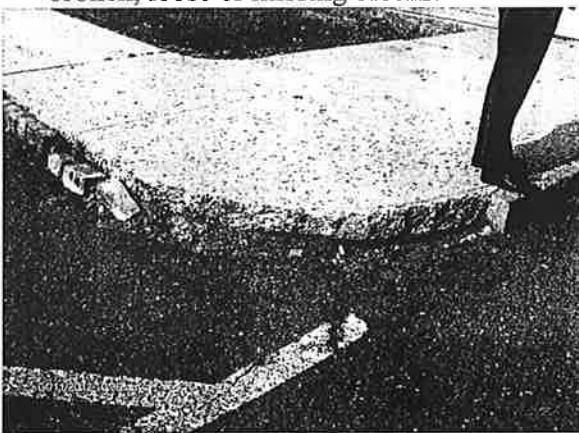
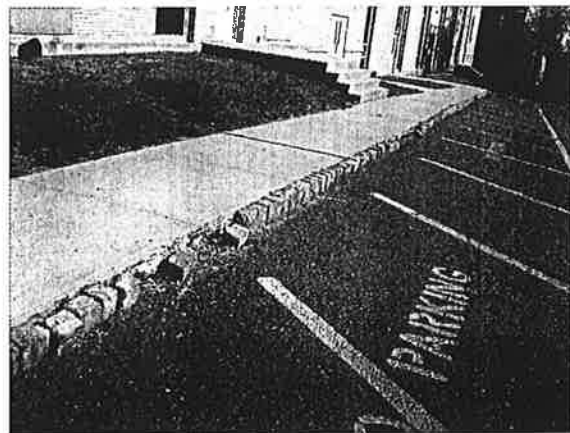
**Belgian Block Curbing**

- **Curbs and Sidewalks** - The parking lot curbing around the school is Belgian block. Approximately 60 lineal feet of numerous sections of curbing along the rear of the school have broken, loose or missing blocks.

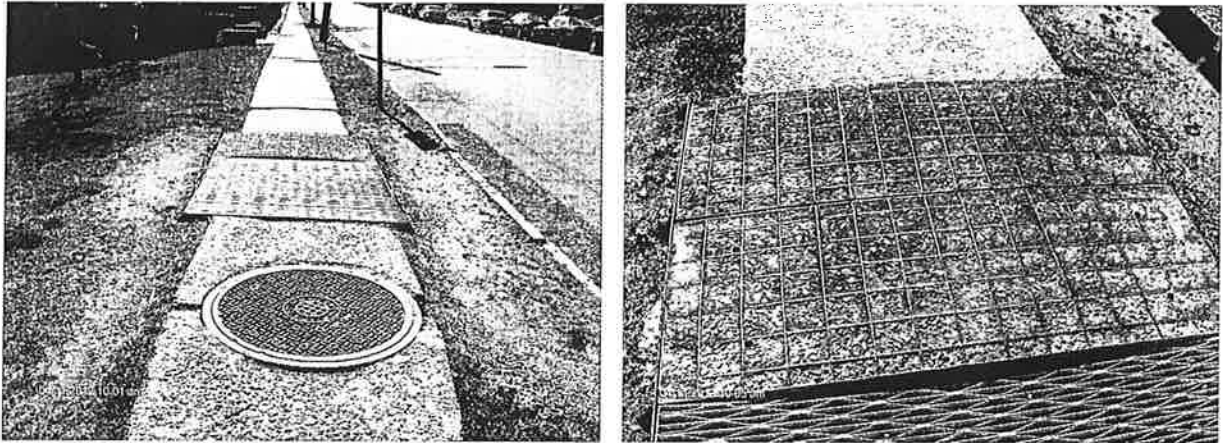
**South Sidewalk**

The sidewalk on the on the south side of the property along Clarendon Place has a 5'x5' section of expanded metal grating and an adjoining 5'x5' section of concrete filled grating that is uneven and humped. This condition is next to a Public Service manhole also in the sidewalk.

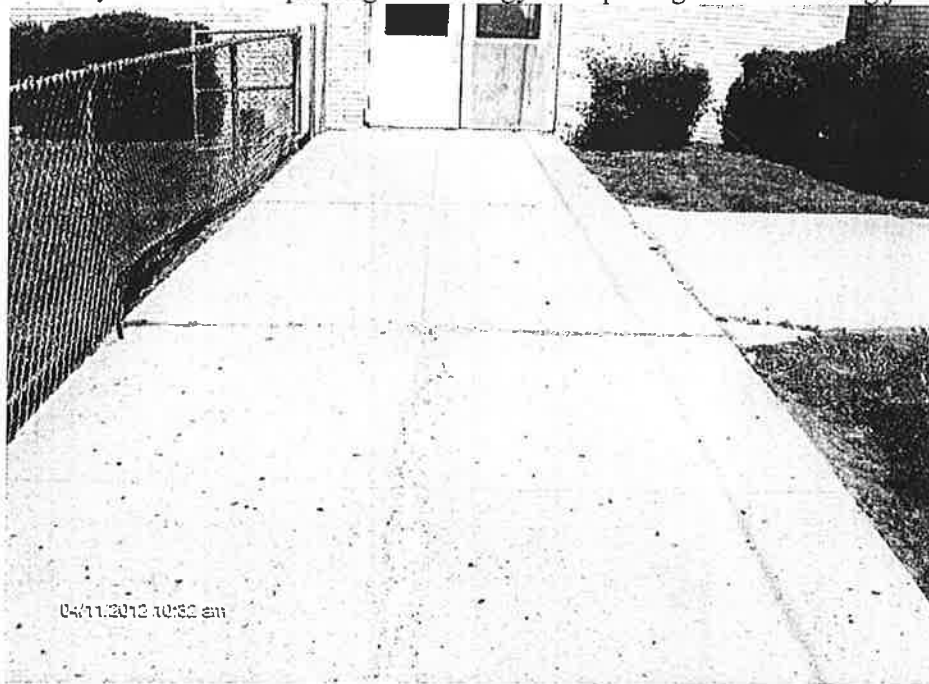
**Walkway From Rear Parking Lot To Gym**

The concrete walkway from the rear parking lot to the gym is spalling with crumbling joints.

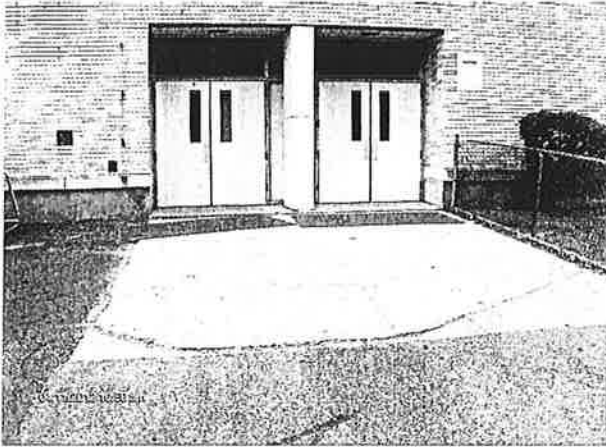
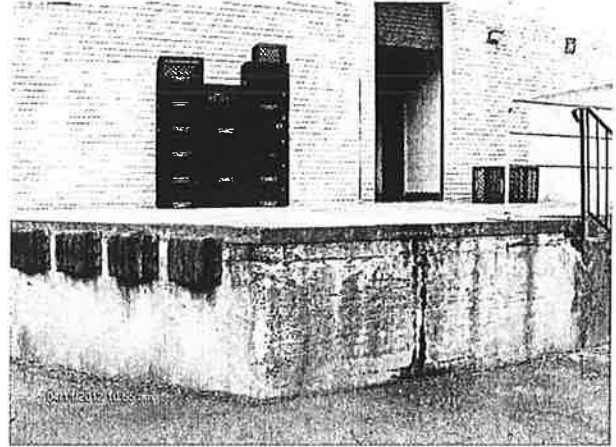
On the north side of the building, a common driveway running between the high school and the middle school was observed. This driveway serves as a narrow passageway for school bus traffic and truck traffic when accessing the kitchen and loading dock,. Concrete flatwork, curbing and ramp walls along this driveway appeared broken in numerous locations.

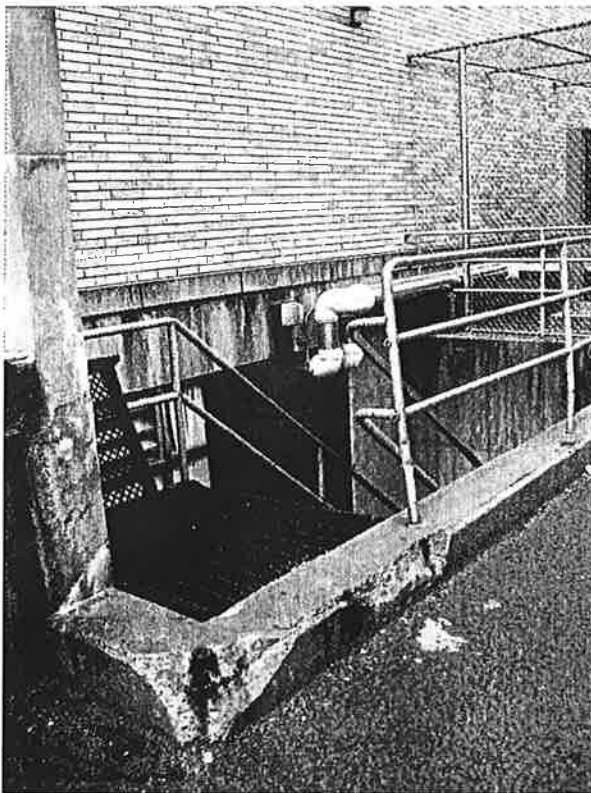
The concrete apron outside the building's north side doors is cracked and spalling. The loading dock wall has areas of concrete breaking away along the top and around the staircase.

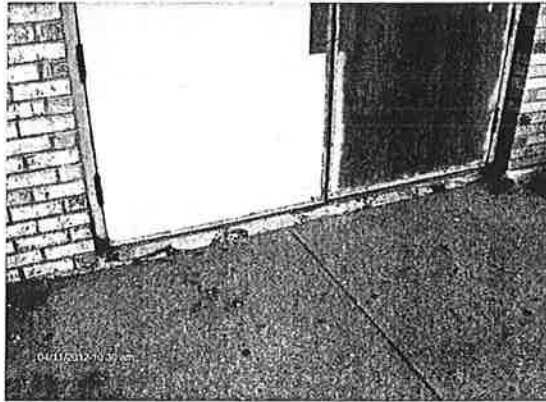
**Saddles Under Gym Doors**

- **Building** - The concrete saddles under the five (5) exterior double doors on the east and west sides of the Gym are breaking up and crumbling.

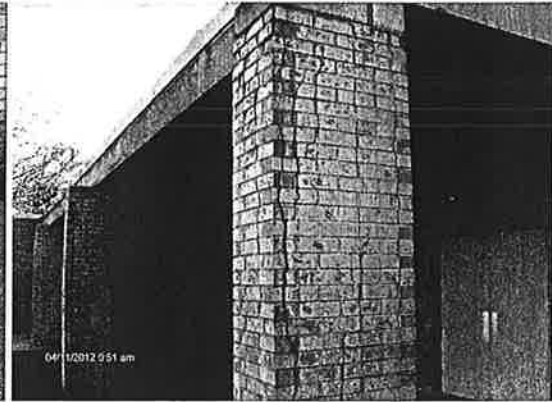
**Canopy Columns**

A one (1) story high exterior canopy, running on the west side of the building from the gym to the main entrance of the school, is supported by three (3) brick surrounded columns. This brick veneer casing has numerous vertical cracks. The concrete lintels above these columns are spalling, exposing rusting steel beneath. This spalling condition also exists at the base of the second floor Media Center outside wall facing the interior courtyard.

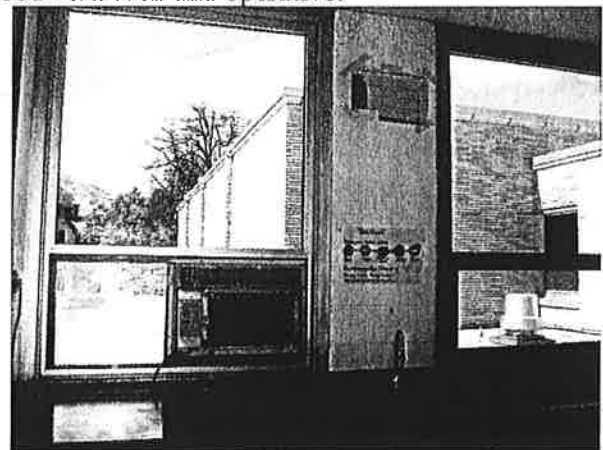
**Modified Window with Air Conditioner**

The windows which appear to have been replaced within the last ten years are double pane hopper type with large stationary glass panels above the tilt in section. In many rooms the hopper section of the window has been removed or modified to accommodate the installation of a window air conditioning unit. The windows observed are in good condition and operative.

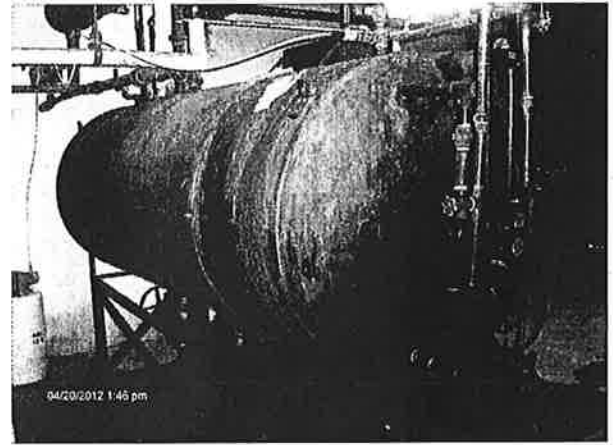
**Condensate Return Tank**

A condensate return tank and three (3) steam condensate return pumps are located in the High School. The condensate return tank show signs of previous leaks and numerous patches and may be nearing the end of its useful life.

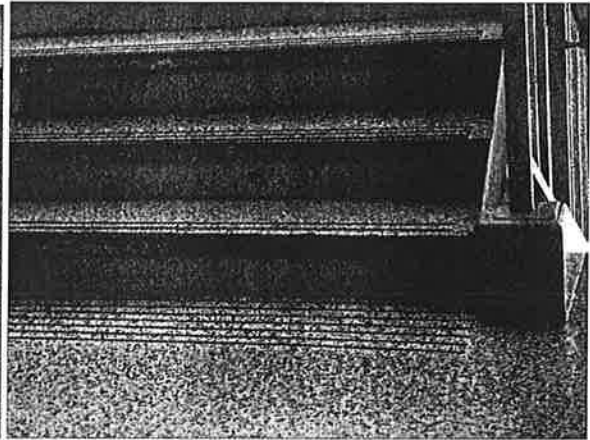
**Broken Terrazzo Stair Tread Nose**

- **Floors** – The school has a variety of different floor coverings including terrazzo, carpeting, wood, vinyl composition tile (VCT), quarry tile and ceramic tile. The first floor corridors and all of the steps and landings in the four (4) stair towers are terrazzo. Several of the terrazzo stair tread noses are broken and chipped. The corridor terrazzo flooring has some cracks but is in relatively good condition.

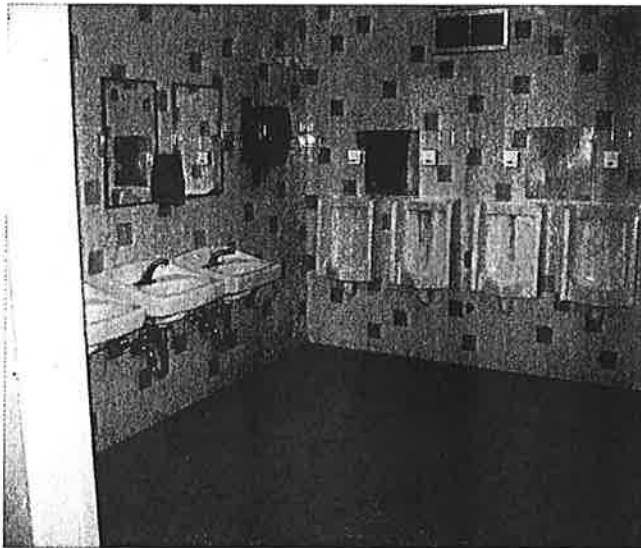
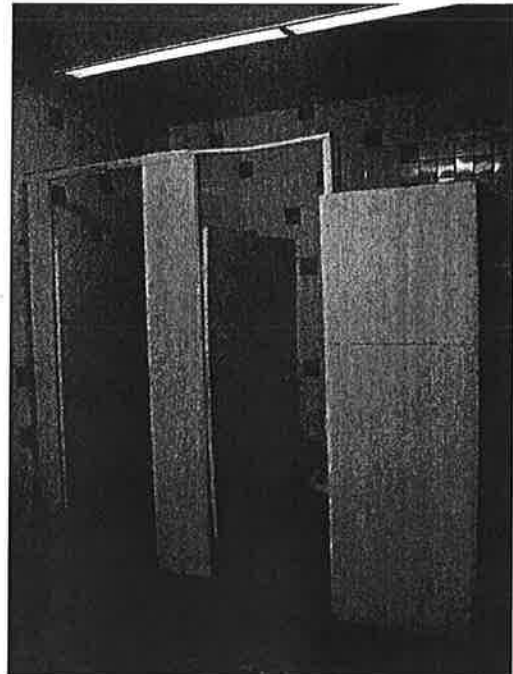
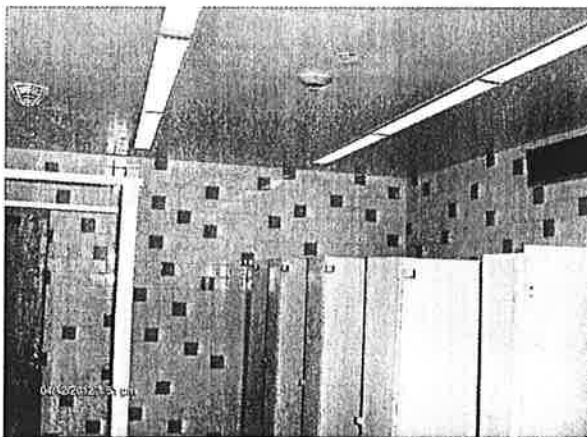
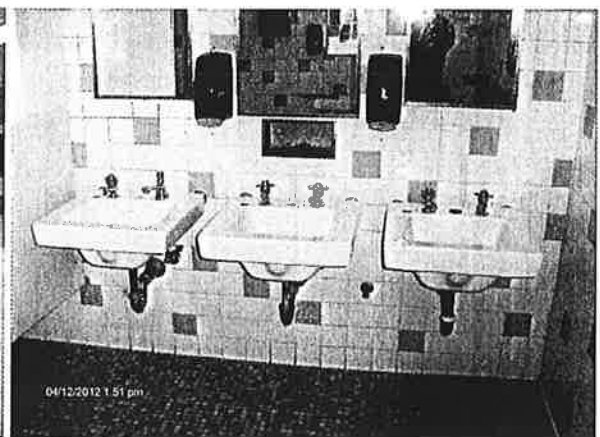
**Group Restrooms**

- **Plumbing** – There are a total of eight (8) group restrooms, two (2) Girls and two (2) Boys on each floor. The rest rooms have ceramic tile floors and walls, drywall ceilings and surface mounted fluorescent lighting fixtures. All of these restrooms are interior rooms with UVs providing heat and no windows. The status of the ventilation could not be determined as it is part of a larger ventilation question detailed in the HVAC section of this report. None of the group restrooms are barrier free and many of the fixtures are over thirty years old.

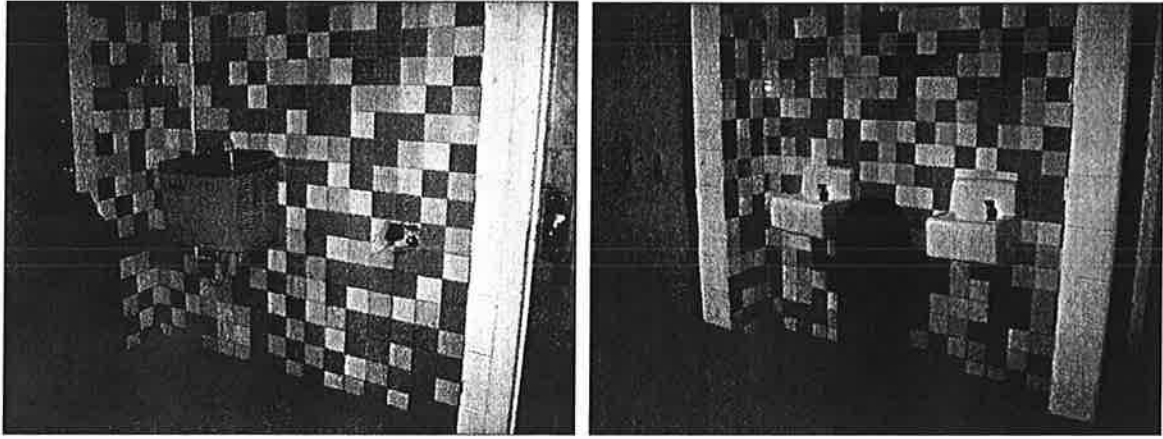
**Hallway Drinking Fountains**

A combination of porcelain and electric stainless steel drinking fountains are located hallways throughout the school. The porcelain fountains appear to be original from 1974 and the stainless steel fountains are over 10 years old. Several fountains are missing from their wall mount locations and none are handicap accessible.

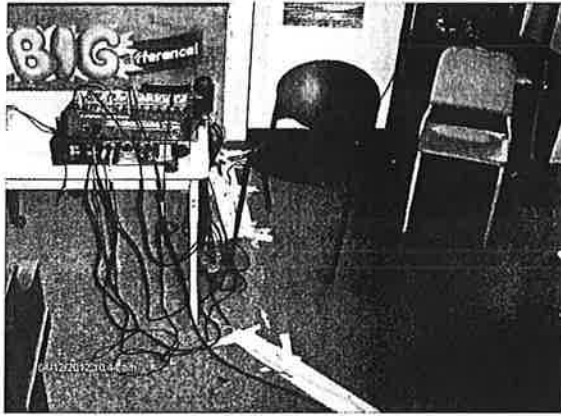
Music Room 246

Most rooms appeared to have sufficient number of electrical outlets either wall or wiremold. Computer rooms and computer areas have power poles and floor boxes. The Music Room (Room #246), containing numerous pieces of equipment, had wire and power cords taped to the carpet floor causing a potential safety hazard.

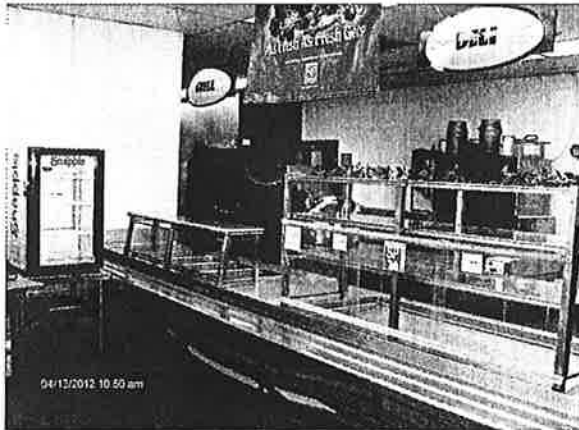
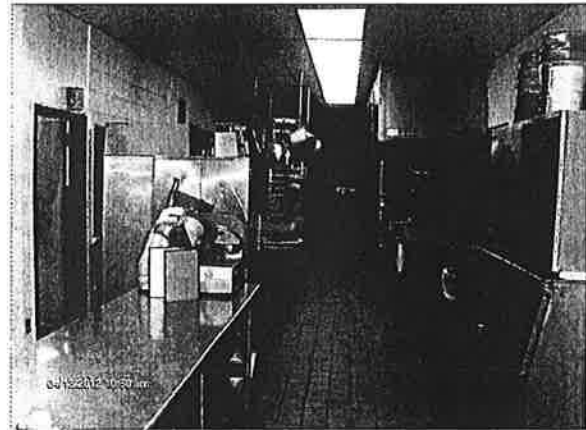
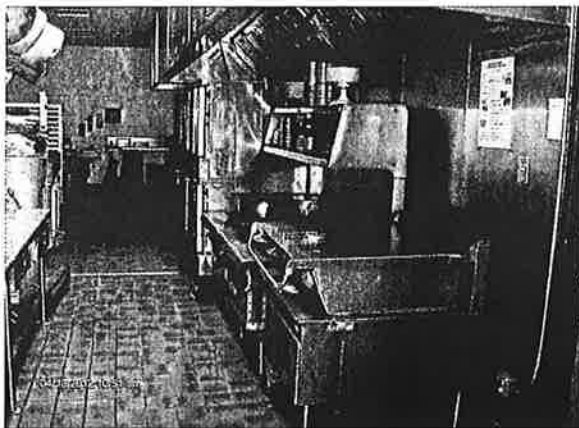
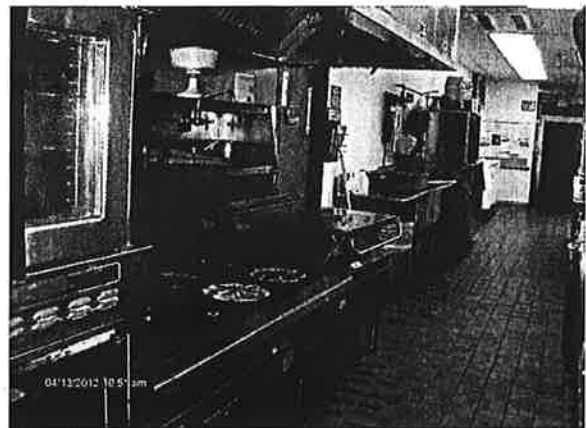
### Kitchen & Serving Line

- **Kitchen** – The first floor 2,500 SF kitchen/serving line is a full service cooking kitchen that also services the adjacent Middle School. The kitchen has quarry tile floors, a suspended grid ceiling with ACT and 2' x 4' lay-in fluorescent light fixtures. Heat is provided by one (1) ceiling mounted fan coil and there is no air conditioning. The kitchen and service area is fully appointed however some of the equipment is old or broken.

It was reported that the slicer, fryer and one of the two walk-in refrigerators were broken. As with the rest of the school, the exhaust ventilation system the status of the kitchen system could not be determined.
