SCHOOLS DEVELOPMENT AUTHORITY

Facilities Condition Assessment Report

Camden High School Camden, NJ

As of April 2012

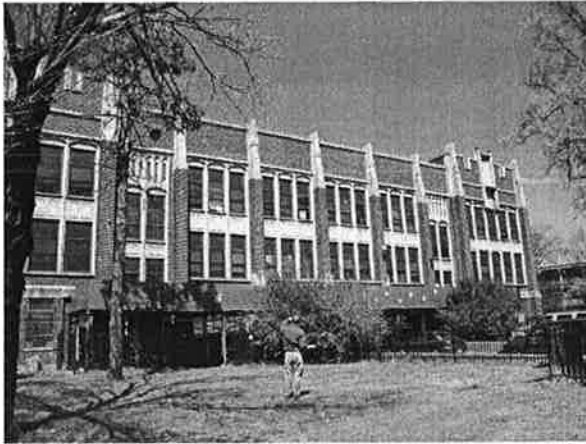
Original 1916 School South Side

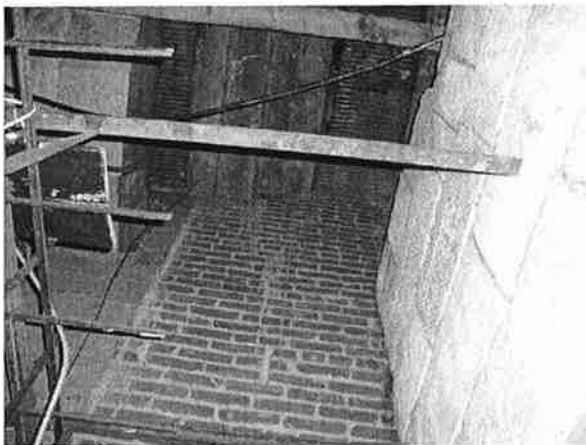
- Roof structure – A limited attic inspection showed the roof structure to be sound and dry and comprised of precast pan joist panels.
- Masonry – Brick load-bearing masonry walls. Exterior walls appear to be in fair condition. These walls show minor settlement cracks but no glaring deficiencies. Interior courtyard walls are in poor condition. Bluestone plinths are spalling from surface water and deicing chemicals. A brick chimney located at the rear of the Main Building appears to be in poor condition with cracks and spalling brick.

Interior Structural View Looking Up

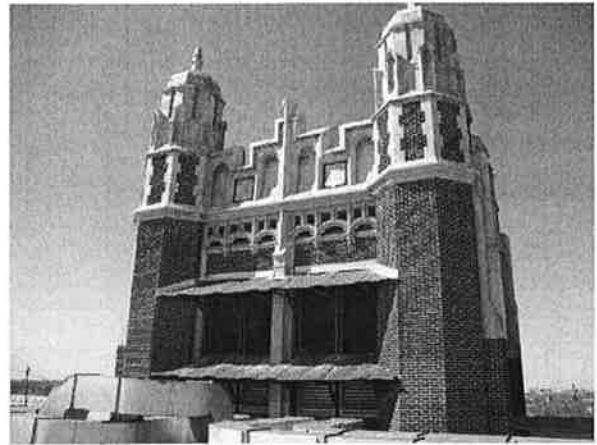
- Exterior doors – Metal doors appear functional even though cosmetic damage was observed.
- Central tower/main entrance – The central tower/main entrance façade restoration was completed in December 2010 by the NJSDA (Contract #CA-0012-C01) with no issues observed. Restoration to these areas included repair, replacement and stabilization of deteriorated terra-cotta, stone and brick.

Restored Central Tower

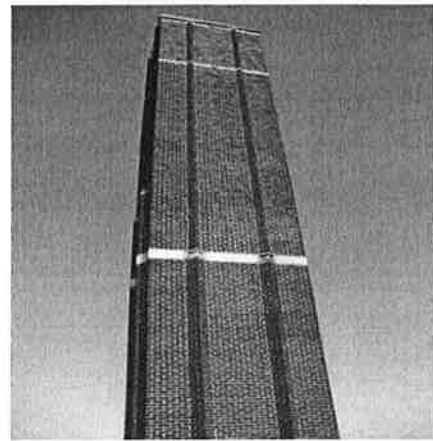
Chimney at Rear of Building

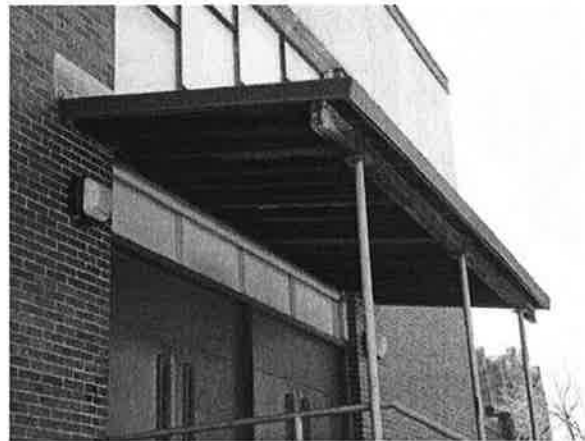
- Exterior doors – Metal doors appear functional even though cosmetic damage was observed.
- Gymnasium Awnings – Metal awnings on gymnasium entrance/exits to parking lot are nearing the end of their useful life. The wooden frames and metal of the awnings are rotting and corroding.

Metal Awning over Gymnasium Entrance/Exit

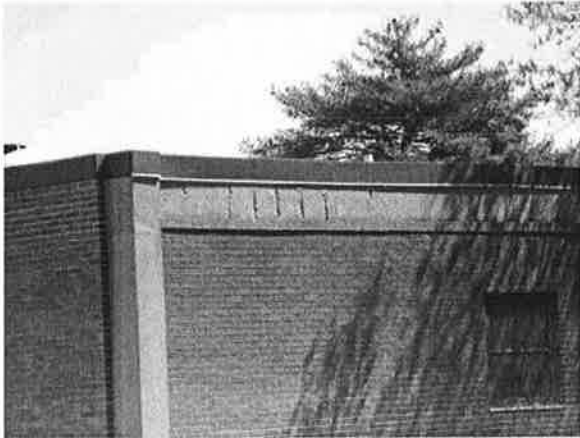
- Masonry – This section of the building has brick masonry walls in fair condition.
- Pre-cast concrete – A decorative border set in pre-cast concrete was observed around the Annex building. Observed sections of the concrete border are showing signs of corrosion and exposed rebar.

Exposed Rebar on Pre-cast Concrete

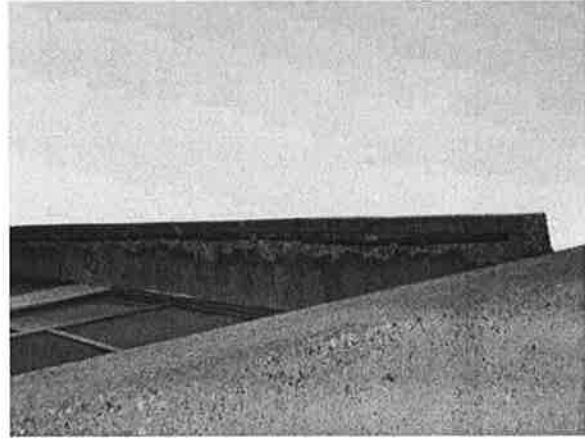
Exposed Rebar on Pre-cast Concrete

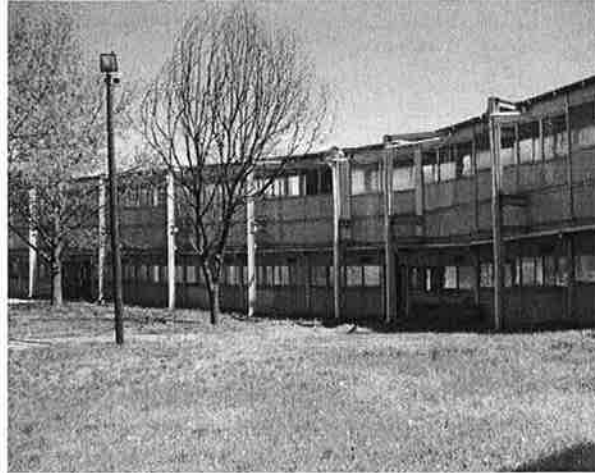
- **Structural Steel Columns** – Issues with the exterior structural steel columns supporting the 1970 bridge have been reported by the District. Only the first floor of this bridge is open for use; the second floor of this bridge is closed due to these District reported structural concerns. SDA staff has requested a copy of any existing reports concerning these issues; further investigation is warranted.

1970 Bridge – Parking Lot Side

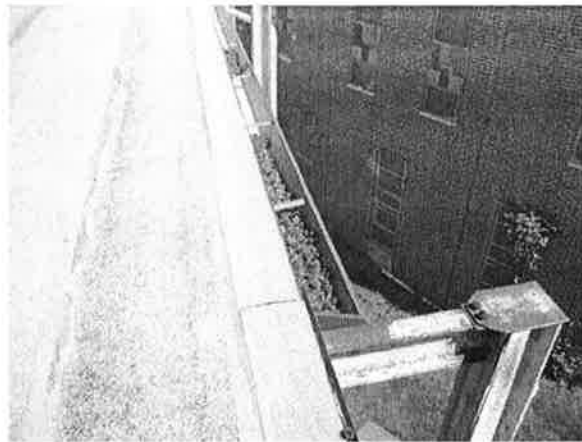
Roof and Gutters of 1970 Bridge

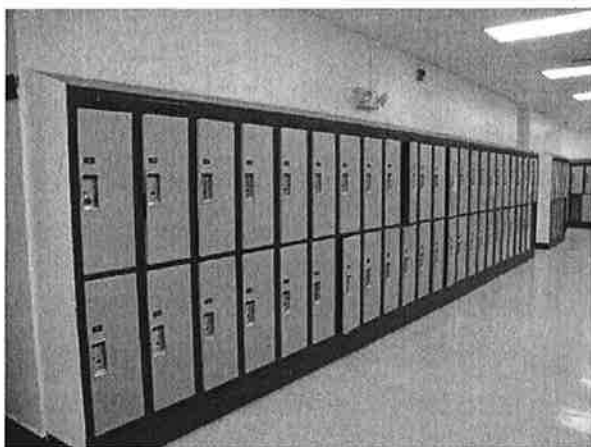
- Casework – Original casework and chalkboards in most classrooms but generally in poor condition.
- Lockers – Appear to be 20 +/- years old. Approximately 1,600 lockers. Majority of lockers in this section of the building have broken latches and/or missing/damaged doors.

Typical Upper Floor Hallway with Lockers

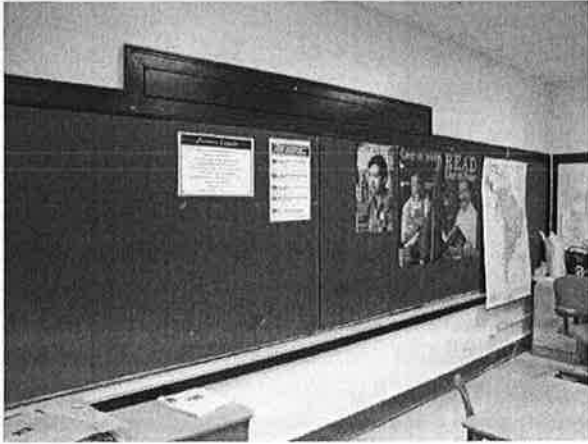
Typical Classroom Display Boards

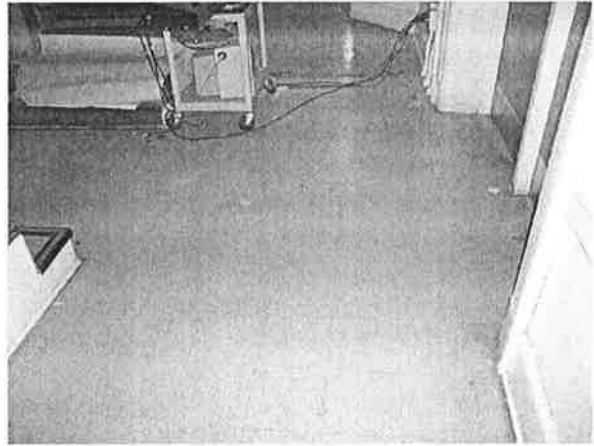
- Auditorium balcony – District staff indicated the auditorium balcony had been closed for a number of years due to structural concerns; however no published report can be produced by the district detailing the issues with the balcony. Visual observation shows no obvious signs of structural distress.

Auditorium Balcony with 9"x9" Tiles

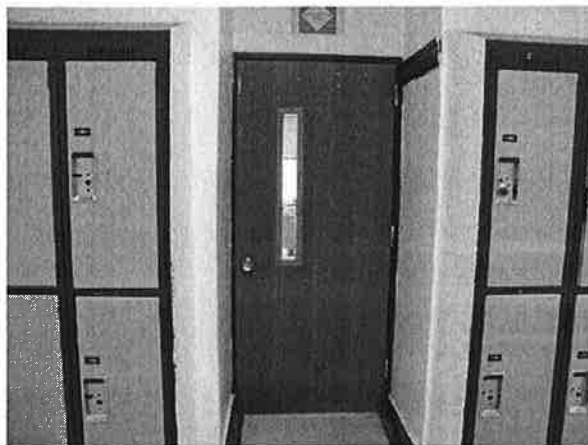
- Interior doors – There is a mix of interior door types – original, solid-wood two-panel doors with glass and replacement solid-core doors with glass. The original, solid-wood two-panel doors are in poor condition in student areas; doors in staff-only locations are in fair condition. Very few have lever-type hardware.

Typical Classroom Door

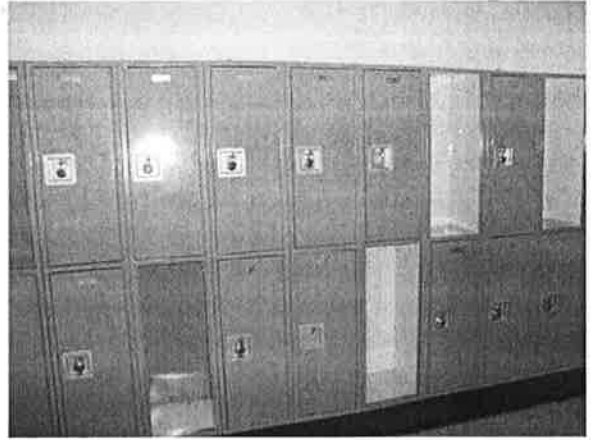
Typical Lockers in the Basement Hallways

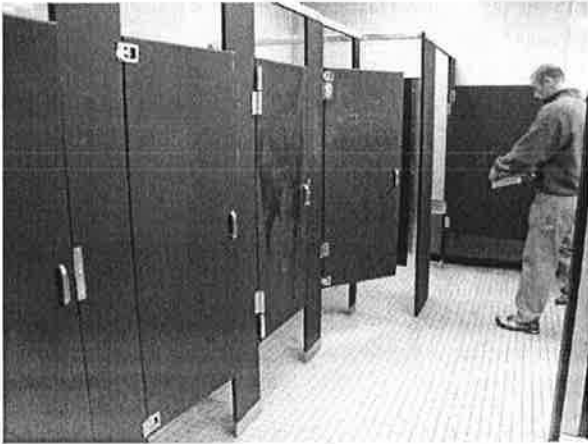
- Toilet rooms – Toilet room walls are floor-to-ceiling 4”x4” ceramic tile while the flooring is sheets of 1”x1” ceramic tile. All tile work appears to be in good condition. Ceilings are suspended 4”x2” ACT that is in good condition and stall dividers are primarily solid core that are in varying states of repair.

Typical Group Toilet room Stall Dividers

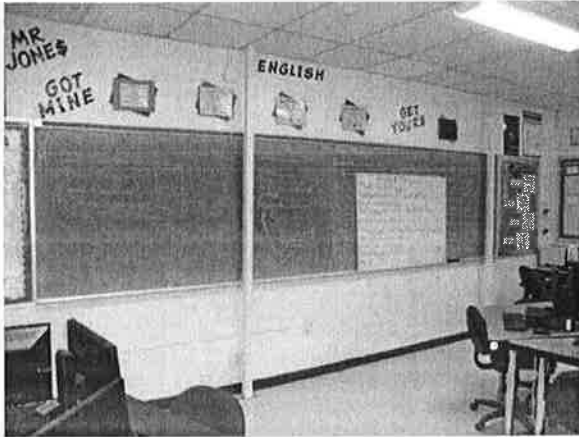
- Casework – Original casework and chalkboards in most classrooms but generally in poor condition. An unidentified amount of classrooms contained interactive whiteboards.

Typical Chalkboard in Annex Classroom

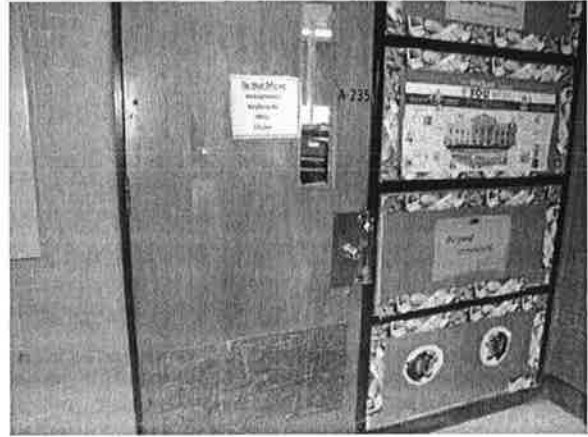
- Doors – Classroom and office doors are solid-wood two-panel doors with glass. Very few doors have lever-type hardware.
- Stairs – Stairways are comprised of metal risers and painted concrete treads. Engraved grooves used for anti-slip footing have been painted over or have worn. Walls within the stairwells are glazed brick and block while the landings are painted concrete. Both walls and landing surfaces appear to be in fair condition.

Typical Classroom Door in Annex Building

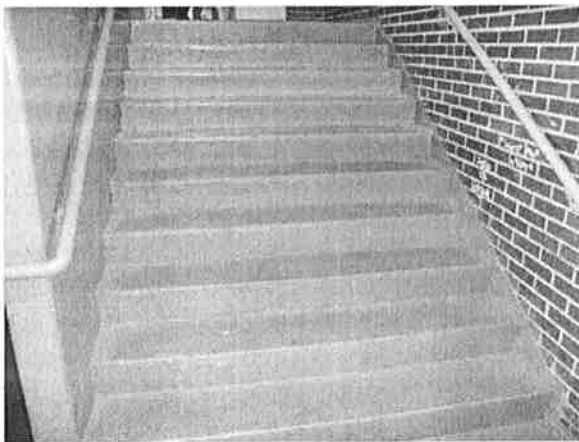
Concrete Steps in Annex Stairwell

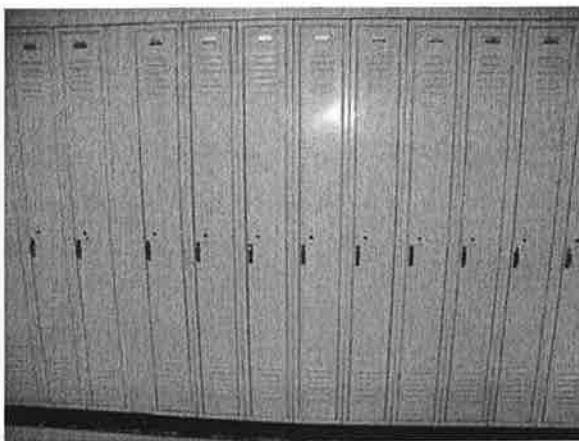
- Lockers – Approximately 500 lockers that are approximately 20 +/- years old. All appear to be functional.
- Locker rooms – District reports the locker rooms are no longer used for gym classes. Locker room floors are painted concrete with glazed block walls and plaster ceilings. Lockers within both spaces appear to be functional; overall both spaces are in good condition.

Typical Lockers in Annex Hallways

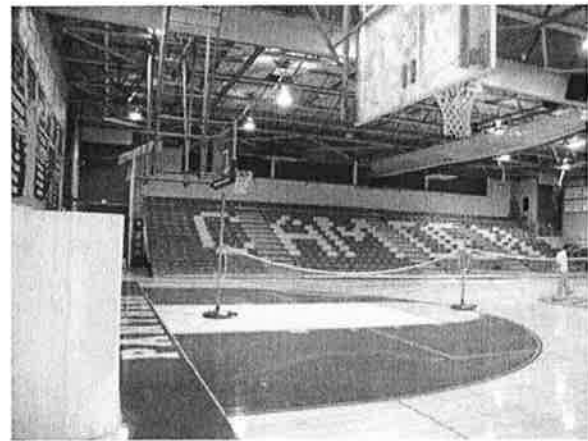
- Walls – Mix of drywall, brick and CMU walls; all in good condition.
- Floors – 12”x12” VCT flooring in halls and classrooms, carpet in library. All appear functional and in good condition. The gymnasium floor is wood and was upgraded as a part of NJSDA Grant #GB-0046 with no issues observed.

Gymnasium Floor

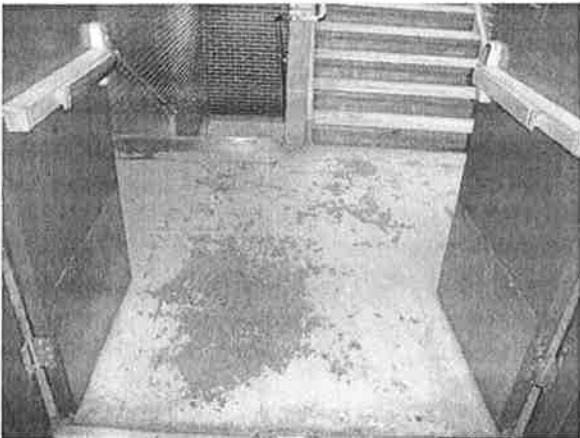
Painted Concrete Floor of Stairwell

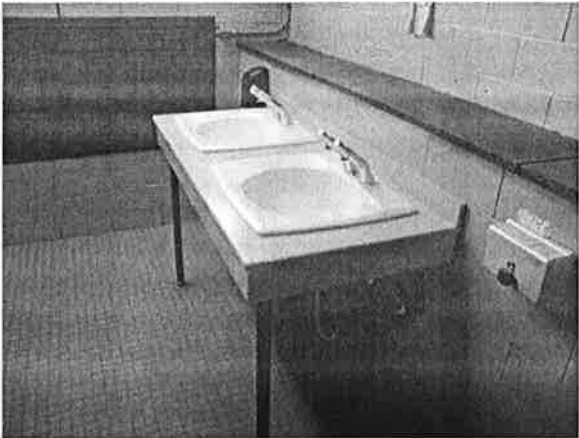
- Toilet rooms – Toilet room walls are floor-to-ceiling glazed block while the flooring is sheets of 1”x1” ceramic tile. All tile work appears to be in good condition. Ceilings are suspended 4”x2” ACT that is in good condition and stall dividers are primarily solid core that are in varying states of repair.

Typical Toilet Room Finishes

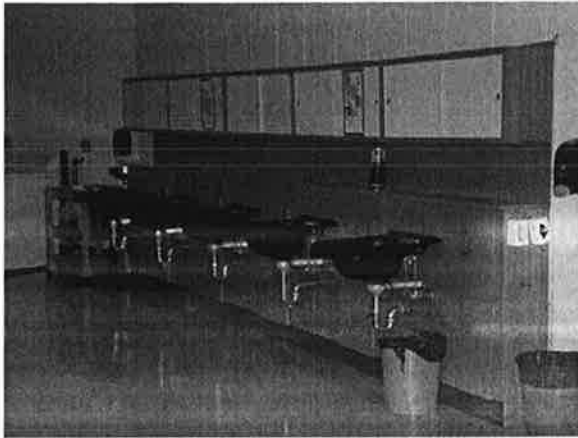
- Casework – Casework in cosmetology classrooms in fair-to-good condition even though these classrooms are reportedly not used for this program any longer. An unidentified amount of classrooms contained interactive whiteboards.

Casework in Cosmetology Classroom

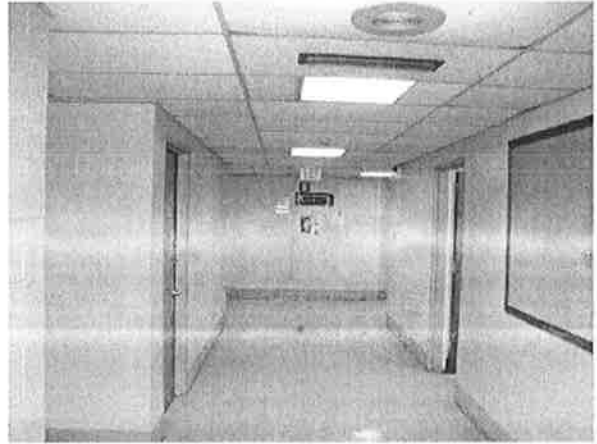
Typical Vocational Hallway

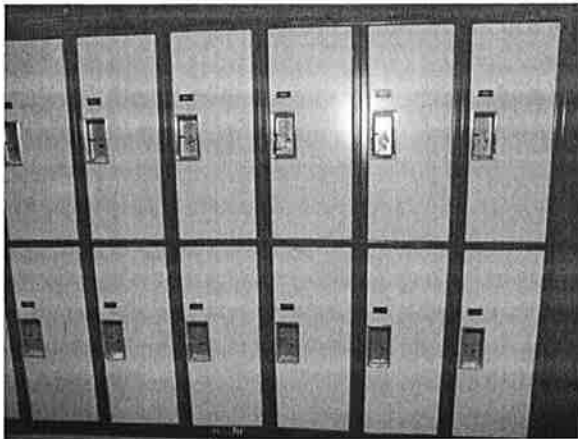
- Lockers – Approximately 500 lockers within the hallways of the Baird Boulevard pod that are in well-maintained condition. Workshop lockers observed also appeared to be functional.

Typical Lockers in Hallway of Vocational Wing

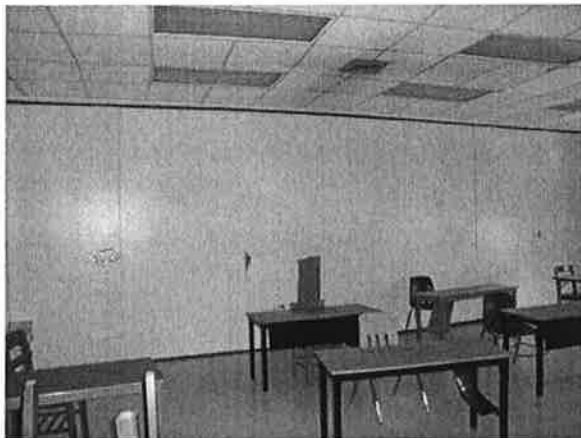
- Walls – Primarily painted concrete masonry units (CMU) walls in classrooms and hallways; some drywall between classrooms. Main corridor has combination glazed and painted brick. Shop areas have unpainted CMU walls. One (1) movable partition wall was observed in a classroom within the three-story pod. All in good condition.

Movable Partition Wall - Vocational Classroom

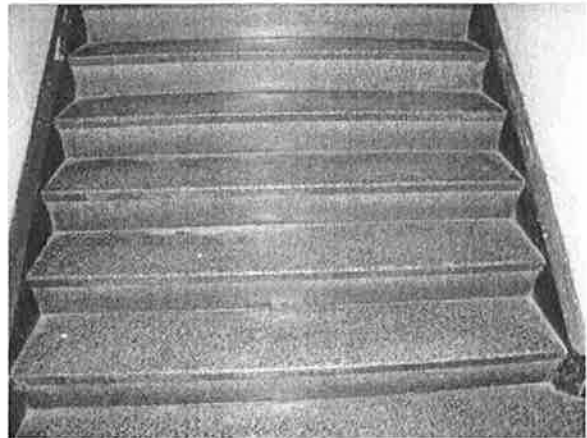
- Interior windows – Original, wire-reinforced windows between classrooms and workrooms. All in good condition.
- Stairs – Terrazzo treads with approximately 5% broken; many tread grooves have worn. Walls within the stairwells are painted CMU while the corridors 12”x12” VCT. Both walls and corridor surfaces appear to be in good condition.

Terrazzo Stairwell in Vocational Wing

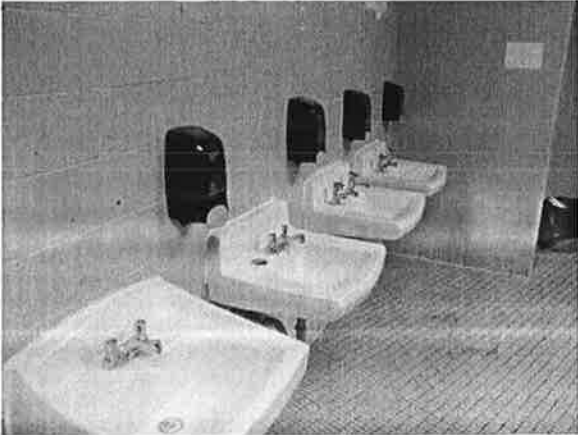
- Interior doors – Metal frame, solid wood, single-light doors in good condition. Some lever-type handles; some original knobs with some in disrepair.
- Toilet rooms – Majority of toilet room walls are floor-to-ceiling ceramic tile while the flooring is sheets of 1”x1” ceramic tile. All tile work appears to be in good condition. Ceilings are suspended 4”x2” ACT that is in good condition and stall dividers are primarily solid core that are in varying states of repair. Other toilet rooms have painted CMU and sheet rock walls with ceramic tile floors.

Typical Toilet Room Finishes

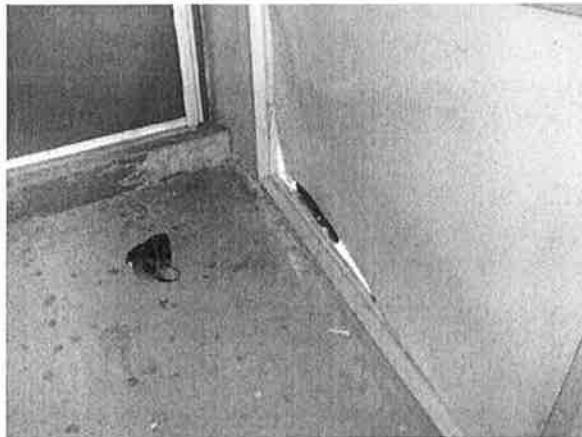
- **Walls** – The 1959 bridge walls contain windows and hot water radiators; the 1970 bridge walls are windows above aluminum sheeting that is nearing the end of its useful life. The aluminum walls within the 1970 bridge are in poor condition.
- **Floors** – The 1959 bridge has flooring 12”x12” VCT; the 1970 bridge has 12”x12” VCT on its upper floor and concrete on the bottom floor. All flooring is in fair condition.
- **Ceiling** – Spray-on popcorn epoxy ceiling in the 1959 bridge; 4’x2’ ACT in the upper and an open ceiling in the bottom floor of the 1970 bridge. All ceilings are in poor condition.

Aluminum Wall Separation in 1970 Bridge

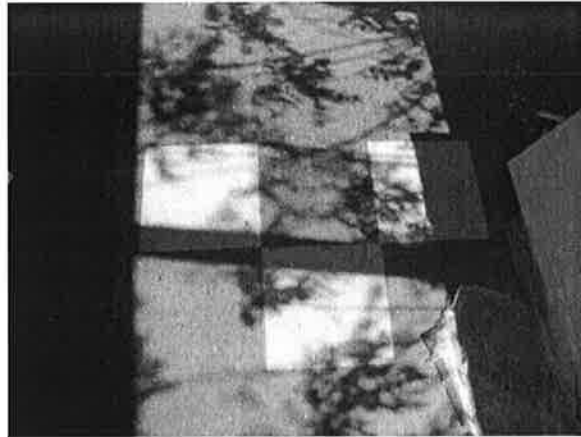
12”x12” VCT in 1970 Bridge

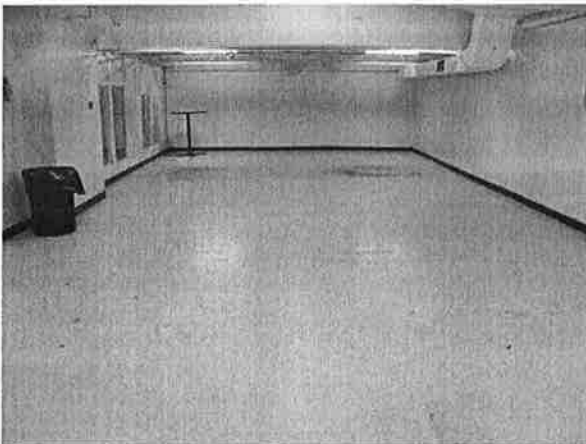
- Full-service public school kitchen in the 1916 basement. The kitchen appears to be sufficient to meet its current needs and is functional. There is seating for approximately 170 students although the cafeteria is only used to half of its capacity as half of the space is empty.

Unused Portion of Cafeteria

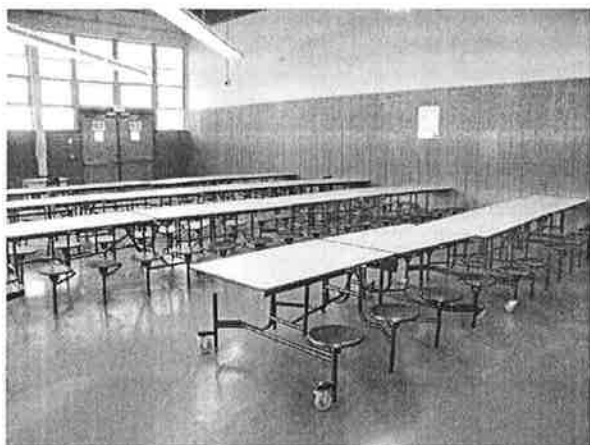
- A second school cafeteria was observed in the 1970 Vocational Wing. District personnel report that this space is currently used for a breakfast program and is not used for lunch periods. There is seating for approximately 160 students within this cafeteria. The kitchen that is attached to this space was not accessible at the time of the site visit.

Cafeteria in Vocational Wing (Unused)

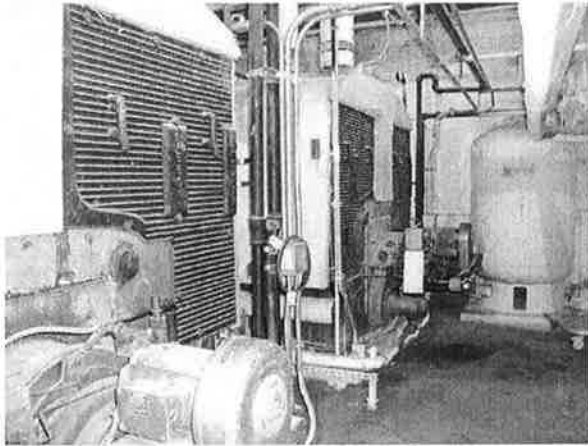
- Heating – Rooms within this portion of the school are heated by hot water radiation and hot water Unit Ventilators (UV's) dating to 1992. All UV's appear in good condition, with no problems being reported. Hot water is provided by two (2) gas-fired 1978 HB Smith hot water boilers located in the sub-basement. The units consist of one (1) HB Smith 650 Mills boiler and one (1) HB Smith 450 Mills boiler. Both boilers were reported as functional. Current certificates of inspection were not posted for either boiler, as the most recent inspection certificate observed expired in April of 2011.

Boiler Room in 1916 Building

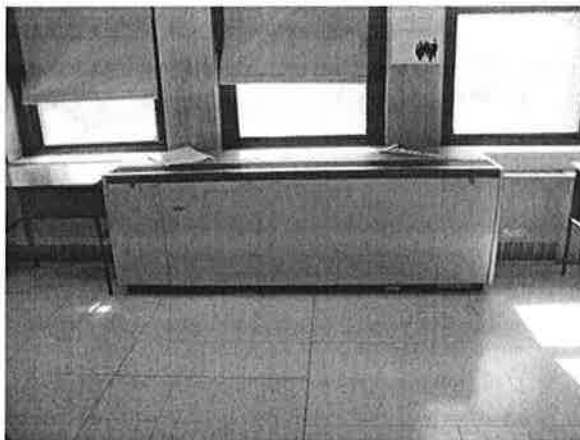
Typical Classroom UV

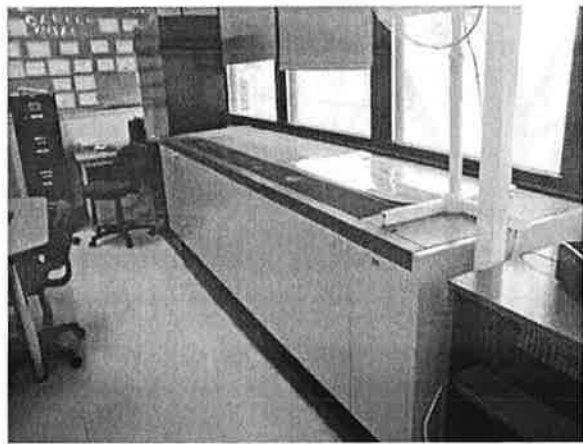
- Heating – Classrooms within this portion of the school are heated by hot water radiation and UV's. Hot water is supplied to the UVs in the Annex via pipes running underground from the 1916 Building. UV's appear to be in good condition with no issues reported. The Gymnasium is heated by a split system comprised of four (4) gas-fired air handlers. These air handlers were upgraded from steam to gas-fired units as a part of an NJSCC Grant in 2003 (Grant # GB-0044) with no issues reported or observed.

Typical Classroom UV in Annex

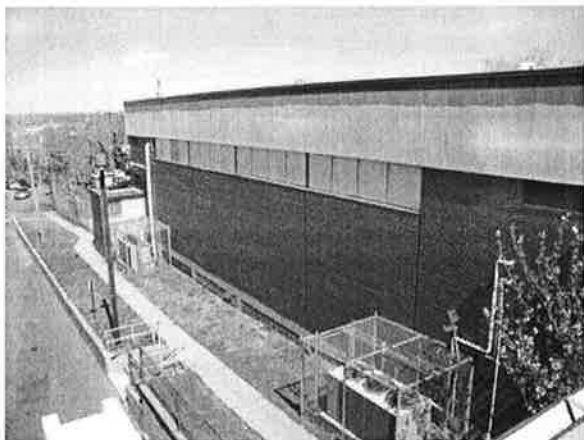
- Ventilation – SECTION REDACTED
- Air conditioning – This section of the school does not have centralized AC. Some rooms in this section are air conditioned by individual AC window units. Cool air provided to the Gymnasium by the air handlers located in the basement of the Gymnasium. Two (2) of the air handlers were observed and were functional at the time of the site visit. At the time of the site visit, two (2) of the four (4) condensers that feed the air handlers for the Gymnasium had been vandalized and were not operable.

Two (2) Condensers outside Gymnasium

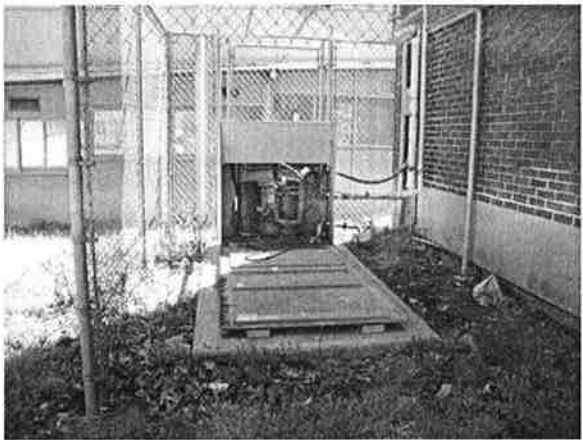
Vandalized Condenser outside Gymnasium

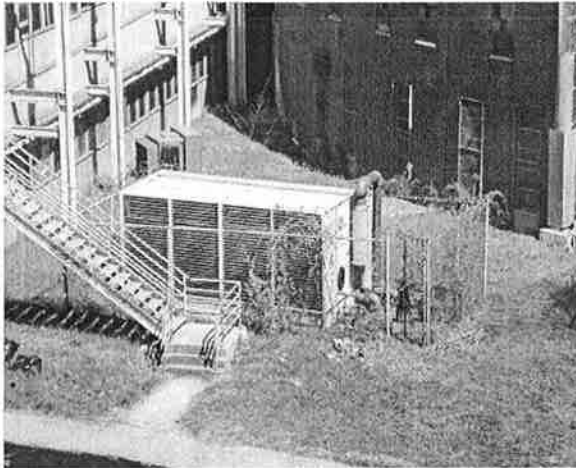
Cooling Tower

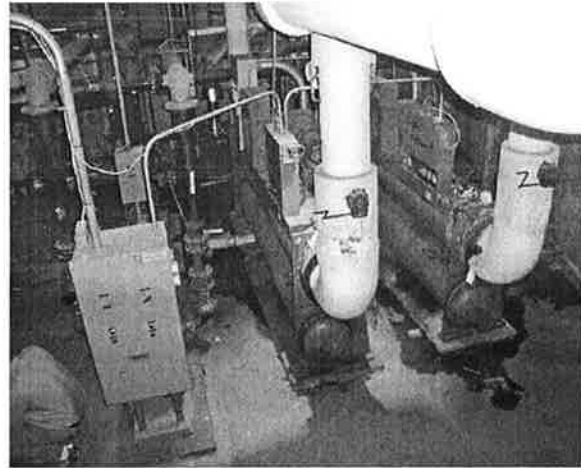
- **Ventilation** – SECTION REDACTED.
- **Air conditioning** – The AC component of this wing is comprised of two (2) 1983 McQuay chillers that supply cold water to air handlers. The District reports one of the chillers as not currently functioning and the other shuts off when it rains. Water to the chillers is provided by a Cooling Tower. This cooling tower was replaced in-kind through an NJSDA emergent project February 2011 (Contract #EP-0045-C01) with no issues observed. The AC component within this building was observed as functional.

McQuay Chillers

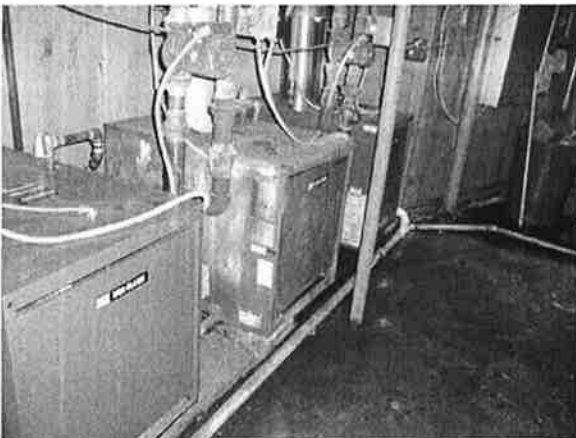
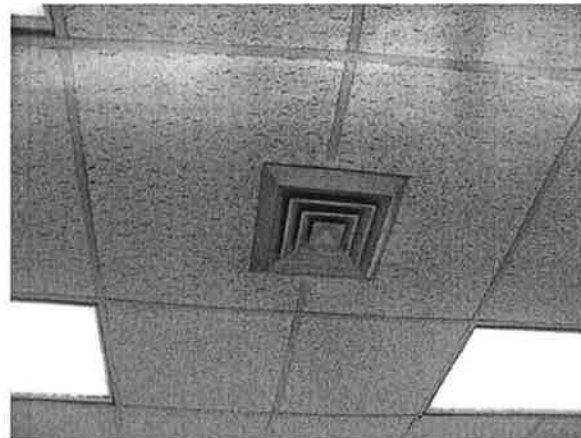
- **Heating** – This wing is heated by its own Heating, Ventilation and Air Conditioning (HVAC) system. Air handlers provide heat to all three (3) pods located within the Vocational Wing. The air handlers are supplied hot water that is produced by three (3) gas-fired Weil-McLain hot water boilers; two (2) are 1995 and one (1) is 2011. Ceiling mounted hot water fan coils were also observed in shop classrooms. An HB Smith 350 Mills boiler of an unknown age and usage was observed within a storage room located adjacent to the electrical shop classroom. This boiler is reported as not functional; a current inspection certificate was not readily available. Two (2) package units were observed, the use for these package units is unknown. No issues with any components of the heating system were reported.

Weil McLain Hot Water Boilers

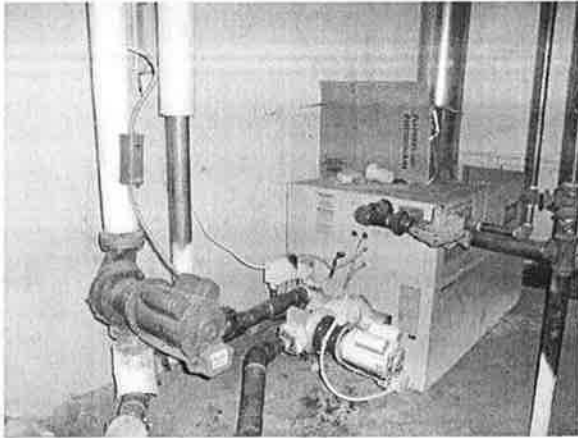
- Electric water coolers – There are 11 Electric Water Cooler (EWC) locations in the building; all are out of service as the district is concerned with water quality. They are all stainless steel of varying age and many are out of service.
- Sprinklers and standpipe – **SECTION REDACTED.**
- Domestic Water – The hot water heater is a 2004 Bradford-White gas-fired unit. The current inspection certificate for this unit expires on June 8, 2012. Domestic water supply lines are copper and in good condition.

2004 Bradford-White Hot Water Heater

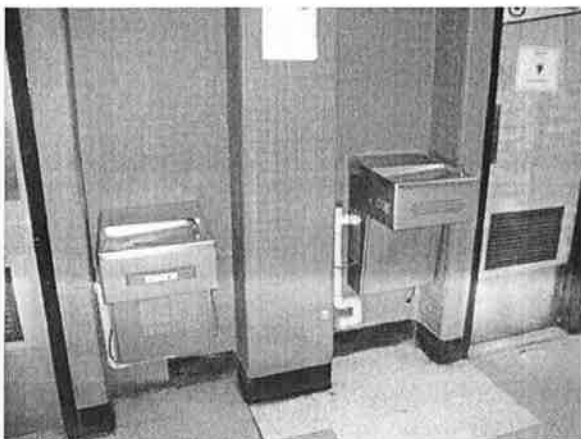
- **Sinks** – There are no sinks in this section of the school outside of toilet and locker rooms.
- **Electric water coolers** – There are seven (7) EWC locations in this section of the building and the gymnasium locker rooms; all are out of service as the district is concerned with water quality. They are all stainless steel of varying age and many are out of service.

Typical Aluminum Water Fountains

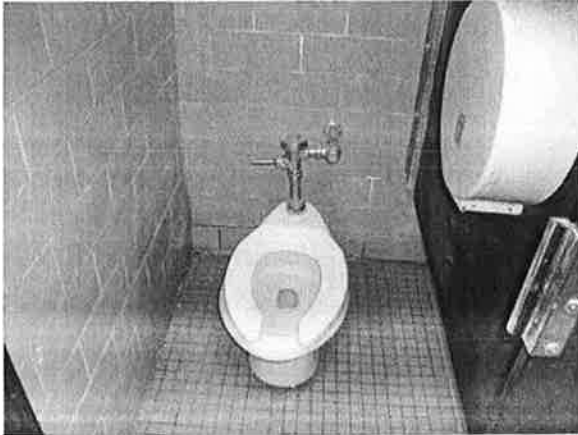
- **Sprinklers and standpipe** – SECTION REDACTED.
- **Locker rooms** – The District reports the boys and girls locker rooms are unused. The girls’ locker room contains two (2) lavatories, 19 showers, two (2) toilets, one (1) faculty toilet and one (1) faculty shower. The boys’ locker room contains two (2) lavatories, 18 showers, three (3) urinals and two (2) toilets. One (1) lavatory is located in the Trainer’s Room outside of the locker rooms. No faculty toilet rooms were observed within the Boys’ locker room. All toilet rooms appear to be in poor condition.

Typical Stall in Locker Room Toilet Room

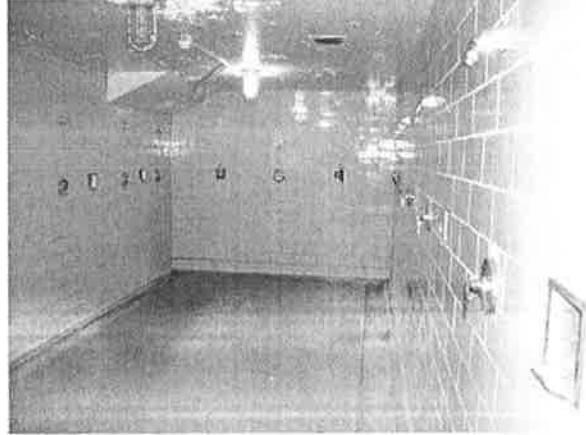
Girls' Shower Room - Locker Room

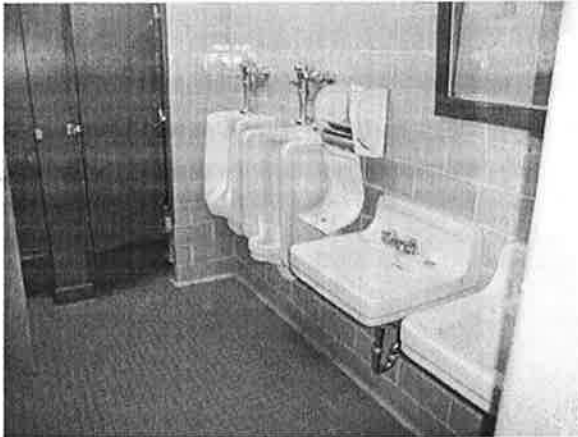
Boys' Toilet Room – Locker Room

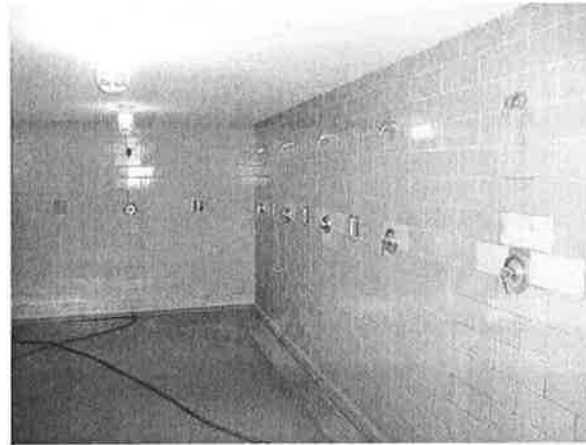
Boys' Shower Room - Locker Room

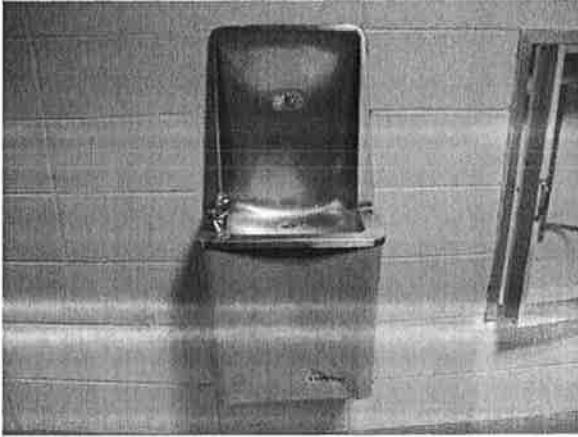
- Electric water coolers – There are 10 EWC locations in the building; all are out of service as the district is concerned with water quality. They are all stainless steel of varying age and many are out of service.

Typical Water Fountain

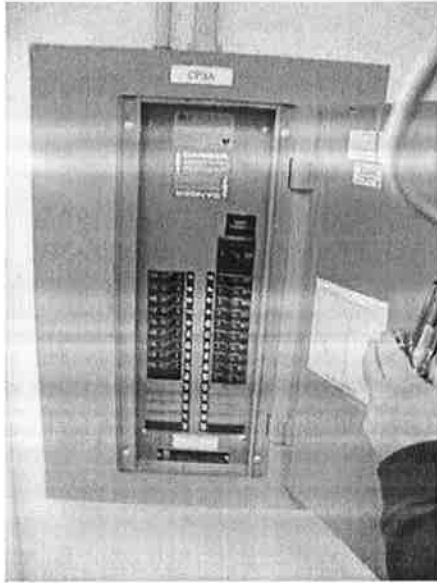
- Panels - Lighting, receptacle, computer and HVAC panels are located in corridors which do not conform to current standards requiring panels to be installed in electric closets. Exterior trims are in fair condition. Visual inspection of wiring in a few selected panels did not display signs of discoloration or brittleness. Wiring connections were tight.

Typical Interior of Electrical Panel

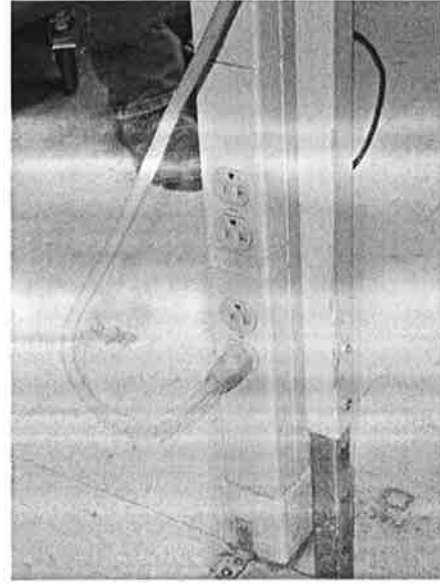
- Wiring - In the computer classroom, computers are powered from overhead power poles that are in good condition. Observed power strips are full but do not appear to pose any electrical hazards due to low power consuming devices. Exposed low voltage cables are run exposed without proper supports. Surface metal raceways (wire mold) were added to accommodate the equipment added over the years.

Floor to Ceiling Power Pole in Computer Lab

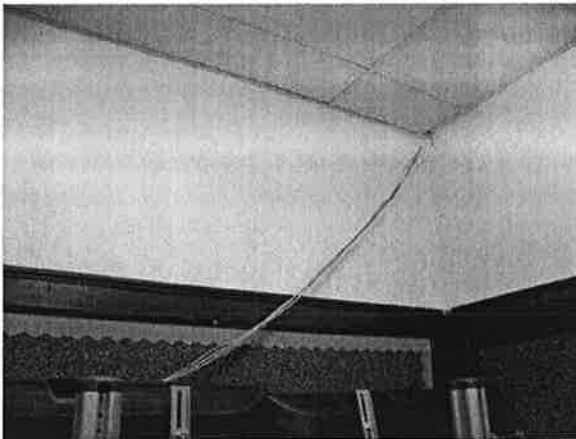
Typical Wiring in Computer Lab

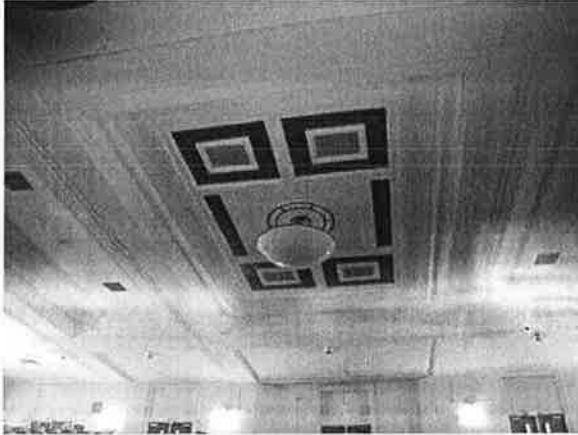
- Roof - Majority of disconnect switches for HVAC equipment contains corrosion on tops of switches and are inadequately supported (loose and wobbly). Some disconnects are lying on the ground, creating an electrical hazard.
- Auditorium - Center chandelier is mounted off center of mounting hole which may represent a mounting problem. All lighting is incandescent.
- Stage Area - Stage lighting consists of two rows of multi colored incandescent lights which are controlled by a dimming control panel. However, lights do not dim and appears the dimmer modules are not functioning. System is labeled as Strand lighting.
- Main Electric Room - **SECTION REDACTED.**
- Boiler Room - The Emergency generator runs on natural gas, rated at 7.5kw and manufactured by Onan. Generator was last serviced on February 6, 2012; condition looks fair. Disconnect switches/starters are heavily corroded.

Center Chandelier in Auditorium

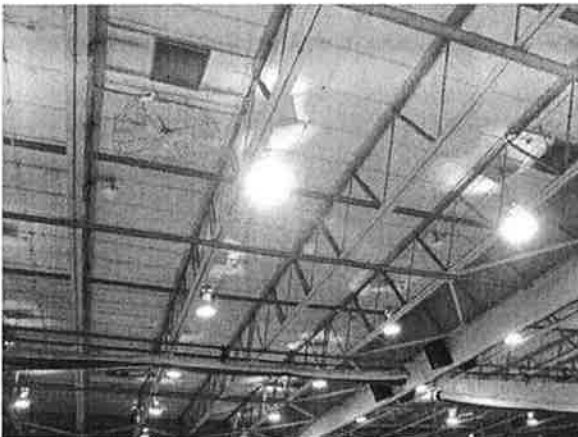
- Gymnasium – Observed gymnasium lighting type is hi-bay metal halide; controlled by circuit breaker in lighting panel.
- Computer Lab – In the computer classroom, computers are powered from overhead power poles that are in good condition. Observed power strips are full.

Gymnasium Lighting

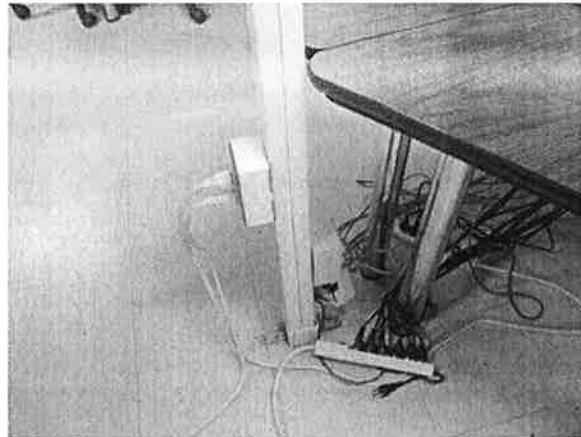
Computer Lab Power Strip/Pole

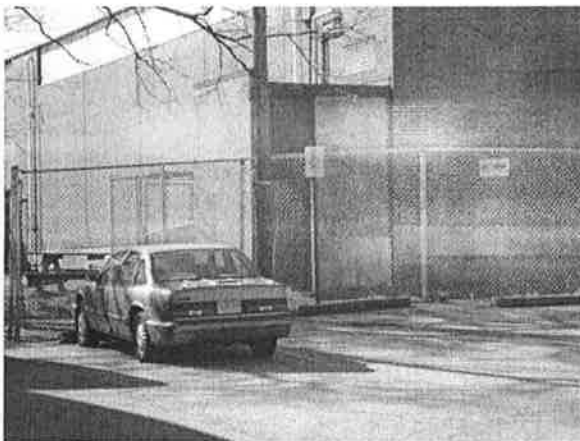
Designated Accessible Parking Space

- Parking – Only one (1) designated accessible (HC) space was observed within the school’s parking lot. This space is located on the side of the gymnasium.

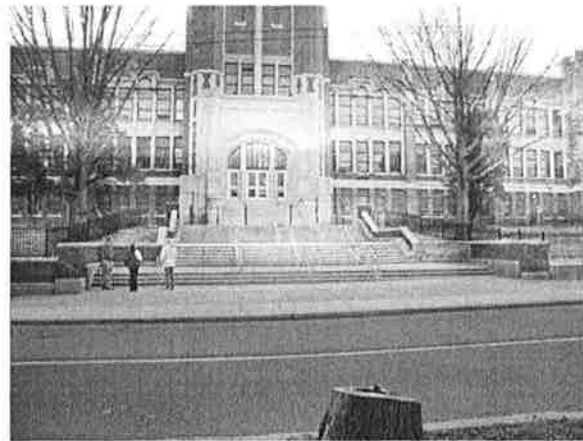
Main Entrance from Park Avenue

- Entrances/accessible routes – There is no accessible route at the main entrance. Only one (1) accessible entrance/exit was observed within the Main Building and is located on the Baird Boulevard side of the building. Neither the Annex nor Vocational Wing has accessible entrances/exits. No doors with automatic door openers were observed throughout the building.

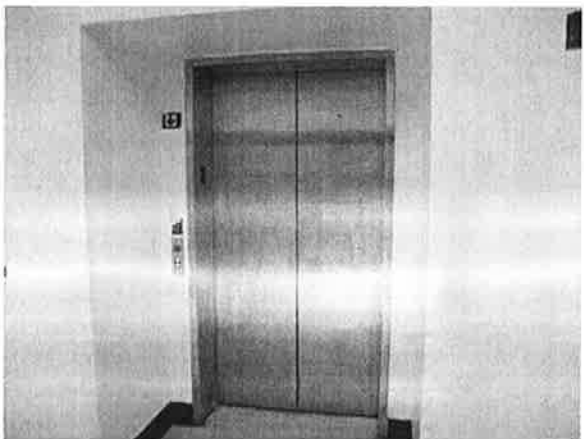
Elevator - Main Building

- Elevators and lifts – There is only one (1) elevator, located in the Main Building which serves all three (3) floors of the Main Building. No elevators or lifts were observed in either the Annex or Vocational Wing. The elevator was functional at the time of the site visit and appears to be accessible.

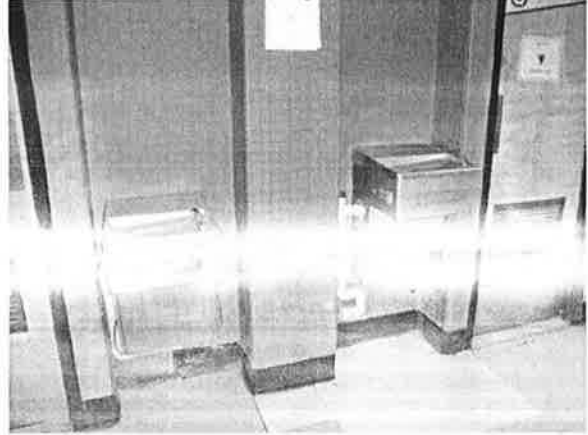
Typical Accessible Water Fountain - Annex

- Electric water coolers – Majority of the EWC’s observed within the Main Building and Annex appear accessible; the Vocational Wing does not appear to have accessible EWC’s.

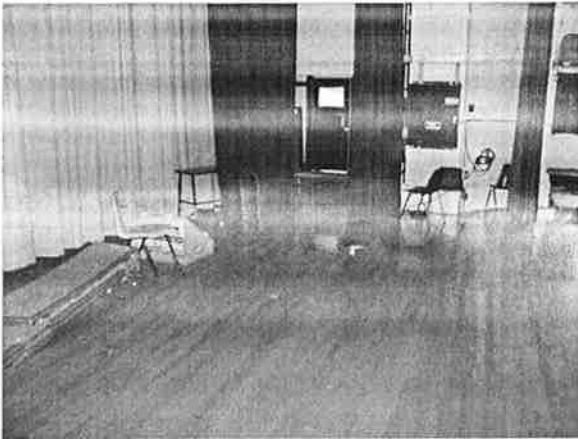
Accessible Entrance to Rear of Stage

- Door hardware – Majority of interior doors do not have lever-type hardware; much of the hardware is in a state of disrepair or worn from use.
- Auditorium/gymnasium – There is no dedicated accessible seating area in the auditorium. Stage is accessible from doors located at back corners of stage, not from main Auditorium floor. Neither the boys’ or girls’ locker rooms have accessible routes of egress.

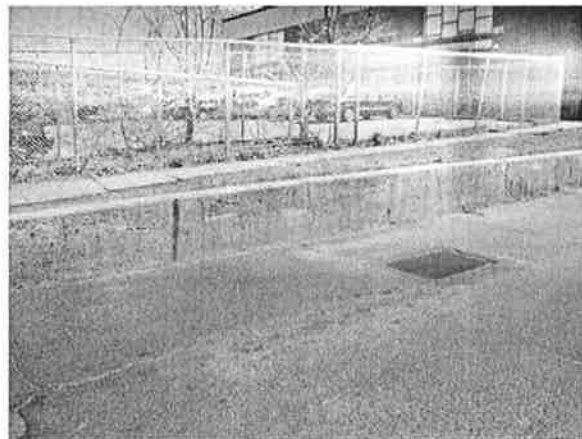
- Fencing - Chain-link fencing around the wooded sections of the school is in poor condition. The wrought iron fencing around the front and Baird Boulevard sections of the building is also in poor condition.

Typical Chain Link Fencing

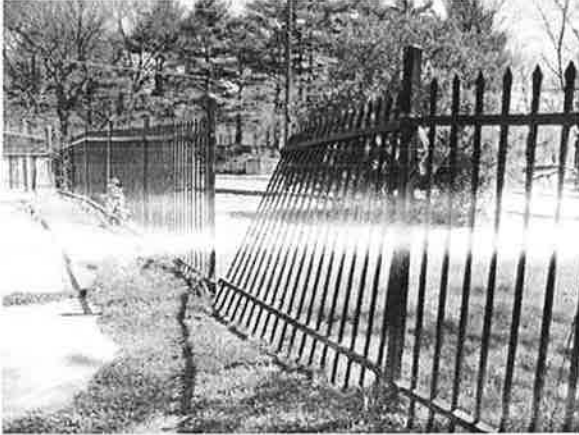
Iron Fencing in Disrepair

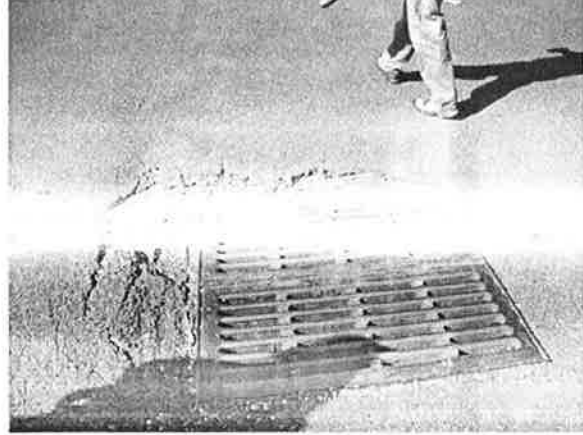
Storm Drain with Poor Paving

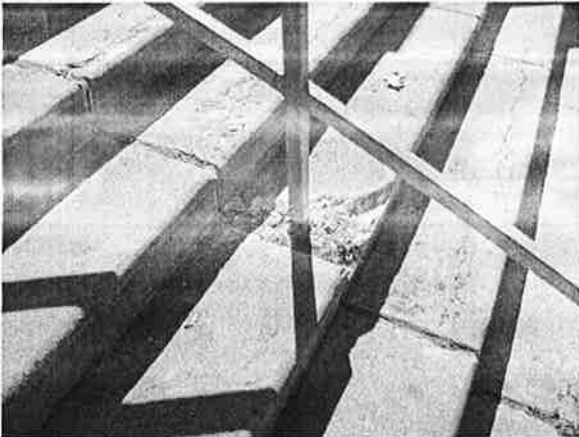
- Handrails - All exterior handrails should be checked for structural integrity but appeared functional.
- Site lighting - **SECTION REDACTED.**
- Sidewalks / Flatwork - Sidewalks appear to be in marginal condition across the site. Leading up to the entrances of the school, the stairs appear to be functional and in fair condition. Much of the concrete flatwork (curbing, landings, etc.) is severely degraded especially where steel fencing or railings meet these areas.

Site Handrail Needing Inspection

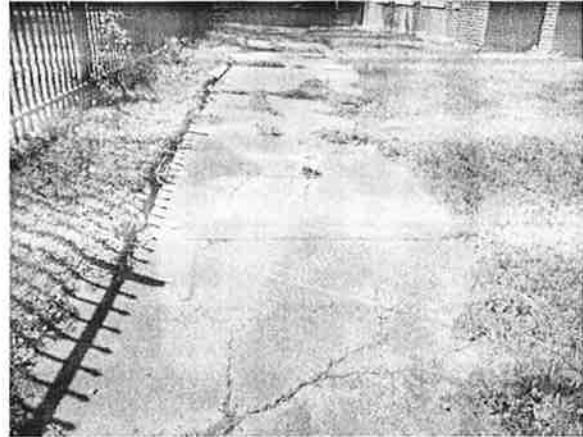
Typical Sidewalk Conditions

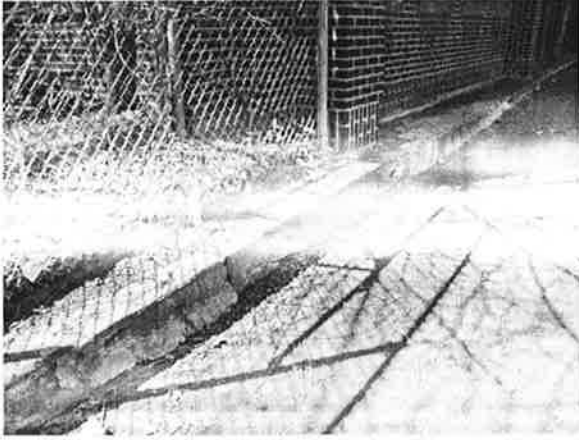
Typical Curbing Conditions

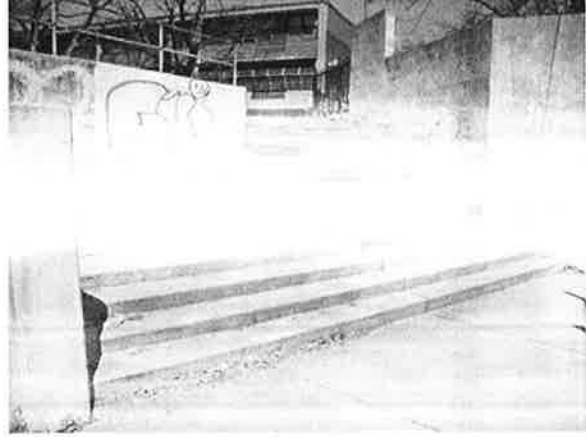
Stairs/Retaining Wall on Baird Boulevard

- Retaining Walls - Brick retaining walls were observed on the Garden Drive and Park Avenue sides of the property; poured concrete retaining walls were observed in the rear of the main building and on the Baird Boulevard side of the Annex. All walls were observed to be in poor to fair condition.
