SCHOOLS DEVELOPMENT AUTHORITY

Facilities Conditions Assessment Report Cleveland Street School 355 Cleveland Street Orange, NJ

As of April 2013

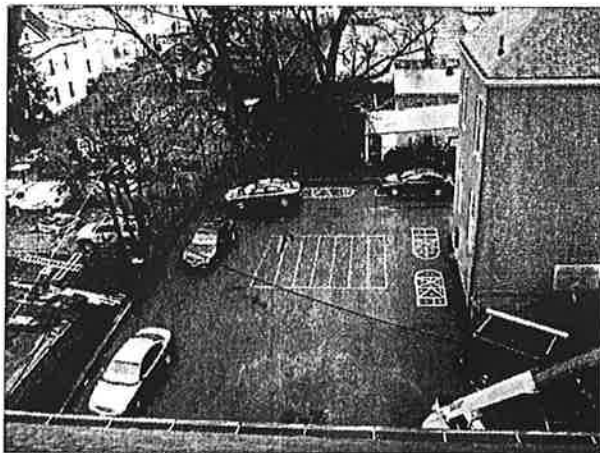
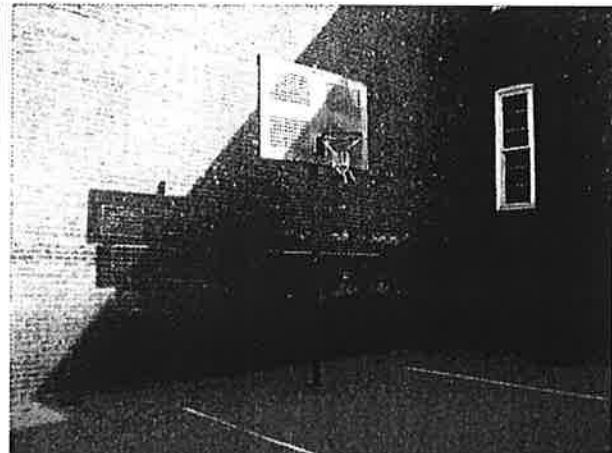
•**Playground:** There is no dedicated playground for the school. Paved areas on the sides and rear courtyard of the building are used for this purpose and contain no playground equipment or soft play surface.

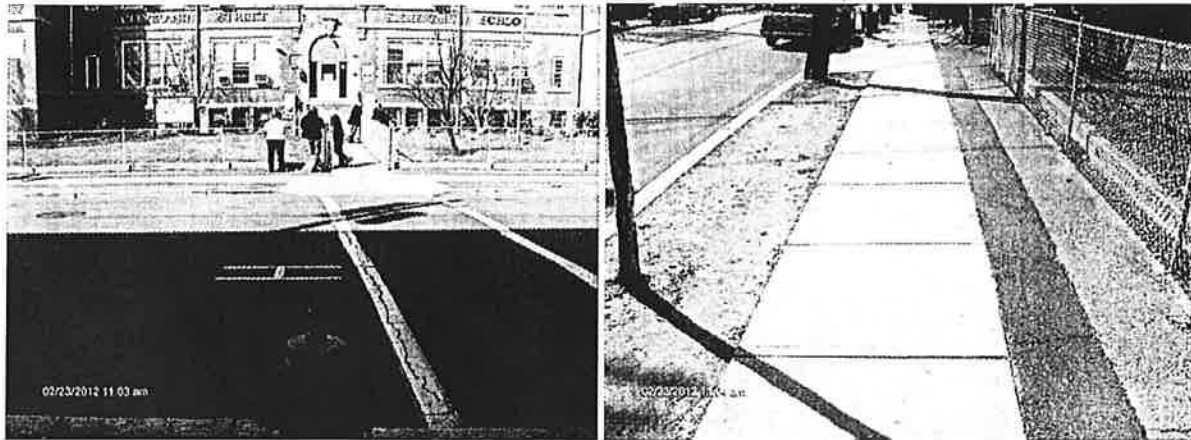
•**Sidewalks:** A 200' poured concrete sidewalk in front of the school along Cleveland Street is in very good condition. There are curb cutouts at the north and south ends for access to the driveways and one in the center of the property leading to the main entrance.

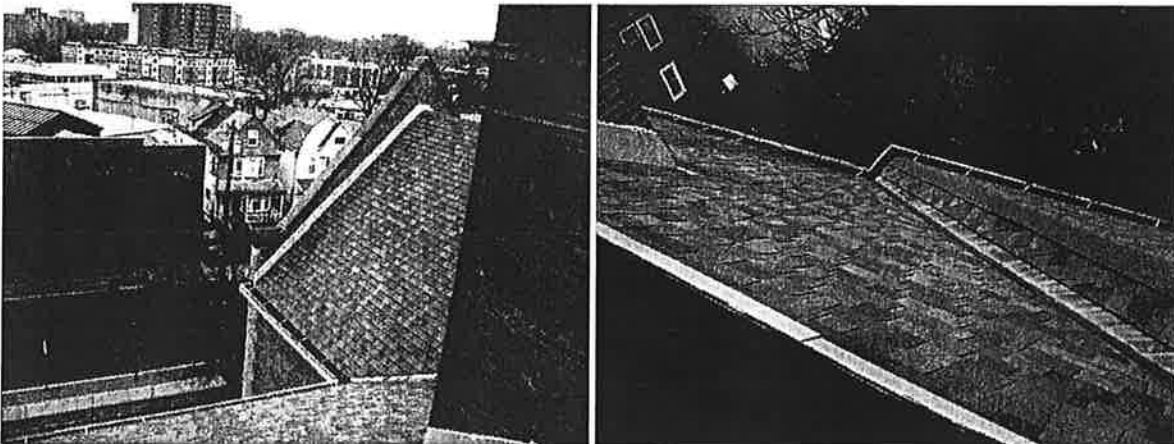
- **Roofs:** There are two different roofing systems used on the building. The shingle roof system, flashings and gutters over the majority of the school appears to be in good working condition with no signs of active leaks.

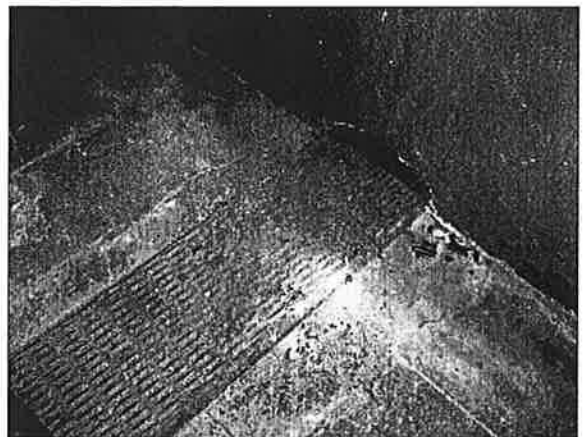
Steam and condensate piping run along ceiling, walls and floor in basement.

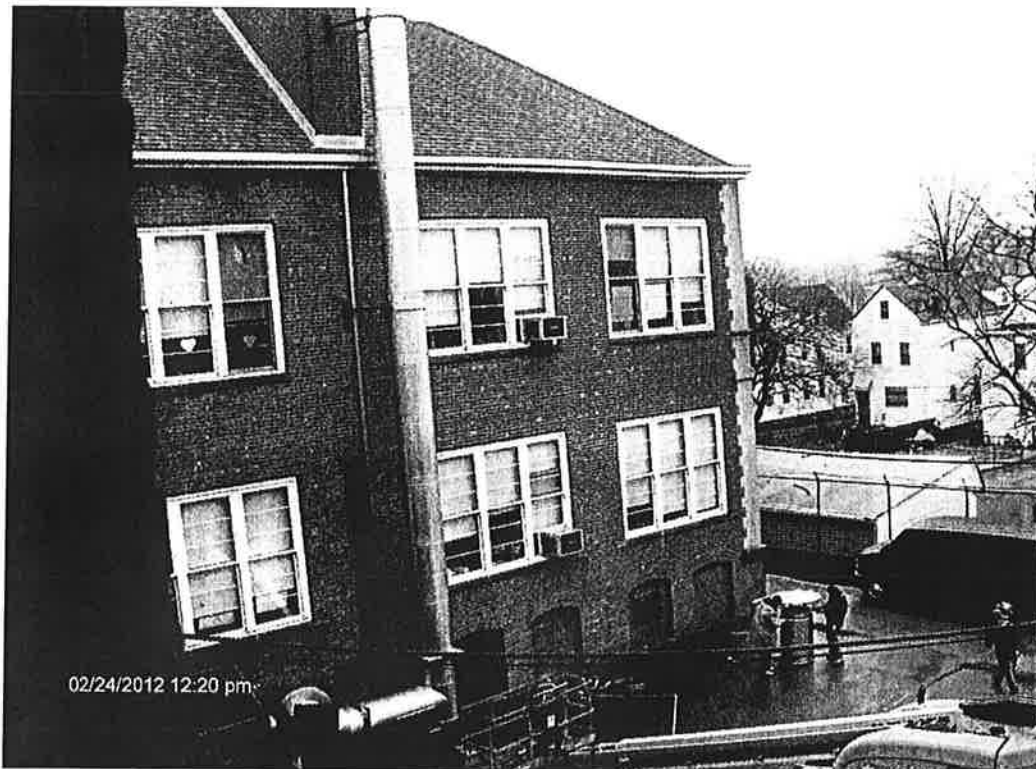
A new boiler vent system was being installed during the site visit to replace the old rusted out stack. The new system included a transition and connection from the new vent system to the existing center section of the boiler smoke hood, a wall penetration and an outside vertical vent. The vertical vent is a Selkirk 24" ID double wall system that runs on the outside of the building from the ground level to above the roof line.
