SCHOOLS DEVELOPMENT AUTHORITY

Facilities Conditions Assessment Report

Connors School

As of June 2013

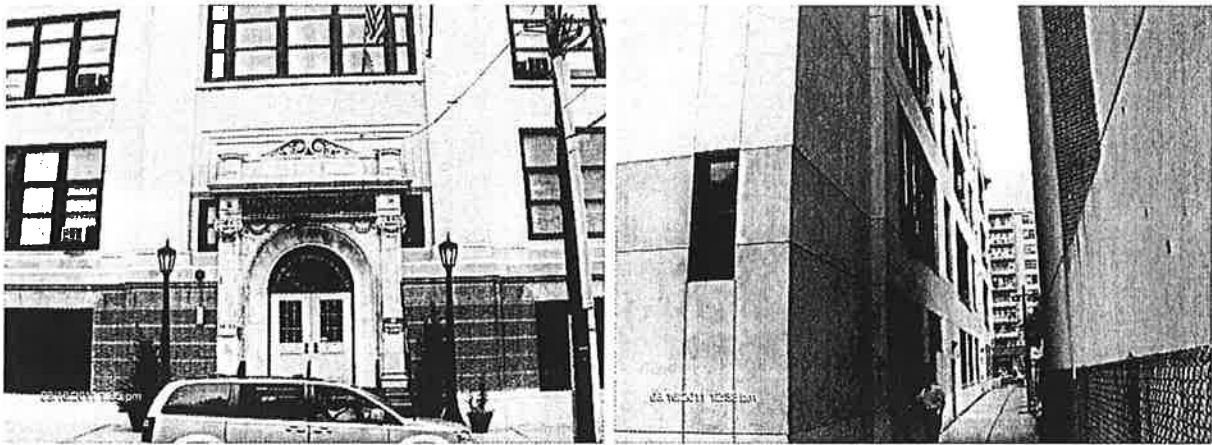
- **General:** The front (west) and side (south) facades are predominately brick. The rear (east) and side (north) are brick covered with a stucco panel system.

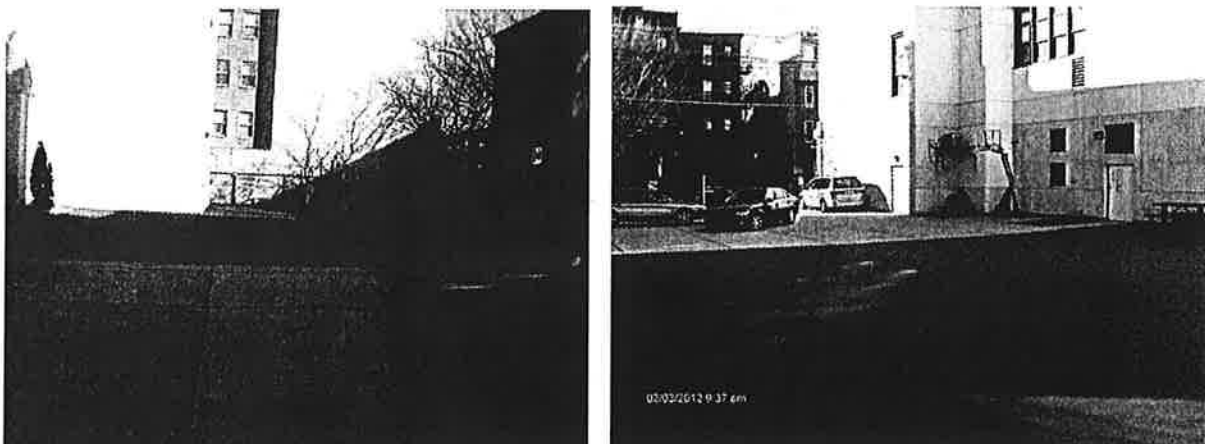
- **Playground:** There is a small fenced in parking and play area located behind the school. The play area has a 4,250 sf. rubberized surface and limited playground equipment.

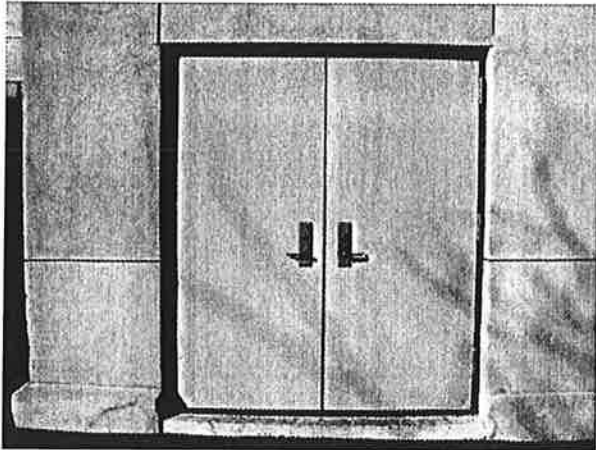
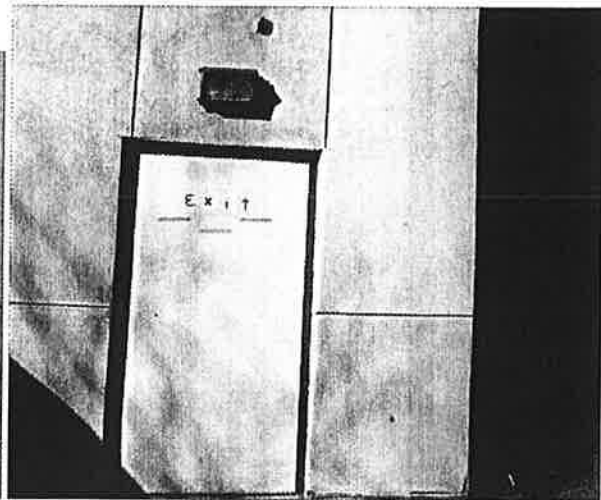
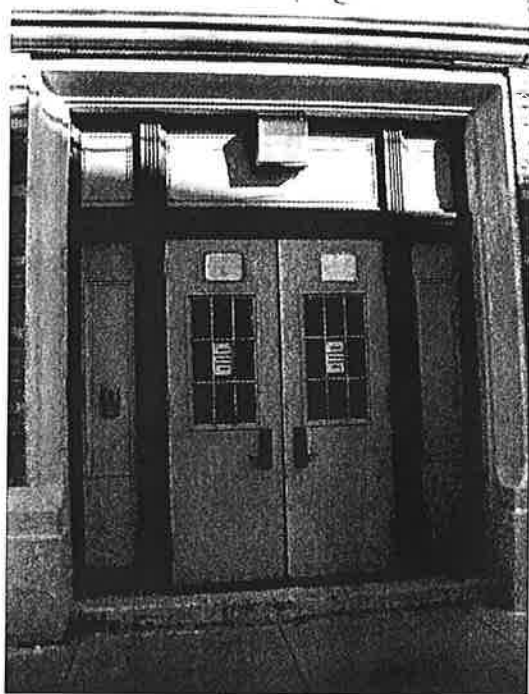
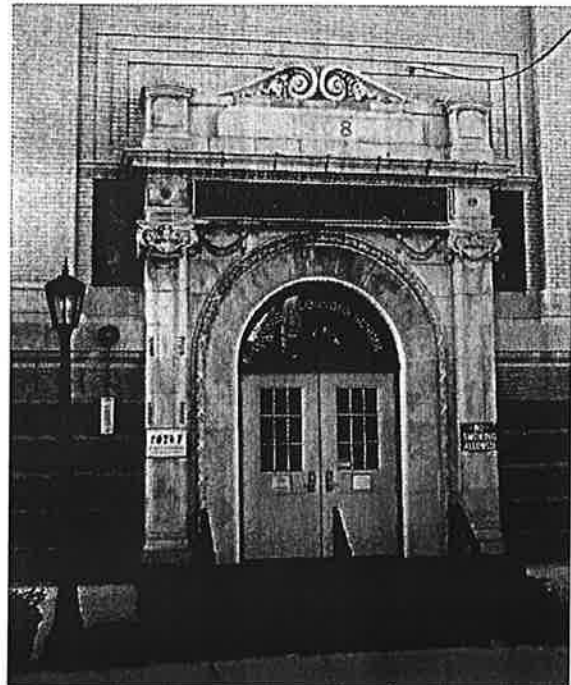
- **External Doors:** All external doors are painted and maintained in good condition with functional hardware.

The only barrier free entrance into the building is the door on the east side of the building that goes from the outside play area into the basement storage area outside of the maintenance shop and boiler room.

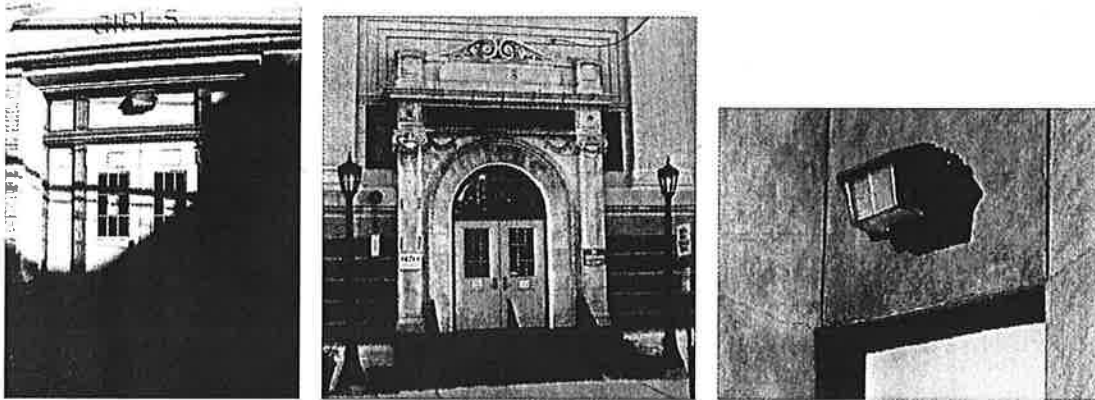
- **Exterior lighting:** All exit doors have lights mounted above the doors and extra wall mounted lights on East side.

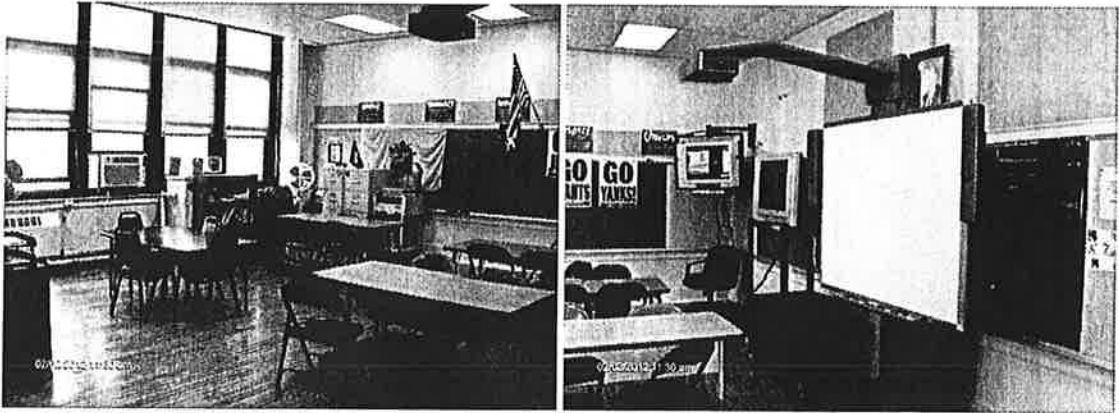
- **Classrooms** – Typical classrooms have wooden floors, plaster walls and 2’x4’ acoustical suspended ceilings with drop-in fluorescent light fixtures. Most classrooms have interactive white boards and attached coat rooms and are well maintained. Classrooms have no built-in casework.

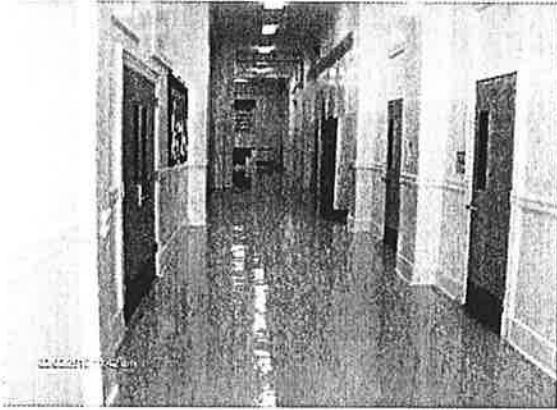
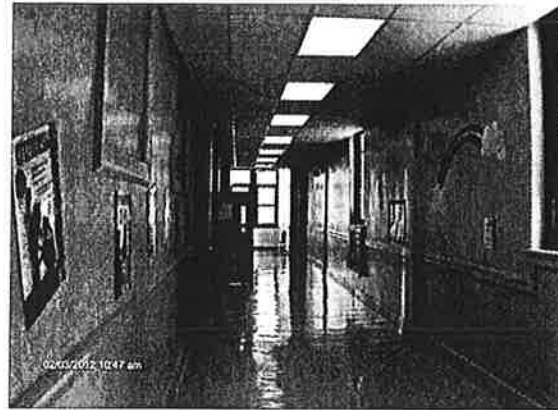
- **Corridors** – The corridors have 12x12 vinyl tile floors, plaster walls and a combination of 2x4 suspended acoustical and plaster ceiling with surface mounted and drop-in fluorescent fixtures. Doors leading to classrooms are newer solid wood with wired glass vision panels and lever handles. The corridors are well maintained.

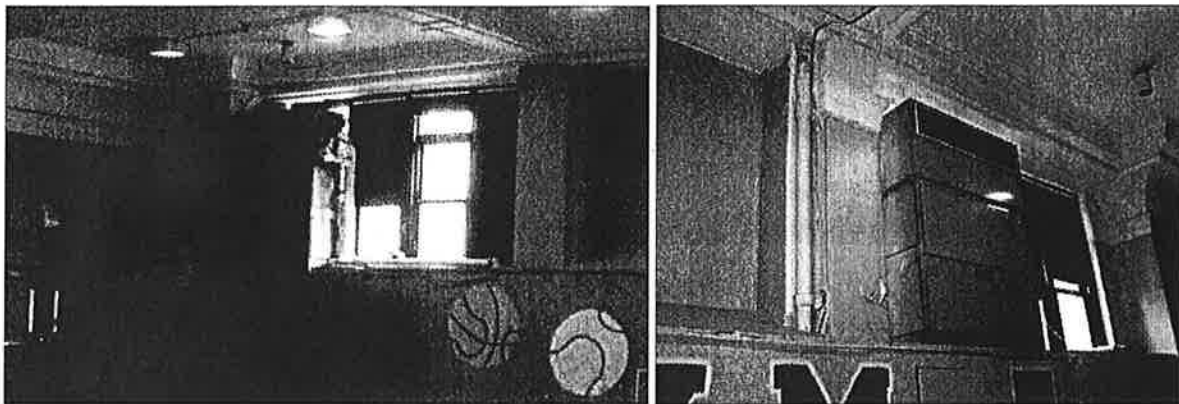
The multi-purpose room (gymnasium/auditorium) has two (2) Trane air handling units with steam coils for heating located in the east side windows and exhaust air louvers on the west side ceiling.

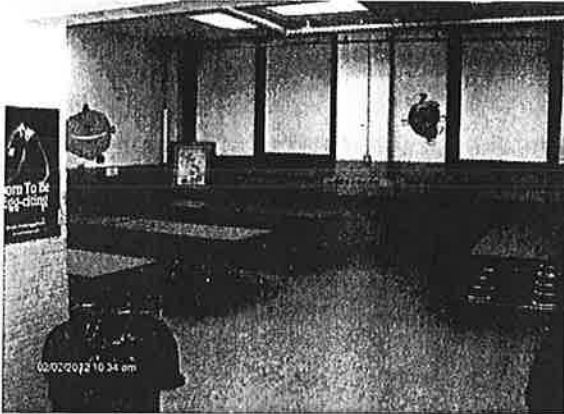
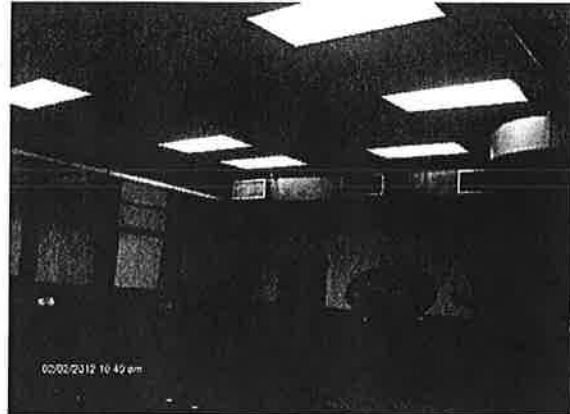
The basement cafeteria is serviced by fin tube radiation and steam coiled air handlers ducted into the dining area providing heat and ventilation.

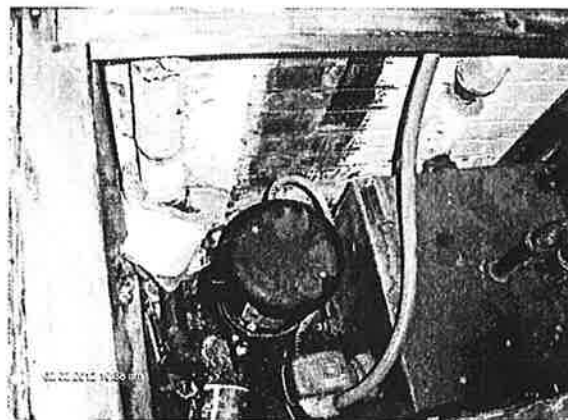
Condensate return pumps are located in wooden boxes located around the perimeter of the cafeteria and in the air handler closets. The cafeteria is not air conditioned.

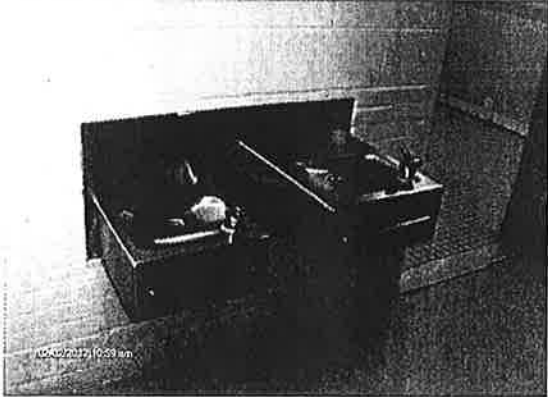
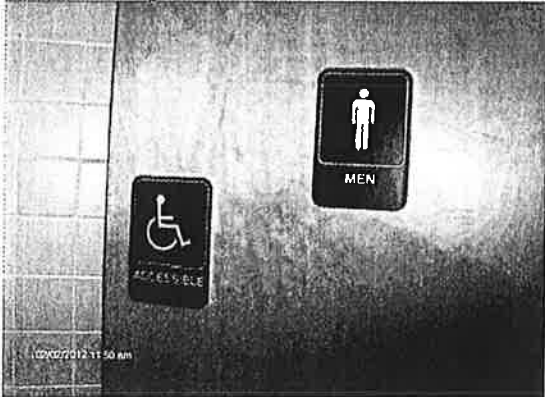
- **Accessibility** – The only barrier free means of access into the building is a door from the play area located at the rear of the building. The school has an operational 1991 elevator that services all floors and is in fair condition. Barrier free restrooms and drinking fountains are located on all floors.
