# SCHOOLS DEVELOPMENT AUTHORITY

Facilities Conditions Assessment Report  
Orange High School  
400 Lincoln Avenue

As of April 2013

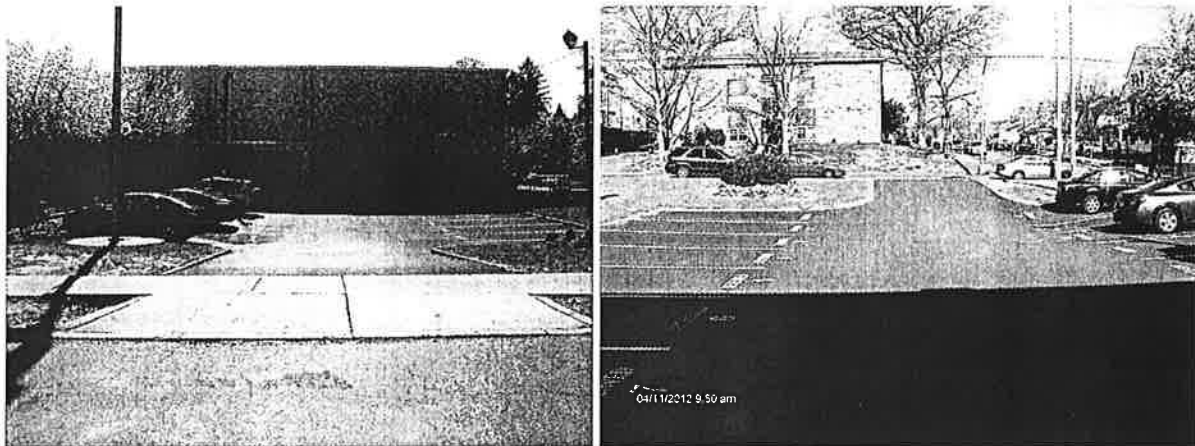
**Main Entrance Parking Lot**

In front of the school at the main entrance off of Lincoln Avenue is a small parking lot with 13 parking spaces (10 reserved, 2 visitor and 1 handicap). All parking spaces are clearly marked.

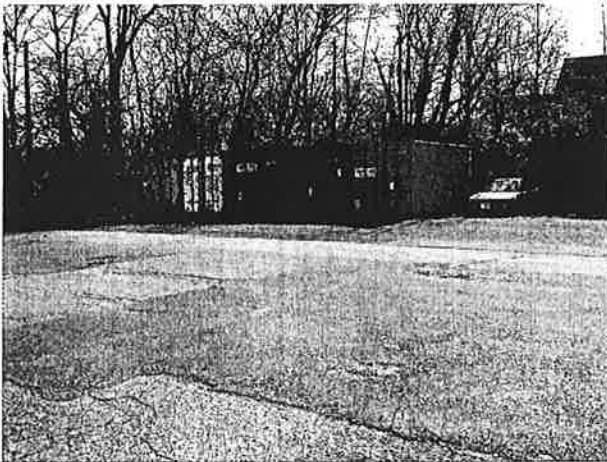
Several metal conex boxes used for storage are located in the rear corner of the parking area.

Painted parking space markings are faded or have been removed as result of patching causing a random parking pattern.

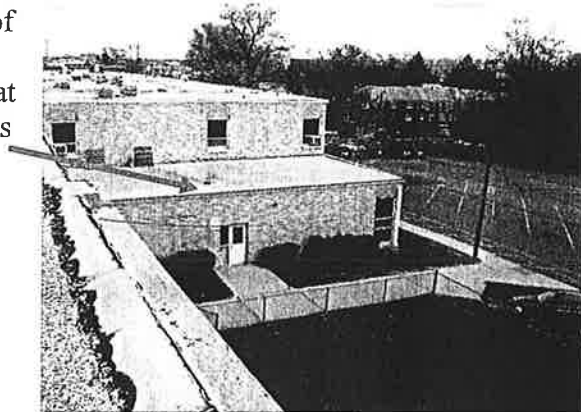
The district did not report any significant roof leaks on either roof system other than a concealed drain leak in the lower BUR roof at the south east corner of the school that affects the corridor below.

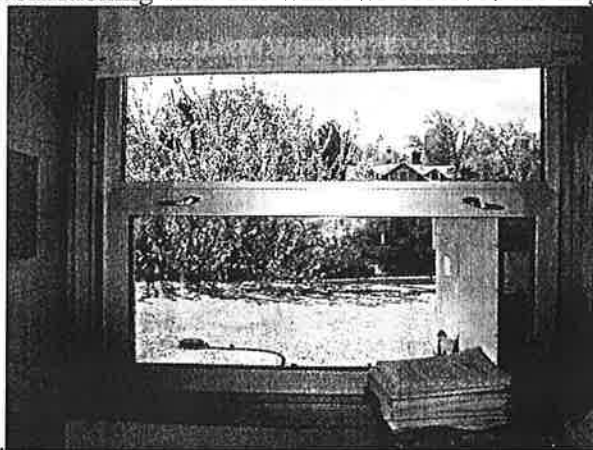
**Typical Window**

The windows which appear to have been replaced within the last ten years are double pane hopper type with large stationary glass panels above the tilt in section. In many rooms the hopper section of the window has been removed or modified to accommodate the installation of a window air conditioning unit. The windows observed are in good condition and operative.

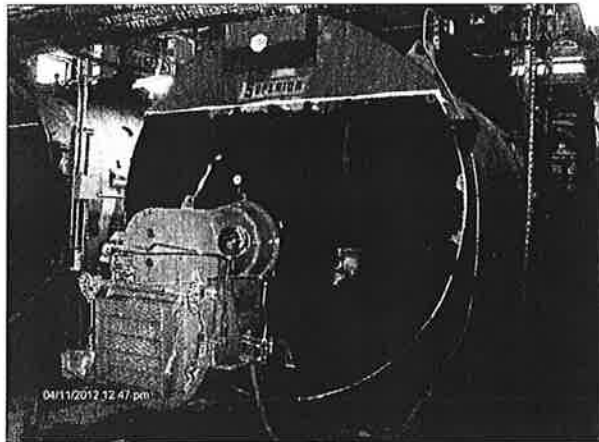
**Middle School**

**HEATING VENTILATING & AIR CONDITIONING (HVAC):** The schools HVAC is comprised of a number of different components, boilers, exchangers, unit ventilator, chiller, exhaust fans and ventilators. Heat is provided by two (2) 1971 Superior gas fueled fire tube steam boilers located in the Middle School located next to the High School on the north side. Steam is delivered to the high school via underground piping.

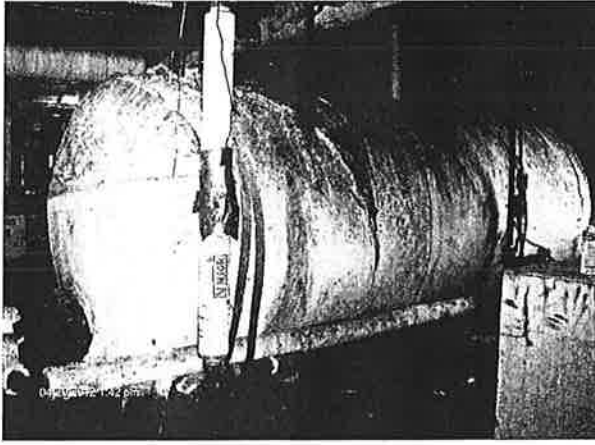
**Domestic Hot Water Exchanger**

In the High School are three (3) steam to hot water heat exchangers. Two (2) of the exchangers provide hot water heat to the schools unit ventilators and the third exchanger provides domestic hot water. Since there is no domestic hot water heater in the high school, one (1) of the two (2) Middle School boilers must be run year round to provide steam to the domestic hot water heat exchanger which makes the domestic hot water. Two (2) AO Smith domestic hot water heaters were installed in the Middle School in 2003 and piping was subbed out to run to the High School but never completed. An explanation as to why the piping was not run to the high school could not be provided by the districts representative participating in the walk through.

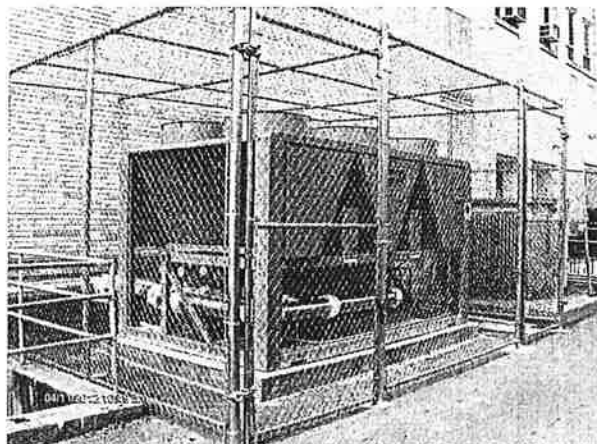
**Air-Cooled Chiller**

- **Air Conditioning** – In 2010 district received SDA Grant GB-0183 to replace existing cooling tower, chiller and condenser pumps and other equipment including classroom ventilators. The recently installed Carrier 100 ton air cooled liquid chiller provides cold water air conditioning to interior windowless classrooms and the Media Center via new unit ventilators. The chiller is located on a fenced in concrete pad located in the north side driveway. Additional air conditioning is provided by a combination of forty-eight (48) window units, split systems with condensing sections on the roof (for 2<sup>nd</sup> floor rooms) and ground (for 1<sup>st</sup> floor rooms) and package unit and Trane Intellipak air-cooled chiller (for Main Office area).

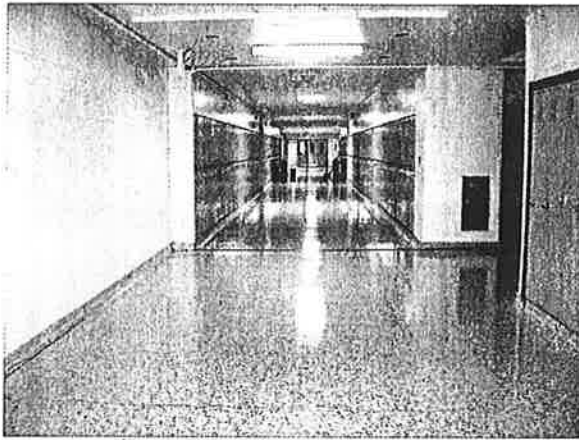
**1<sup>st</sup> Floor Terrazzo Corridor**

- **Floors** – The school has a variety of different floor coverings including terrazzo, carpeting, wood, vinyl composition tile (VCT), quarry tile and ceramic tile. The first floor corridors and all of the steps and landings in the four (4) stair towers are terrazzo. Several of the terrazzo stair tread noses are broken and chipped. The corridor terrazzo flooring has some cracks but is in relatively good condition.

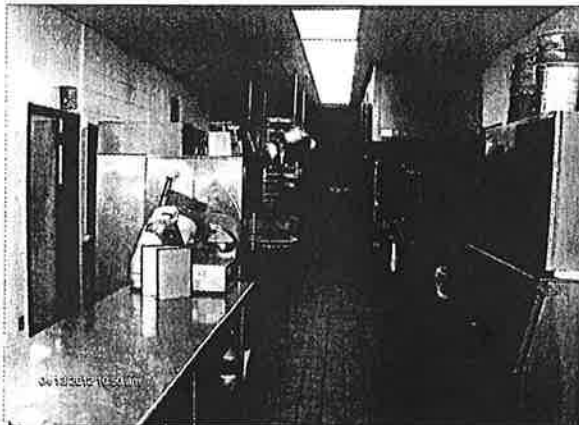
**Kitchen Quarry Tile**

The floors on the 2nd floor corridors and classrooms on the 1<sup>st</sup> and 2<sup>nd</sup> floors are covered in 12"x12" VCT. This floor appears to be original and areas of replaced tiles were observed. The kitchen floor is 4"x 4" quarry tile and is good condition. The locker rooms are a combination of terrazzo and ceramic tile, with terrazzo in the locker area and sheets of 1"x1" ceramic tile in the shower and restroom areas. A crack running the entire length of the girls shower floor does not appear to pose a structural problem. The gang student restrooms floors are covered in 1"x 1" ceramic tile and appear to be original.

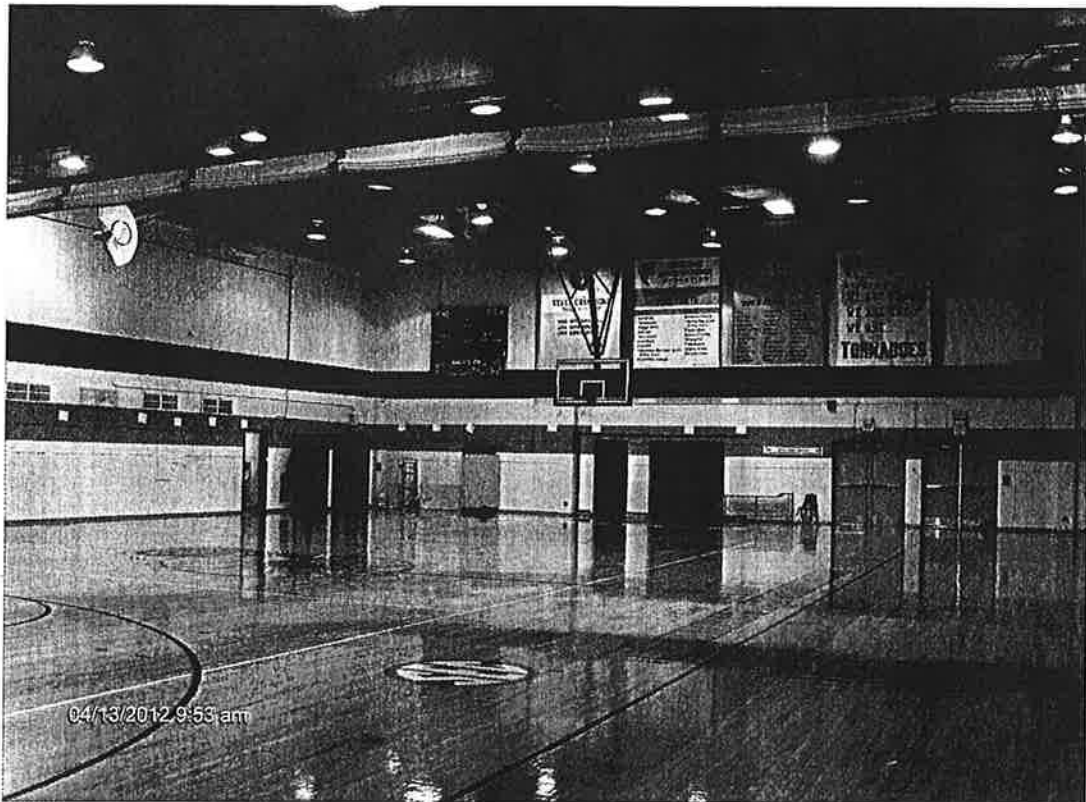
**Gymnasium**

The Gymnasium floor is a light colored hardwood that appears to be well maintained. Several rooms in the school are carpeted; these include the Media Center, Band and Music Rooms, Lounge and miscellaneous offices.

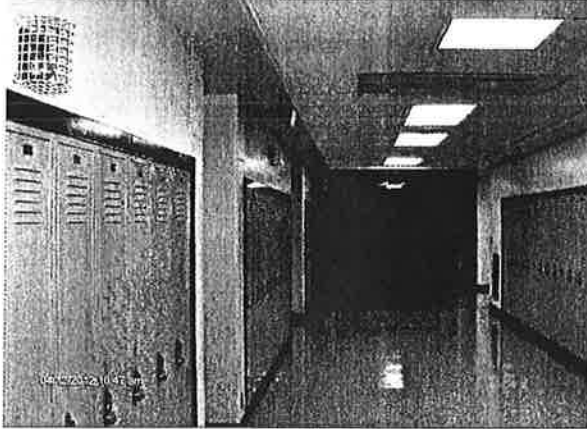
**Hallway Student Lockers**

- **Walls** – Classroom, hallway and specialty room walls throughout the school are primarily painted CMU. The hallway walls are lined with metal student lockers on both the 1<sup>st</sup> and 2<sup>nd</sup> floors. The restroom walls and the hallway water fountain recesses are covered in 4”x 4” glazed ceramic tile.

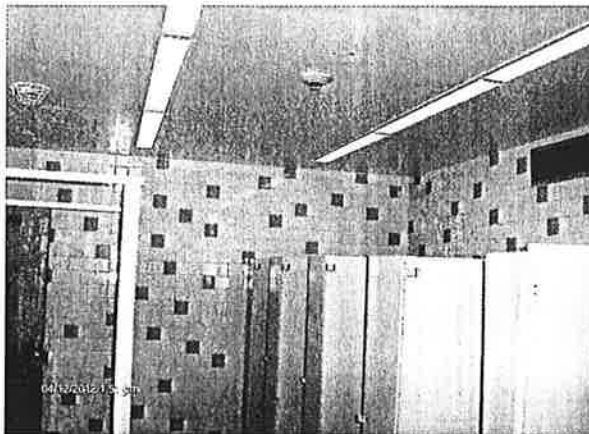
**Restroom Ceiling**

- **Ceilings** – The ceilings throughout the school, classrooms, hallways, offices, Media Center, cafeteria, kitchen and specialty rooms are acoustical ceiling tile (ACT). The ACT are a combination of 2’x4’ and 2’x2’ set into a suspended grid system. The gymnasium ceiling has exposed structural steel under the precast roof planks. Water stained ceiling tiles were observed in approximately half of the rooms on the second floor. It was felt that these stains were likely the result of condensation from mechanical pipes above the ceiling and previous active water leaks. The restroom ceilings are painted drywall. Hallway ceilings have a drywall soffit along perimeter and drywall ceiling at hallway intersections that are in good condition.

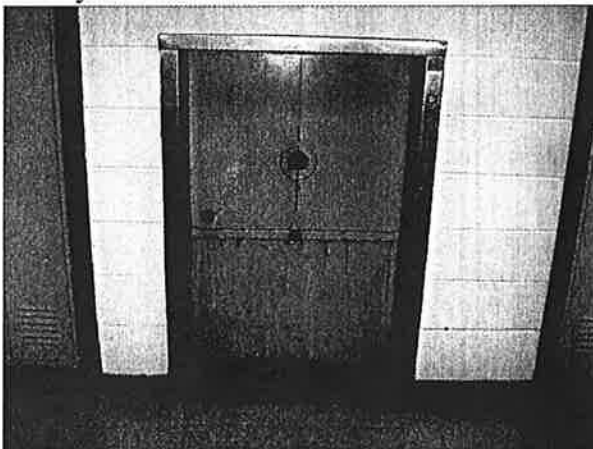
**Dumbwaiter**

- **Elevator** – The school does not have an elevator, stair chair lift or other mechanical personnel lifting device. A dumbwaiter is located in the north corridor outside the Media Center on the 2<sup>nd</sup> floor and the Cafeteria on the 1st. A portion of the west corridor is ramped next to the open court yard to transition between different elevations of the first floor.

There is no handicap access between different floors or levels of the school. The operational status of the dumbwaiter was not confirmed during the site visit.

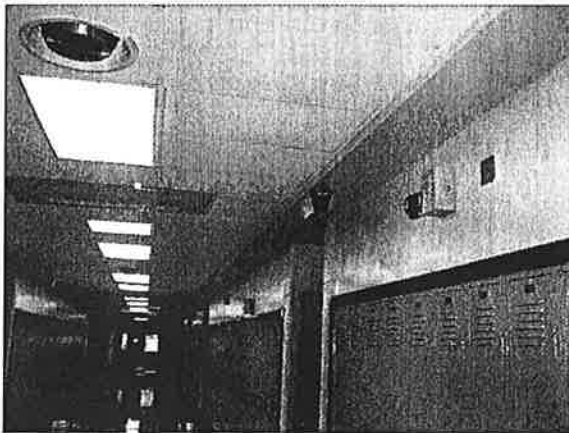
**Lay-in Fluorescent**

- **Electric** – Interior lighting is primarily provided by a combination of 2' x 4' lay-in and parabolic recessed fluorescent fixtures in the suspended ceilings. Hallway intersections have recessed high-hats in the drywall ceilings. Group restrooms have recessed fluorescent fixtures. Overall, illumination appears to be good with the exception of the restrooms which appeared to be dim.

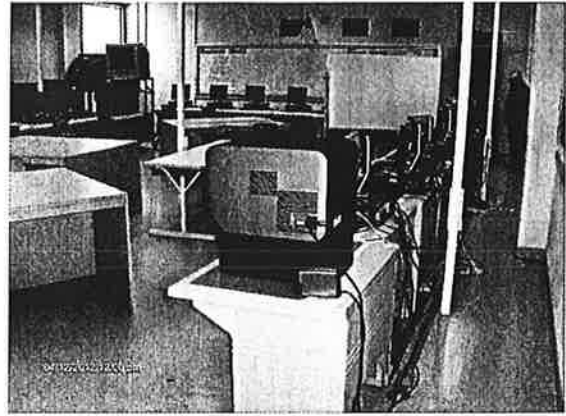
Computer Room 225

Most rooms appeared to have sufficient number of electrical outlets either wall or wiremold. Computer rooms and computer areas have power poles and floor boxes. The Music Room (Room #246), containing numerous pieces of equipment, had wire and power cords taped to the carpet floor causing a potential safety hazard.

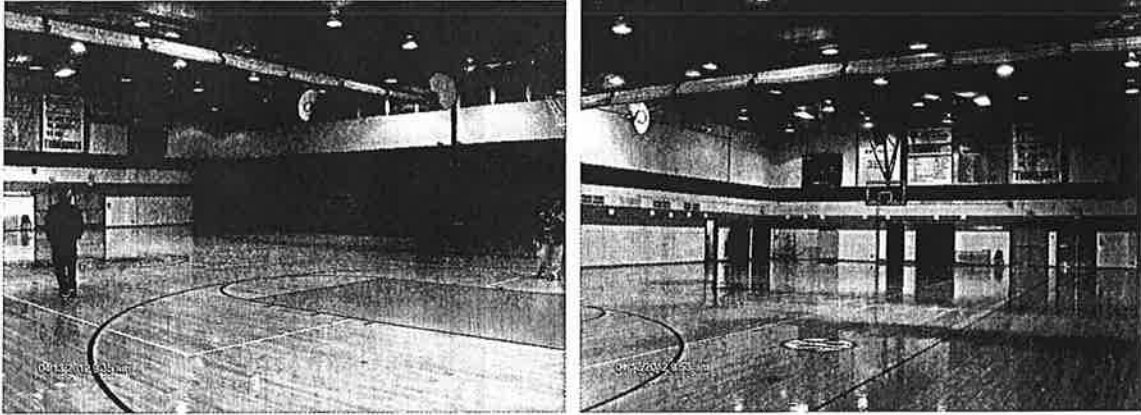
- **Cafeteria** – The 5,080 SF student cafeteria has a 13'4" ceiling, painted CMU walls and 12' x 12' VCT floor. The Cafeteria opens out to the interior open court yard. Six (6) new UV's were recently installed that supply heat only; there is currently no air conditioning in the cafeteria.
- **Gymnasium** - The Gym is 9,520 SF and has a 28'4" ceiling, painted CMU walls and hardwood flooring. The gym can be divided in half with the use of a drop down separation screen.

There are retractable power operated bleachers on the south side of the gym and Boys and Girls Locker Rooms located on the north side. Direct access to the outside is available on both the east and west sides of the room. Overall the gymnasium appears to be well maintained. The Boys and Girls locker rooms are located next to the gym. The Girls shower room has a crack in the ceramic tile floor running the entire length. The room also has two toilets and a water fountain that does not work. The Boys locker room has broken locker doors, benches have been removed but floor anchors still remain.
